Area 9 Joint Heater Trials

Technical Report

Kier Services

Project number: 60485963

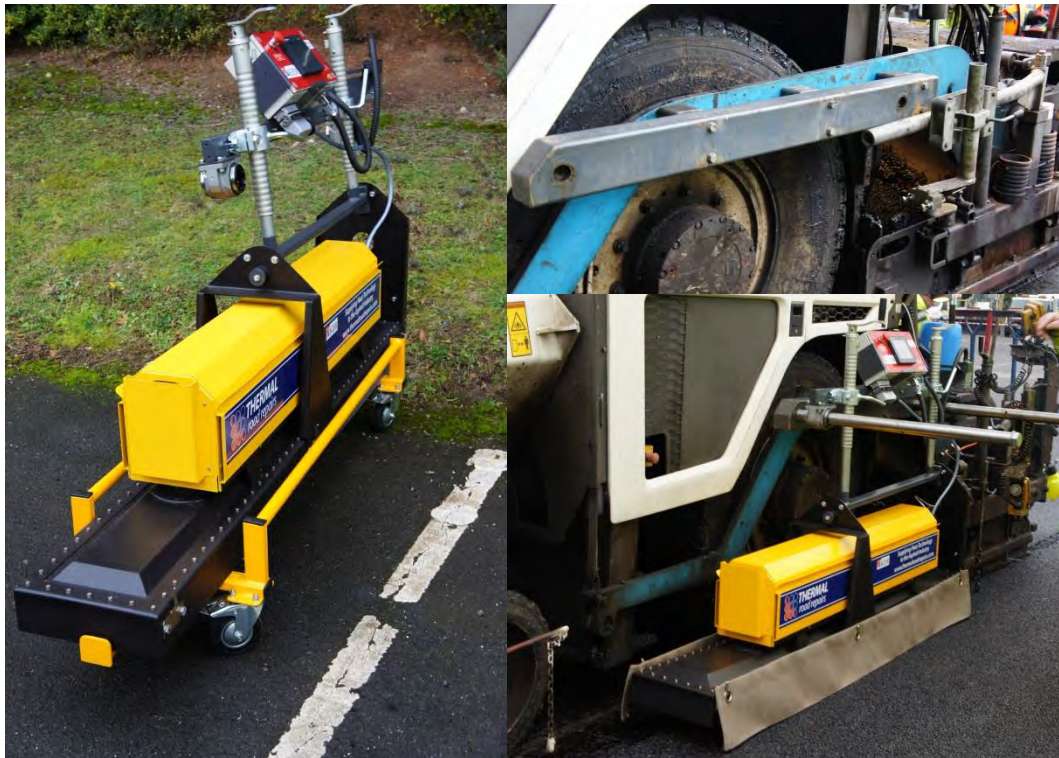
The heater was fitted to the side bar on the paver ahead of the augers. TRR fitted the heating equipment which took around 15 minutes to mount and appeared to be a simple well designed process. The equipment heated up at the same time as the paver screed and caused no delay to operations.

Figure 3: Photographs of the equipment; (clockwise) i) Joint heater equipment, ii) Paver side bar mount, iii) Joint heater technology fitted on the paving machine

Photographs of the equipment and set up for the trials are presented in Figure 3.

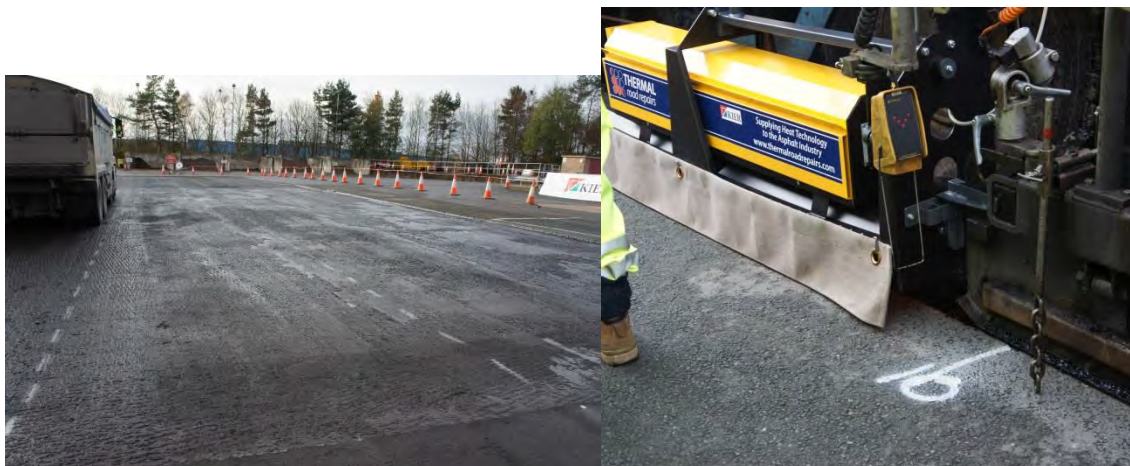
Figure 4: i) Planed surface prior to installation, ii) Joint heater in operation

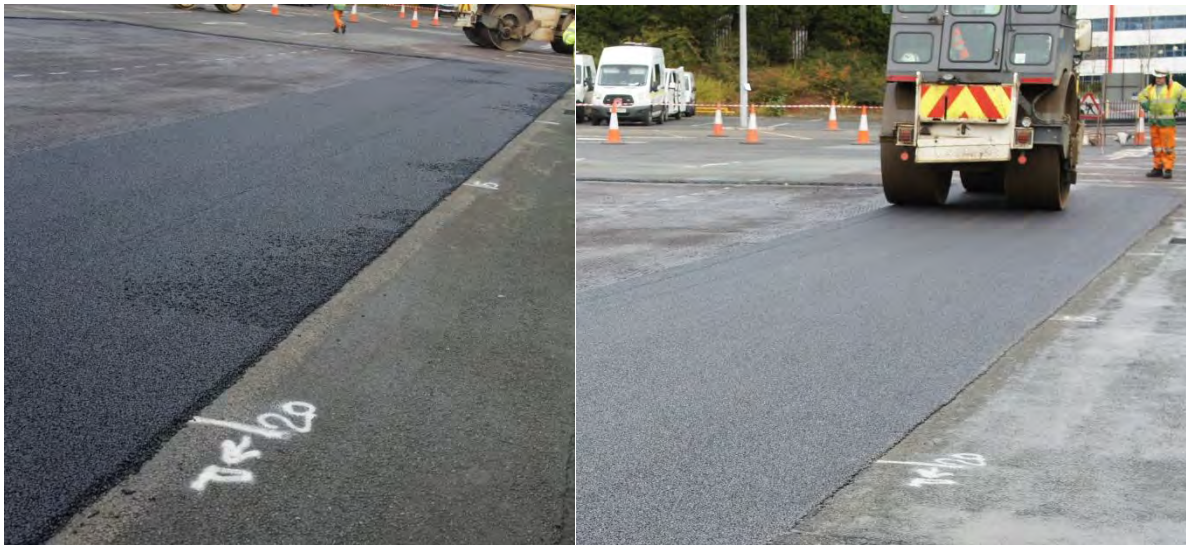
Figure 5: Heated Joint A i) before compaction ii) after compaction

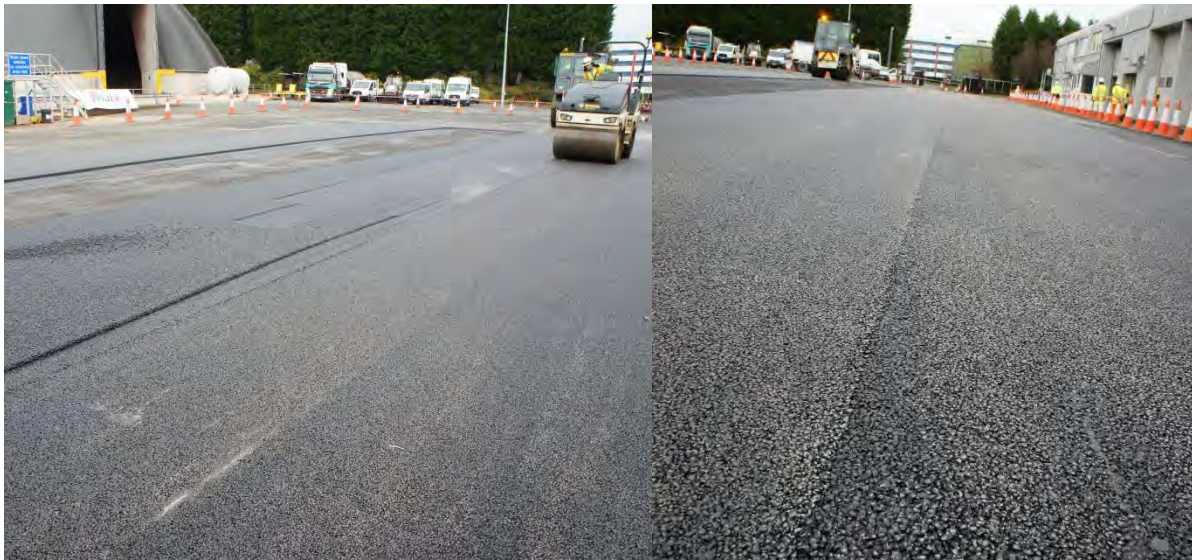
Figure 6: Heated joint B i) before compaction; ii) after compaction

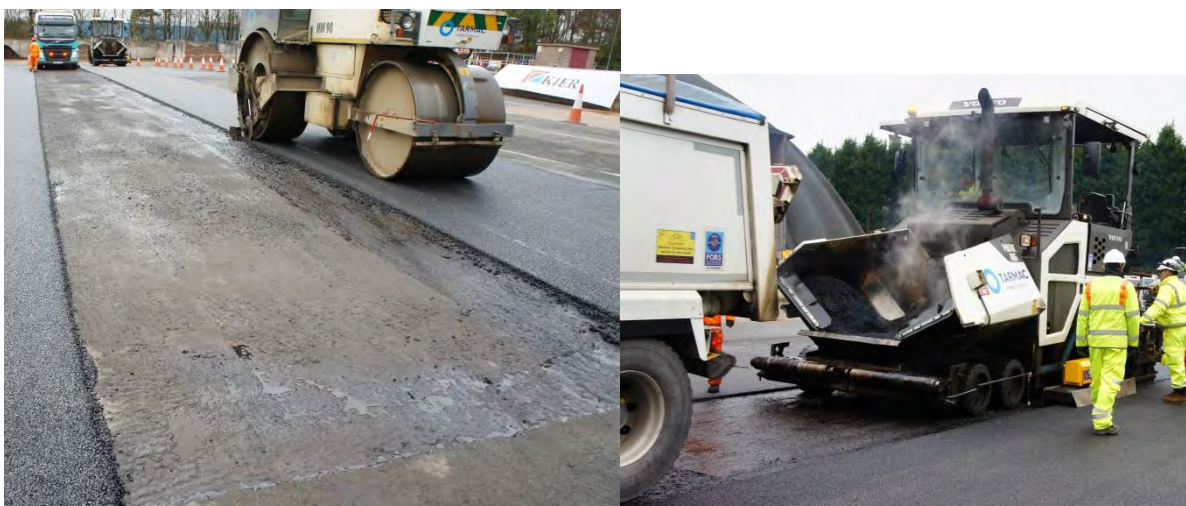
Figure 7: i) Cutting back Rip 2 unconfined edge prior to painting and installing Rip 4; ii) Installing Rip 4

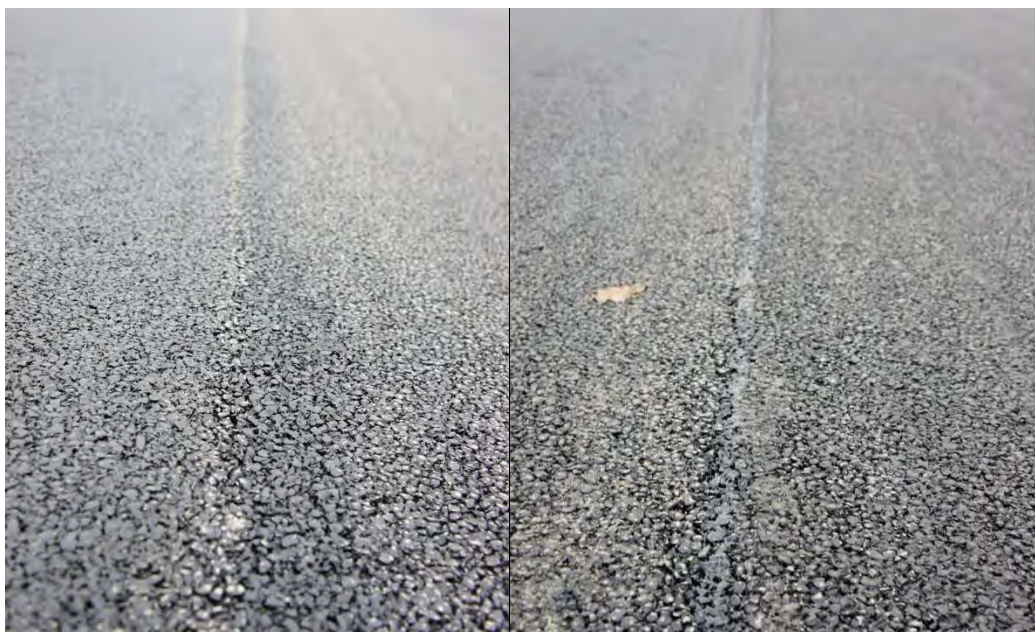
Figure 8: i) Heated Joint C (between Rips 3 and 4); ii) Painted joint D (between Rips 4 and 2)

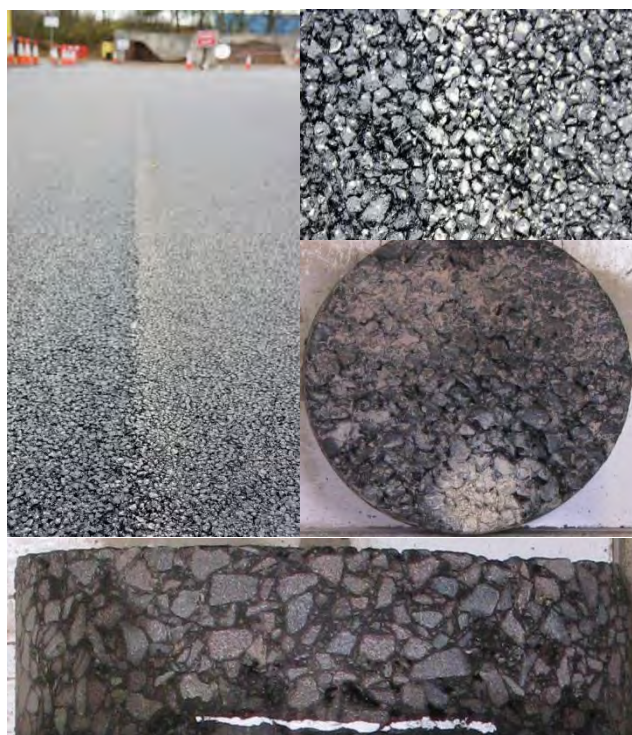
Figure 10: i) Photograph of joint B ii) Close up of joint iii) Surface of core 18 iii) Profile of core 18

The joint appears to be uniform at the surface with good aggregate interlock. In general, Rip 3 finished slightly proud of Rip 1.

Material is uniform and well compacted with good interlock evident in all of the cores. It was difficult to visually determine the joint location based on the side profile of the joint cores.

The confined edge of Heated Joint B was found to have 10% air voids (based on two cores at 9.9% and 10.0%) which was higher than Joints C and D and the central mat. The time before first pass of the roller is a possible contribution to higher air voids at the edge of Joint B. The time before first pass was observed to be reduced at heated Joint C compared with heated Joint B.

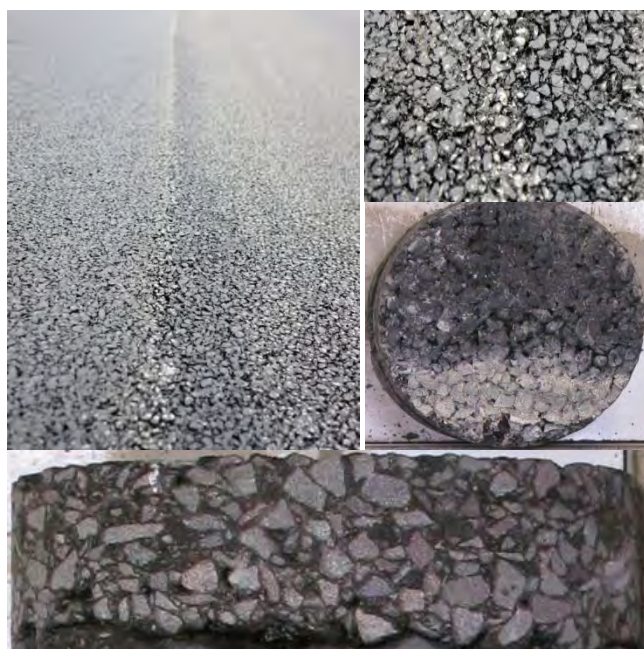
Figure 11: i) Photograph of joint C ii) Close up of joint iii) Surface of core 26 iii) Profile of core 26

The surface of the joint appears to be level, consistent and well formed with aggregate interlock evident. Heated Joint C appeared to be the most well-formed and uniform of the heated joints based on visual assessment of the surface.

Inspection of the core log photographs for the cores tested for permeability from Heated joint C show visually higher voids on the unconfined edge half of the core. This is generally consistent with visual assessment of other cores taken from this joint and the same is noted but to a lesser degree in cores from Heated Joint B.

Furthermore, it is noted that the two Heated Joint C cores tested for vertical permeability were also tested for DTT and during this test broke through material at the unconfined edge and did not split directly through the joint which suggests that the unsupported edge is having the greatest influence on the permeability results. It is expected that if Heated joint C was constructed as a painted joint, then the result may have been similar as the influence of the unconfined edge is expected to be much greater than the joint interface.

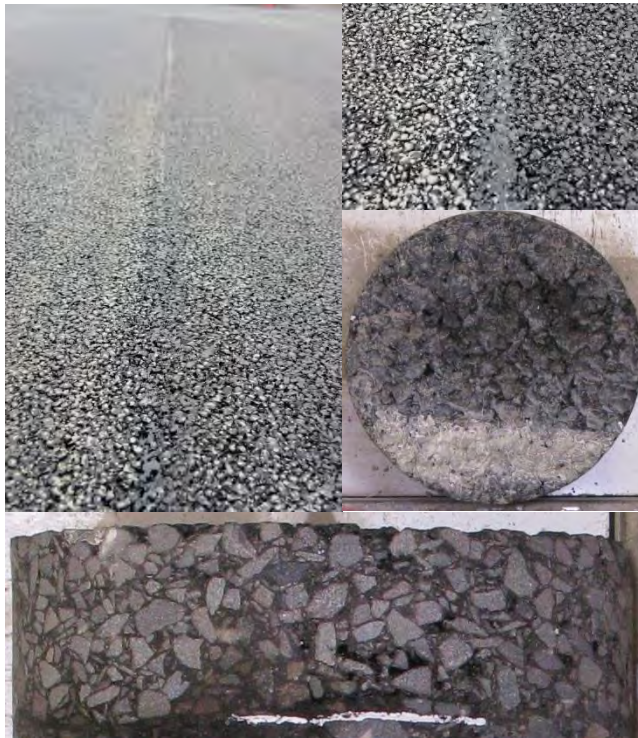
Painted Joint D

The surface of the joint appears to be level, consistent and well formed. Some bond coat is visible at the surface.

From inspection of the cores, there is a visible difference in voids between the unconfined edge and the confined edge in all of the Joint D cores, with the unconfined edge showing voids. The confined edge appears to be dense and very well compacted. It was noted during the trials that the edge of the Rip 2 material was cut back to vertical using a roller mounted cutting wheel. The amount of material cut back was estimated to be around 25 mm.

The joint is observed to be at a slight angle on all of the cores taken.

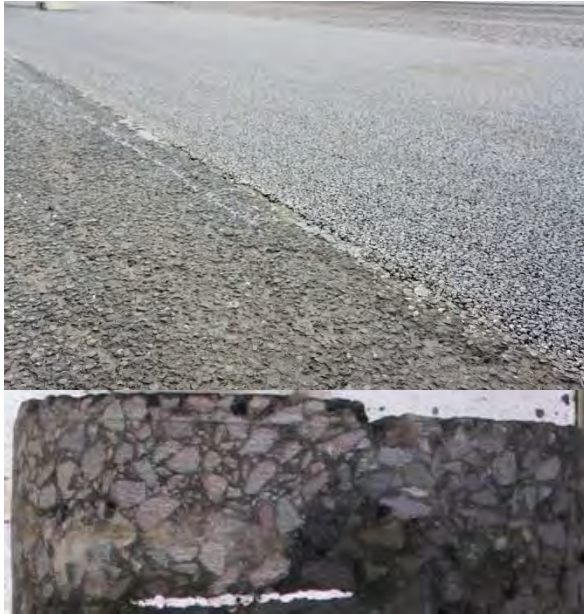
Painted Joint A

Bituminous sealant was applied to the edge of the existing material ahead of the paving operation.

Thin Surface Course appeared to finish proud of the existing surface with some minor overlap.

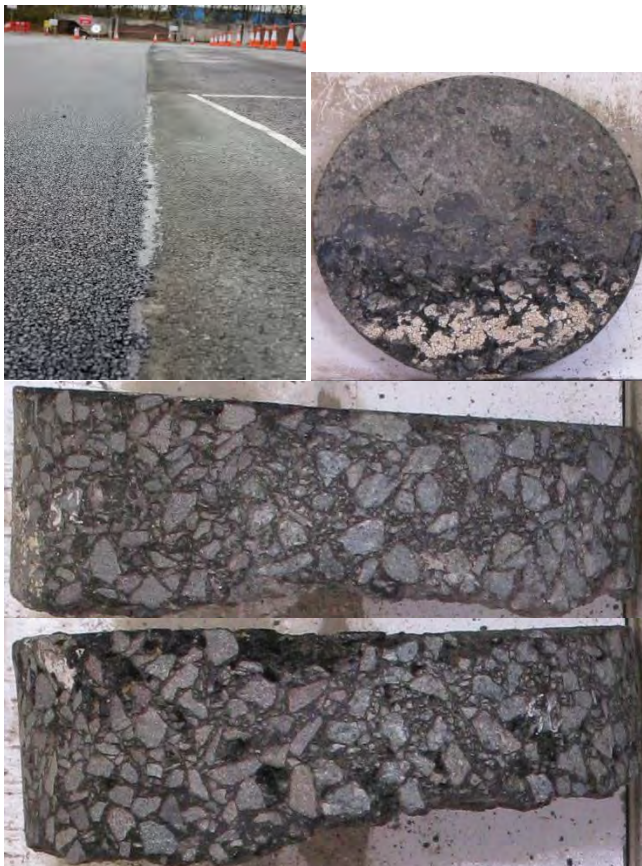
Painted Joint E

Bituminous joint sealant was applied to the edge of the existing surfacing and spilled over to the surface.

The existing surfacing was cracked in some places. Coring was targeted to avoid any cracks.

Some loss of aggregate at the edge of the new surfacing was noted on three of the joint cores which is expected to have been caused by the coring operation. In addition, visible voiding was observed in the thin surfacing of two of the cores. The remaining cores appeared to produce a well compacted tight joint.

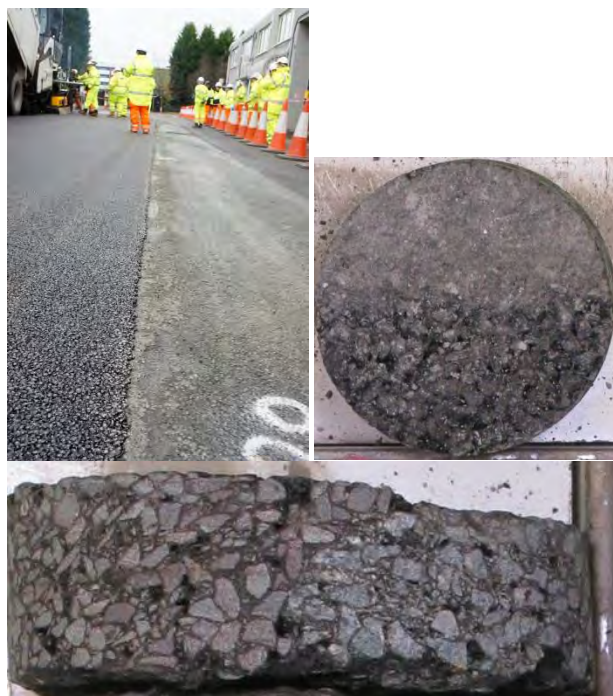
Thin Surface Course appeared to finish proud of the existing surface with some overlap.

The joint is observed to be at an angle in all of the cores taken.

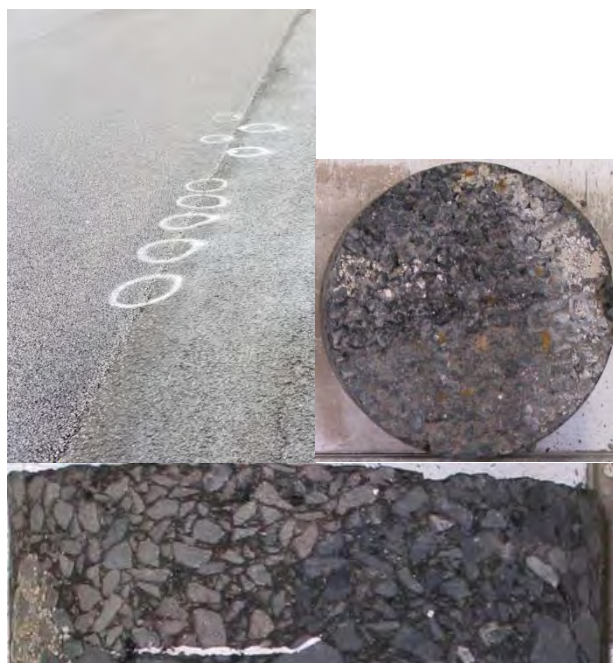
Heated Joint E

The newly installed surfacing was generally slightly high of the existing surfacing (to a lesser degree than was observed in Heated joint A).

The cores suggest that in general, the newly installed surfacing appears to be well compacted forming a tight joint. Slight voiding is visible in the thin surfacing in one of the cores only.

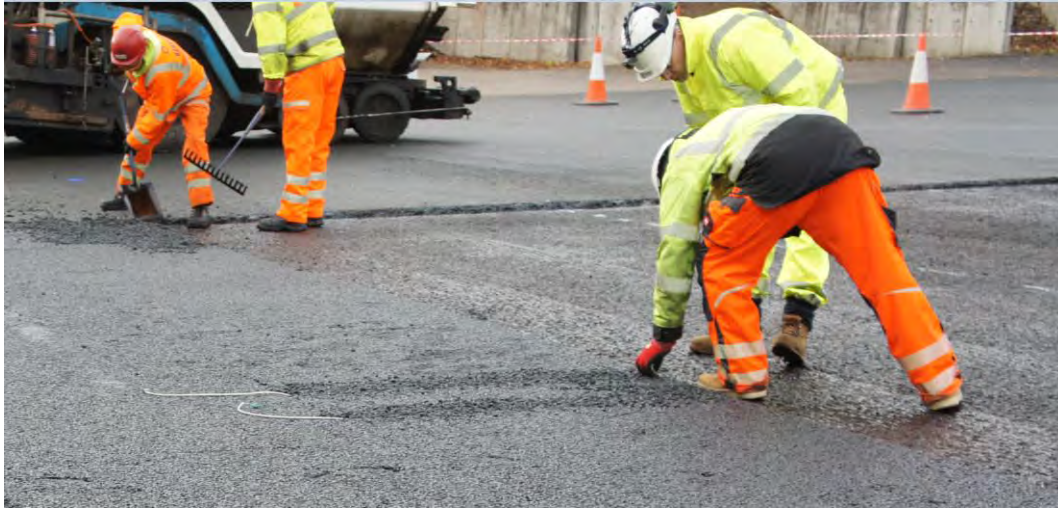
In situ temperature monitoring was carried out at one location of a heated joint, comprising thermocouples installed at the joint. The aim was to record temperature rise of material at the joint through the depth of the layer. Thermocouples were placed in surfacing material in Rip 1 at chainage 34 m prior to compaction of the surfacing. The thermocouples were placed at the joint targeting 10 mm and 20 mm depth.

Figure 17: Installation of thermocouples at Rip 1 joint (chainage 34 m)

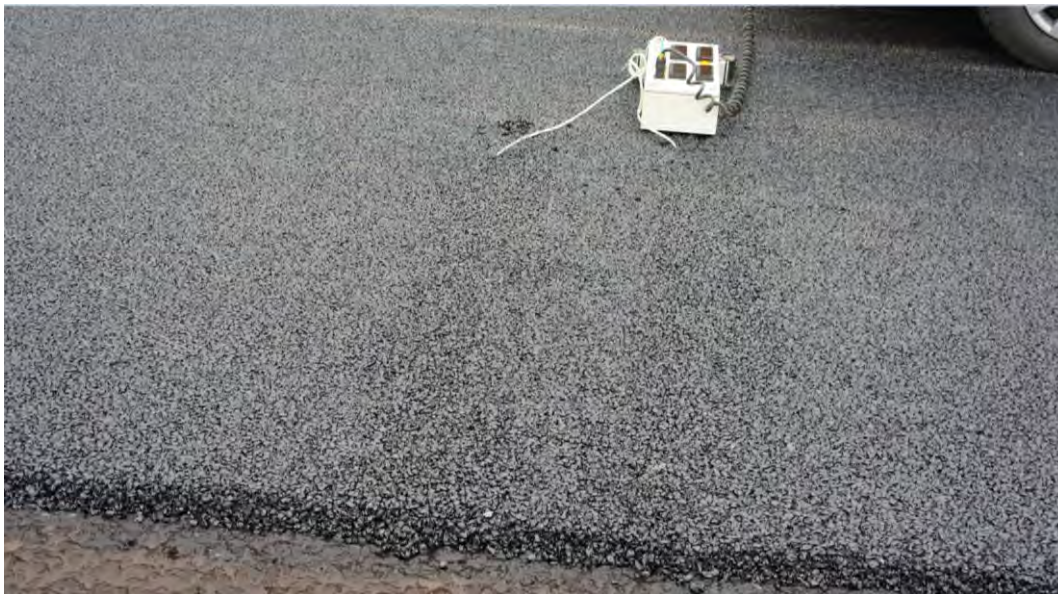
Figure 18: Installed thermocouples and data logger

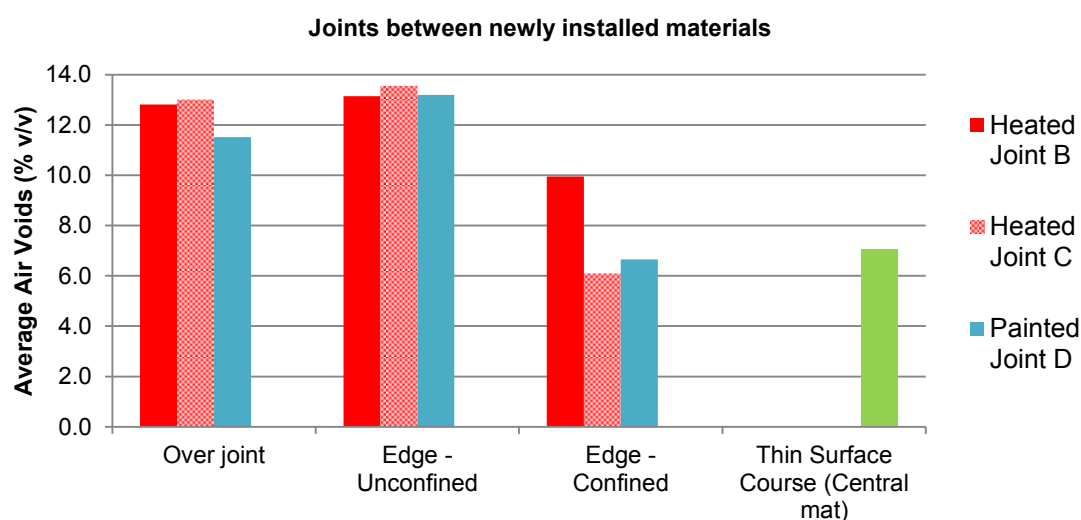
Figure 21: Average air voids for newly installed materials

Thin surfacing at the unconfined edge was found to be similar for heated and painted joints.

Figure 21 presents the average air voids for cores taken over / next to joints between newly installed materials.

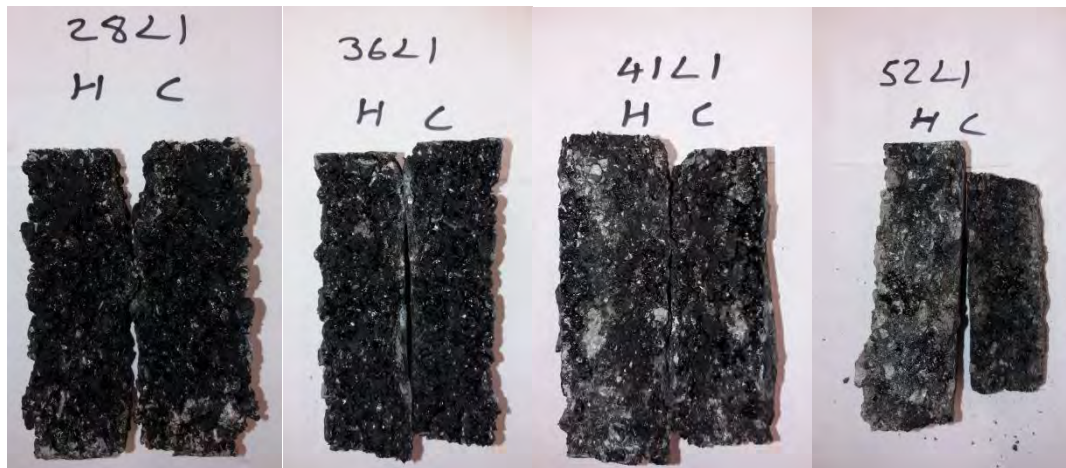
All samples tested (excluding core 47) failed along the joint. Core 47 exhibited a puncture type failure and was discounted from the results.

Figure 26: Example photographs of ITST samples after test

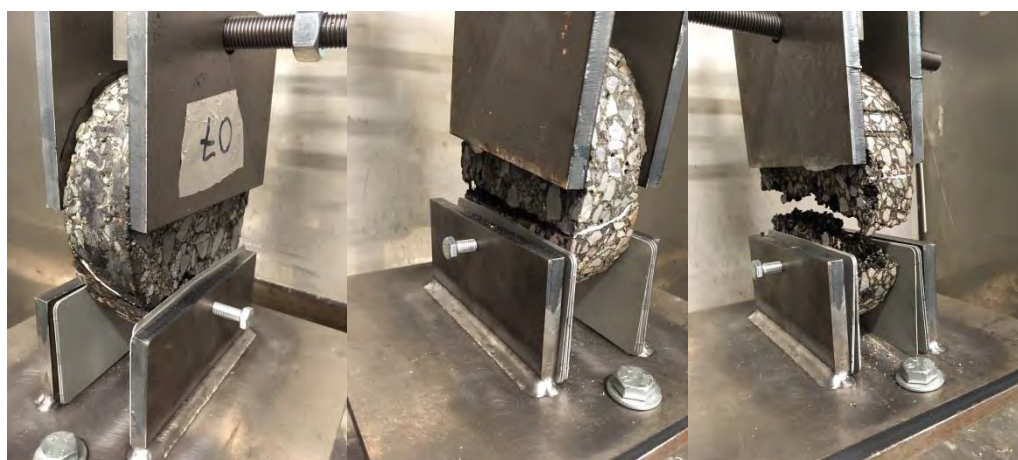
Load rate of 1mm per minute is applied and the peak force (kN) at failure is recorded. The sample is assessed for failure type and to see if the sample fails along the joint. The surface area of the failure plane is measured (length x width) to account for samples where the joint is positioned off centre and the peak stress is reported as N/mm².

Figure 28: Photograph of test i) early test, started splitting, ii) testing just before failure iii) post test

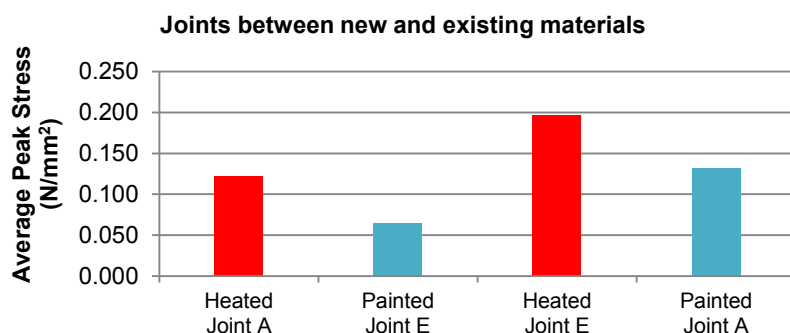
Figure 30: Average peak stress for joints between new and existing materials

Comparing Heated Joint A with Painted Joint E (both joints incorporate Existing substrate A) and Heated joint E with Painted Joint A (these joints incorporate Existing substrate B) it can be seen that heated joints have higher peak stress than painted joints. However, comparing the data set as a whole suggests that the trend is not entirely conclusive.

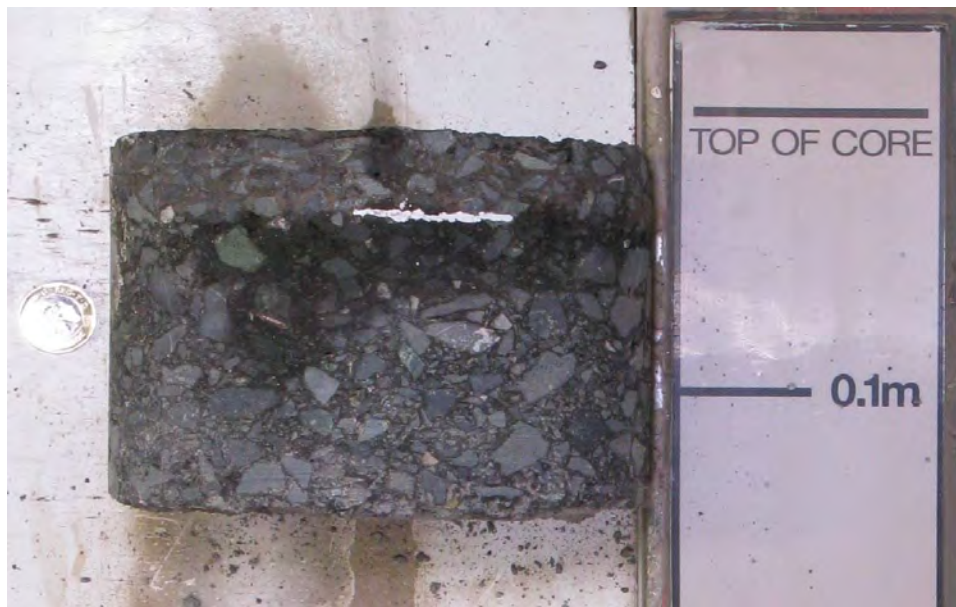
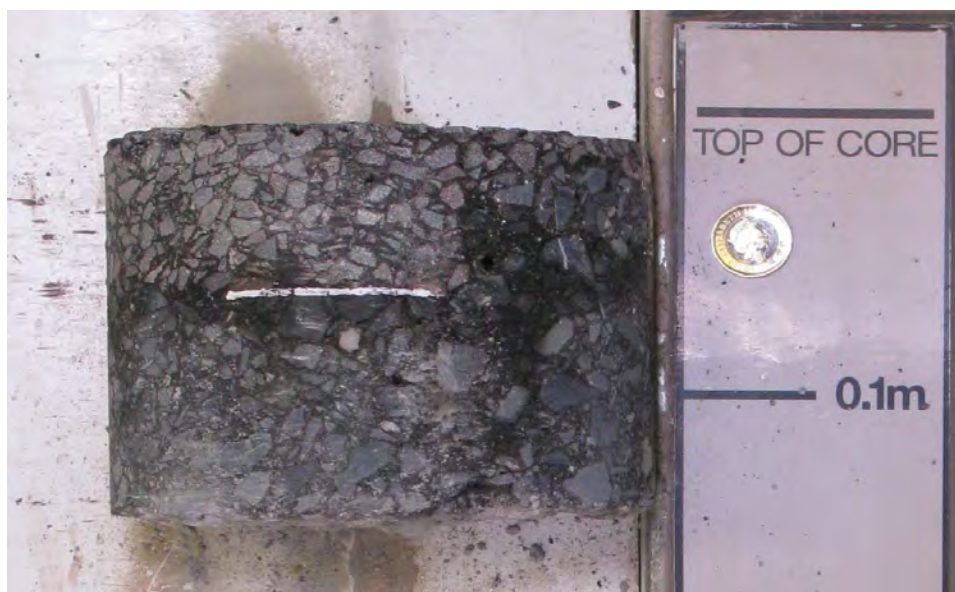
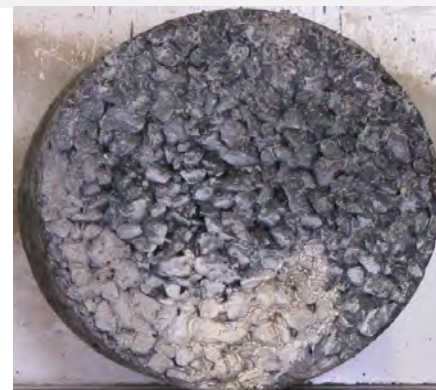
| Job Number : 60485963 Sample Number : T0824 Core Number : 04 Cored / Logged By : RF / BM Date Cored / Logged : 07-12-17 / 20-12-17 Nominal Diameter : 150mm | Scheme : Stafford Depot : Telford Notes: 1. Edge core 2. Coin is placed on the edge closest to the joint |

| Layer | Depth (mm) | | Thickness (mm) | Material Description ¹ | Suitable for NAT/CS Testing (Yes/No) | PAK-Marker ² | Binder ³ | Aggregate | |
|---|---|---|---|---|---|---|---|---|---|
| 2 | 40 | 114 | 74 | Asphalt Concrete | Yes | -ve | Bitumen | 20 | Crushed Rock |

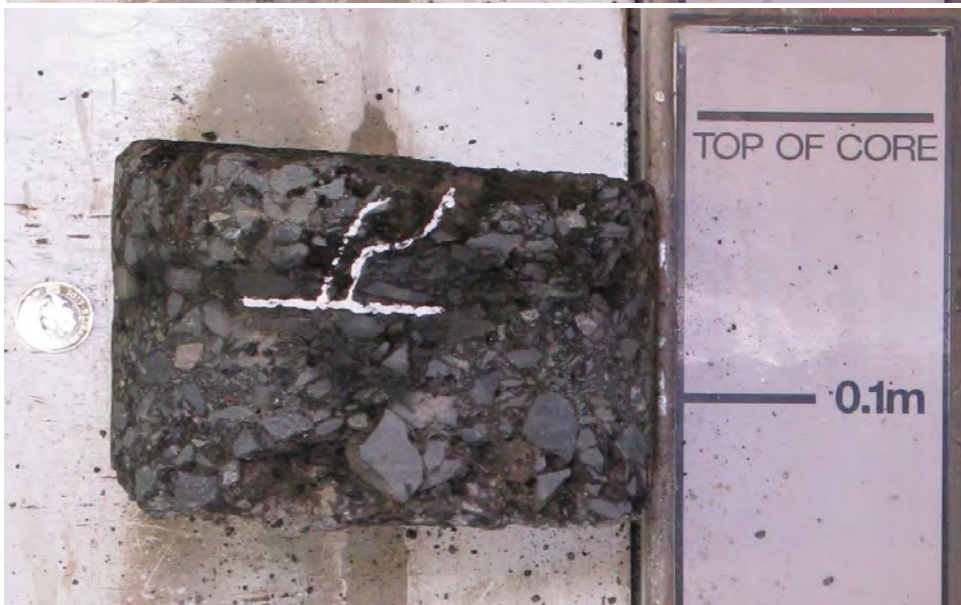
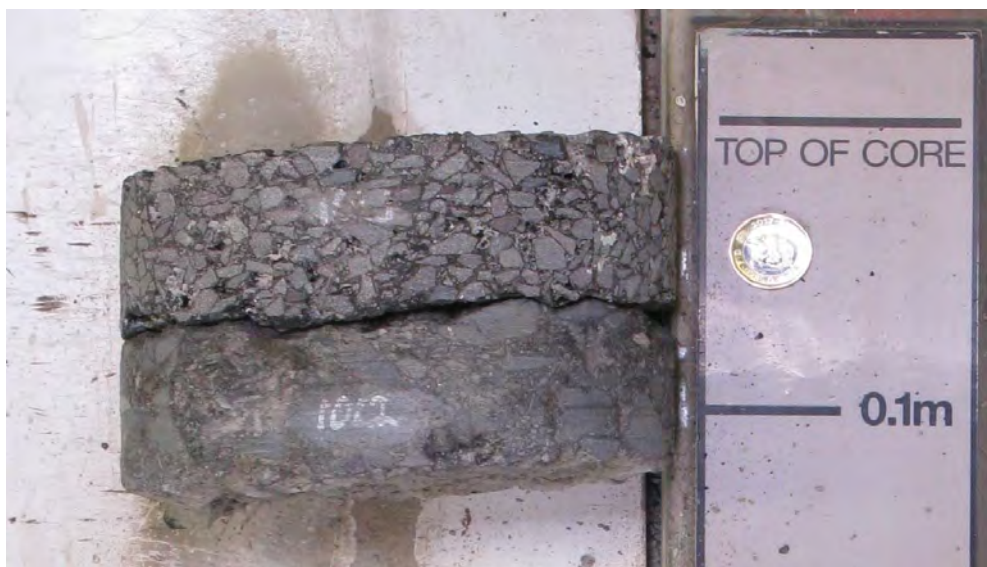
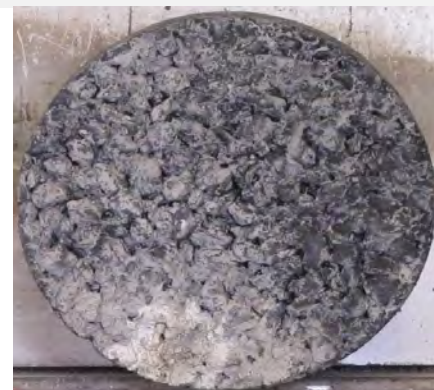
| Job Number : 60485963 Sample Number : T0824 Core Number : 10 Cored / Logged By : RF / BM Date Cored / Logged : 07-12-17 / 20-12-17 Nominal Diameter : 150mm | Scheme : Stafford Depot : Telford Notes: 1. Edge core 2. Coin is placed on the edge closest to the joint |

| Layer | Depth (mm) | | Thickness (mm) | Material Description ¹ | Suitable for NAT/CS Testing (Yes/No) | PAK-Marker ² | Binder ³ | Aggregate | |
|---|---|---|---|--|---|---|---|---|---|
| 2 | 50 | 100 | 50 | Asphalt Concrete | Yes | -ve | Bitumen | 20 | Crushed Rock |

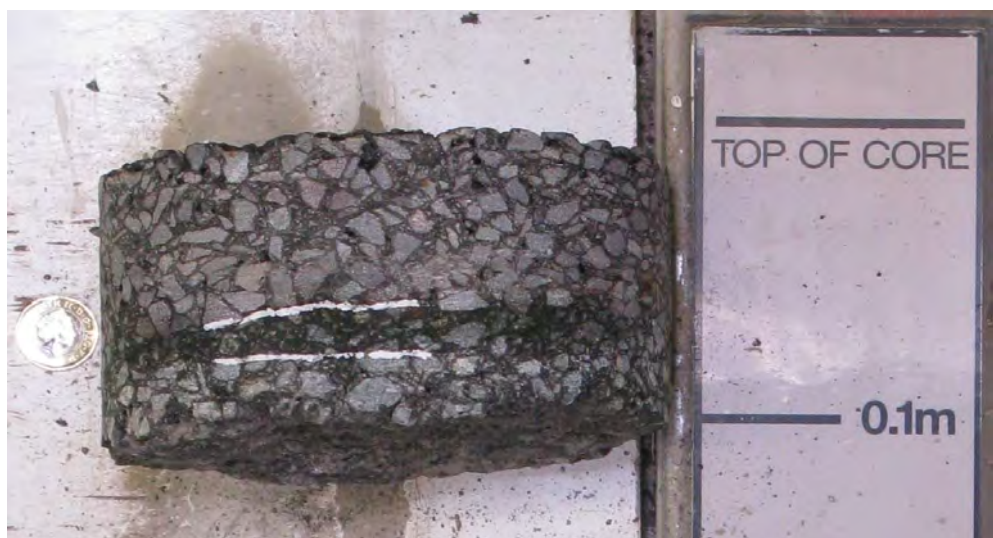
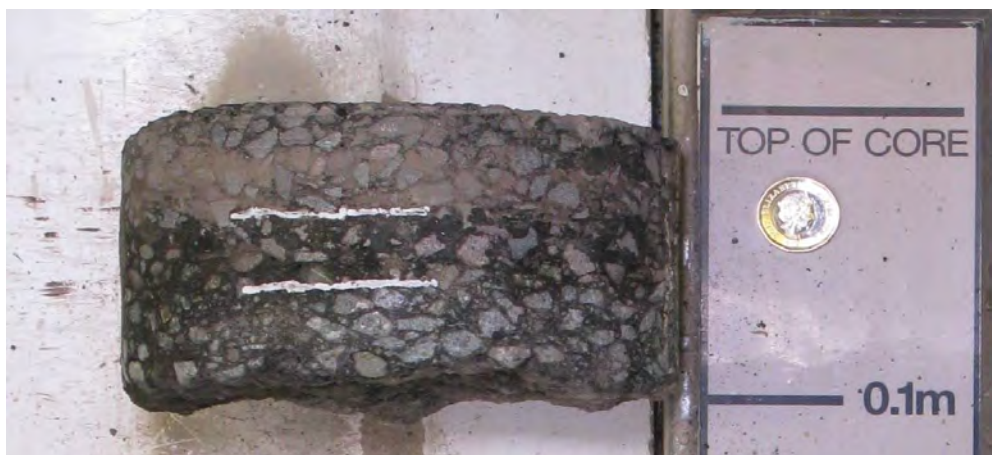
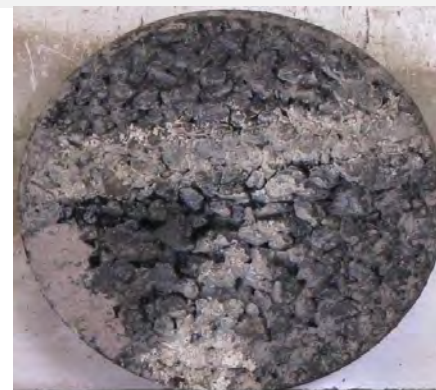
| Job Number : 60485963 Sample Number : T0824 Core Number : 14 Cored / Logged By : RF / BM Date Cored / Logged : 07-12-17 / 20-12-17 Nominal Diameter : 150mm | Scheme : Stafford Depot : Telford Notes: 1. Core taken over joint 2. Coin placed on the heated side of the joint |

| Joint reference | Core number | Test temperature (°C) | Peak force (kN) | Mean Peak force (kN) | Peak stress (N/mm ²) | Mean Peak stress (N/mm ²) | Observations of failure interface |
|---|---|---|---|---|---|---|--|
| Heated Joint B | 14 | 20.1 | 0.72 | 0.77 | 0.148 | 0.146 | Ductile failure along the joint |

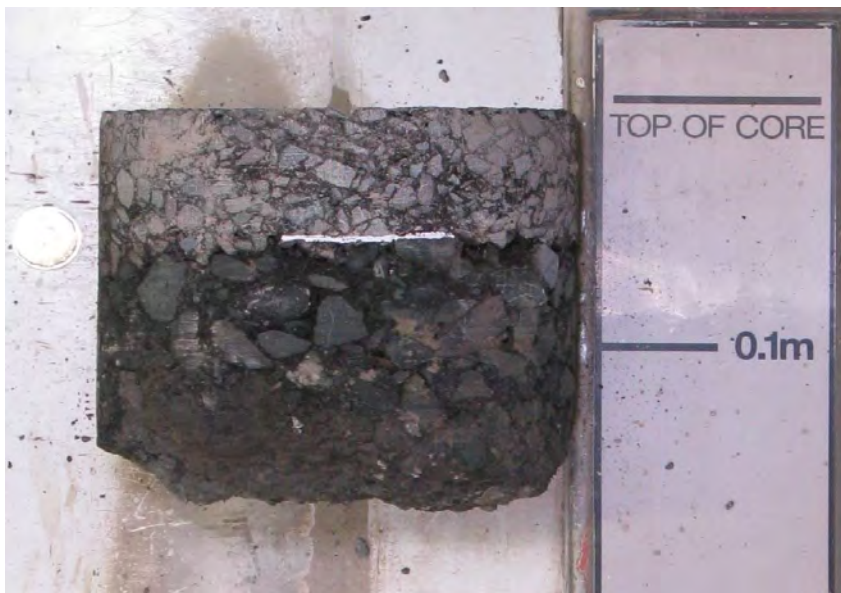
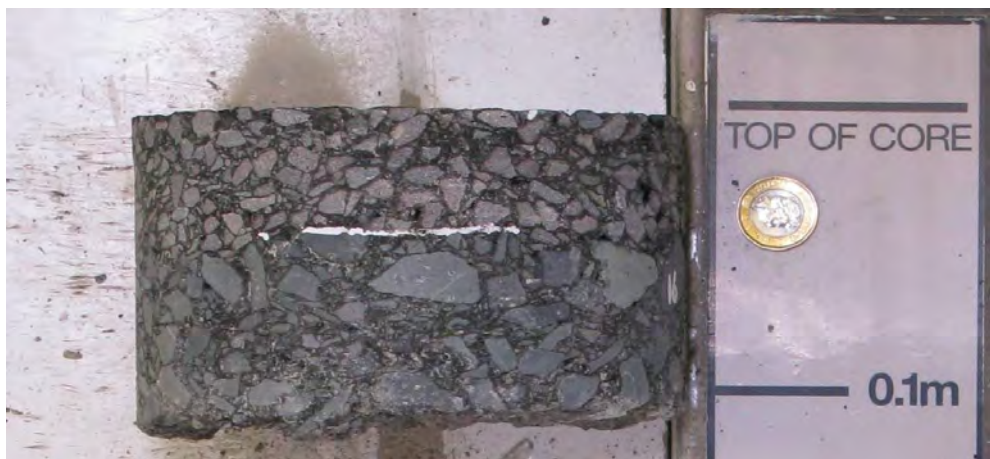
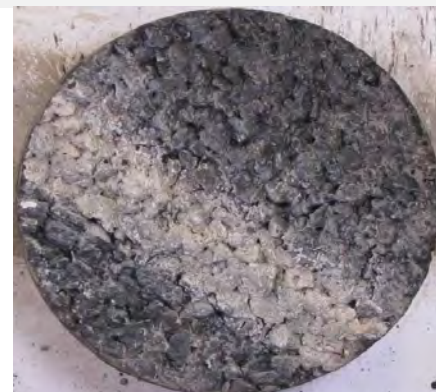
| Job Number : 60485963 Sample Number : T0824 Core Number : 16 Cored / Logged By : RF / BM Date Cored / Logged : 07-12-17 / 20-12-17 Nominal Diameter : 150mm | Scheme : Stafford Depot : Telford Notes: 1. Core taken over joint 2. Coin placed on the heated side of the joint |

| Layer | Depth (mm) | | Thickness (mm) | Material Description ¹ | Suitable for NAT/CS Testing (Yes/No) | PAK-Marker ² | Binder ³ | Aggregate | |
|---|---|---|---|---|---|---|---|---|---|
| 2 | 35 | 100 | 65 | Asphalt Concrete | Yes | -ve | Bitumen | 20 | Crushed Rock |

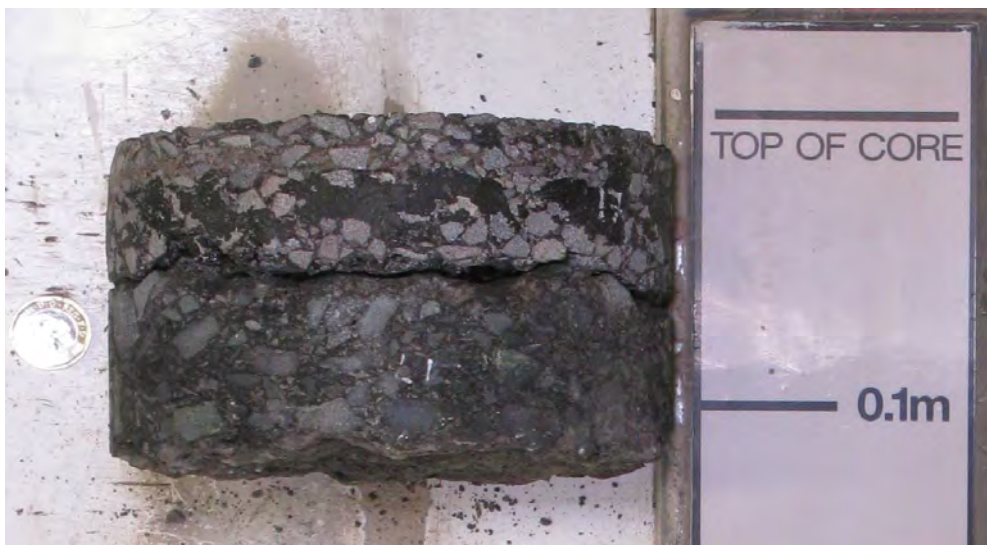
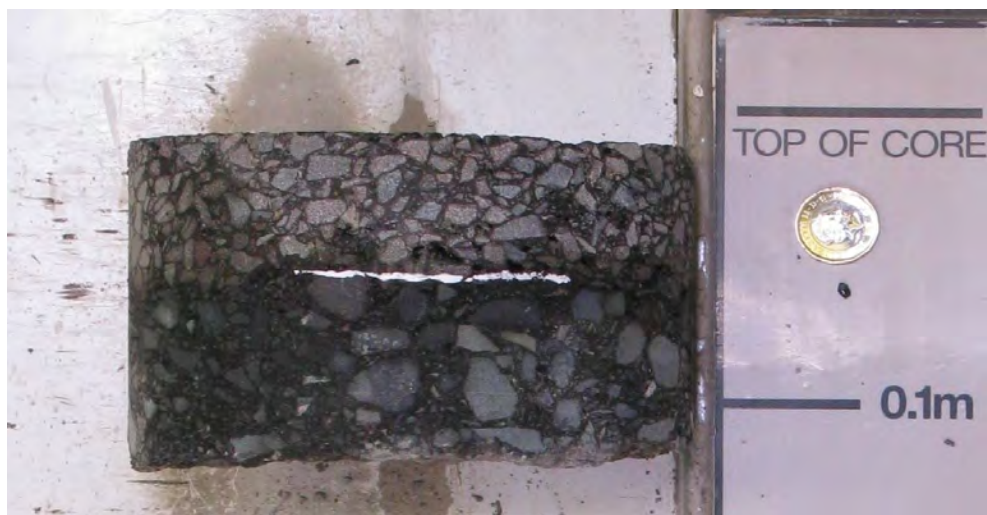
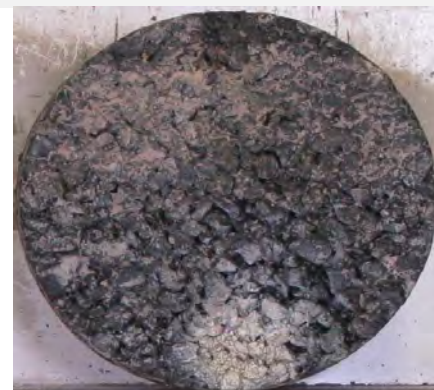
| Job Number : 60485963 Sample Number : T0824 Core Number : 18 Cored / Logged By : RF / BM Date Cored / Logged : 07-12-17 / 20-12-17 Nominal Diameter : 150mm | Scheme : Stafford Depot : Telford Notes: 1. Core taken over joint 2. Coin placed on the heated side of the joint |

| Layer | Depth (mm) | | Thickness (mm) | Material Description ¹ | Suitable for NAT/CS Testing (Yes/No) | PAK-Marker ² | Binder ³ | Aggregate | |
|---|---|---|---|---|---|---|---|---|---|
| 3 | 55 | 95 | 40 | Asphalt Concrete (voided) | Yes | -ve | Bitumen | 20 | Crushed Rock |

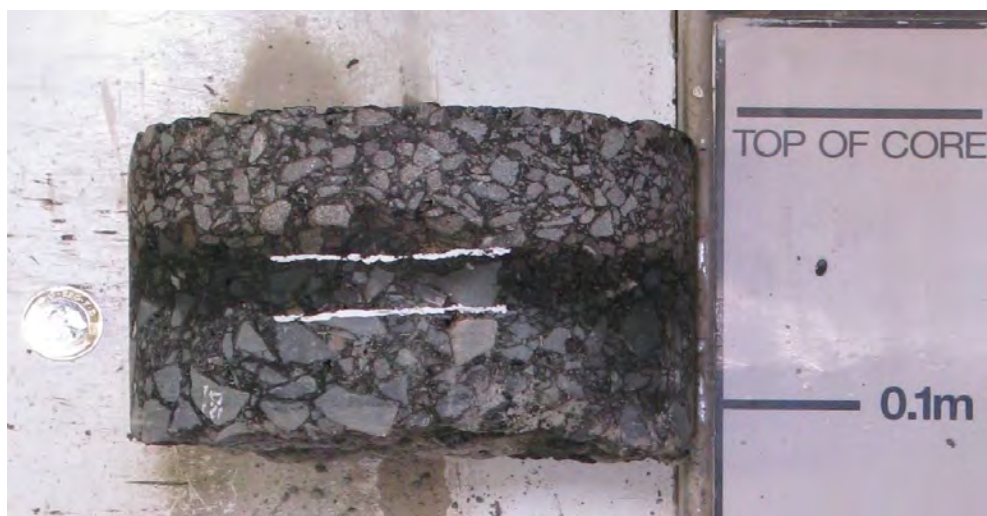
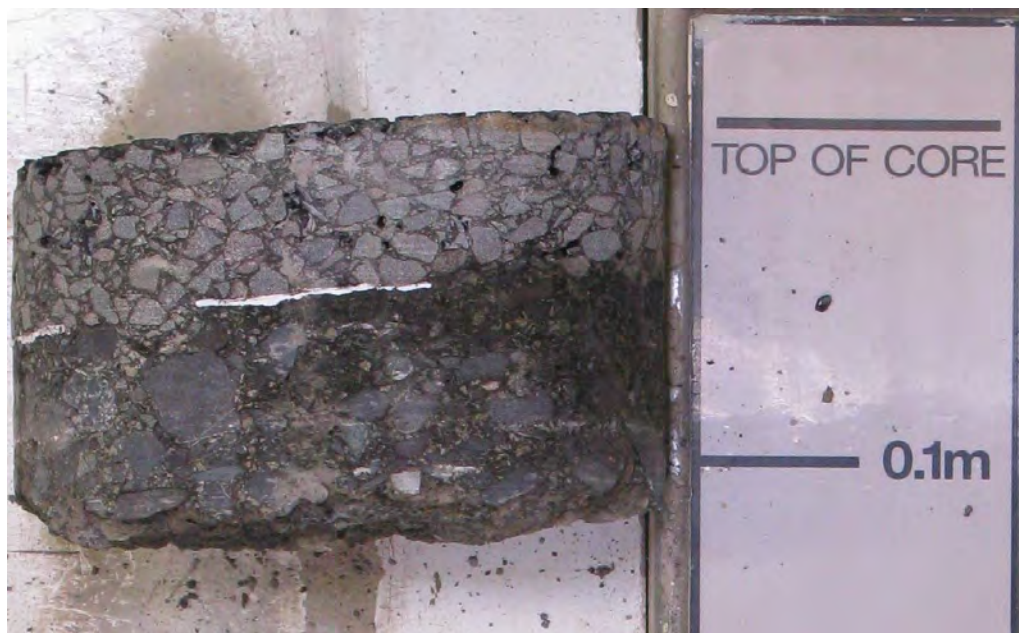
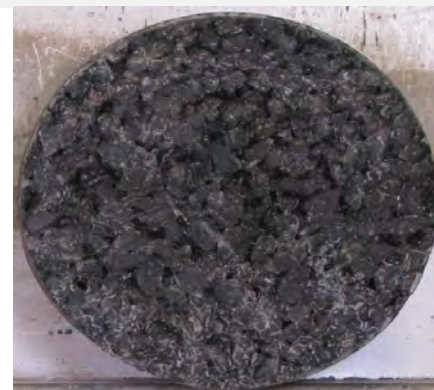
| Job Number : 60485963 | Scheme : Stafford Depot : Telford |
| Sample Number : T0824 | Notes: 1. Core taken in central mat |

| Layer | Depth (mm) | | Thickness (mm) | Material Description ¹ | Suitable for NAT/CS Testing (Yes/No) | PAK-Marker ² | Binder ³ | Aggregate | |
|---|---|---|---|---|---|---|---|---|---|
| 2 | 45 | 70 | 25 | Asphalt Concrete | No | -ve | Bitumen | 20 | Crushed Rock |

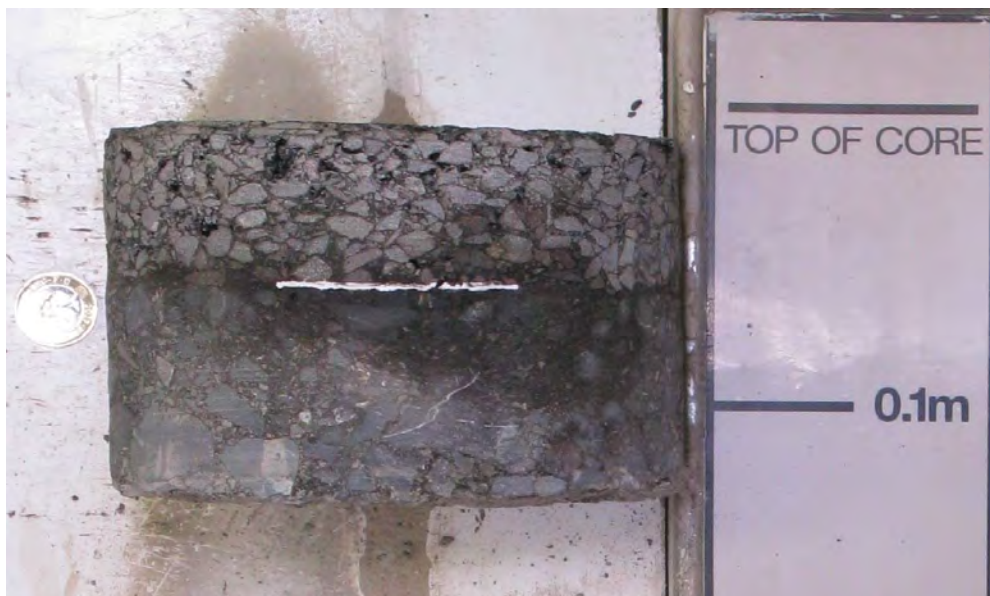
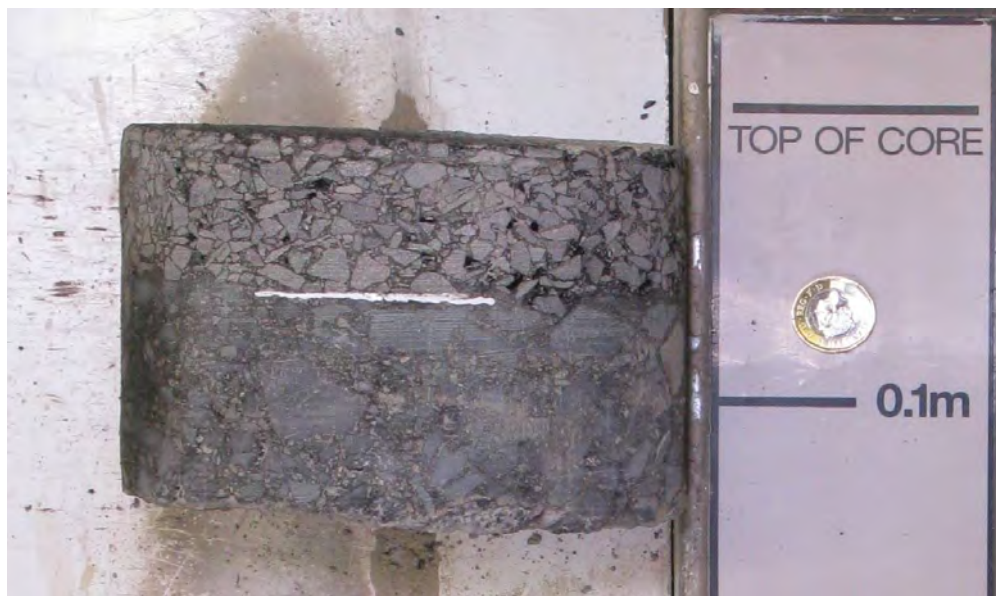
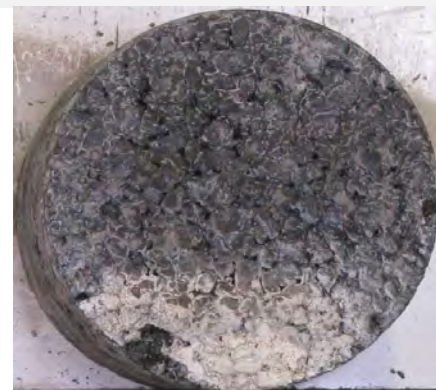
| Job Number : 60485963 | Scheme : Stafford Depot : Telford |
| Sample Number : T0824 | Notes: 1. Edge core |

| Layer | Depth (mm) | | Thickness (mm) | Material Description ¹ | Suitable for NAT/CS Testing (Yes/No) | PAK-Marker ² | Binder ³ | Aggregate | |
|---|---|---|---|--|---|---|---|---|---|
| 2 | 45 | 110 | 65 | Asphalt Concrete | Yes | -ve | Bitumen | 20 | Crushed Rock |

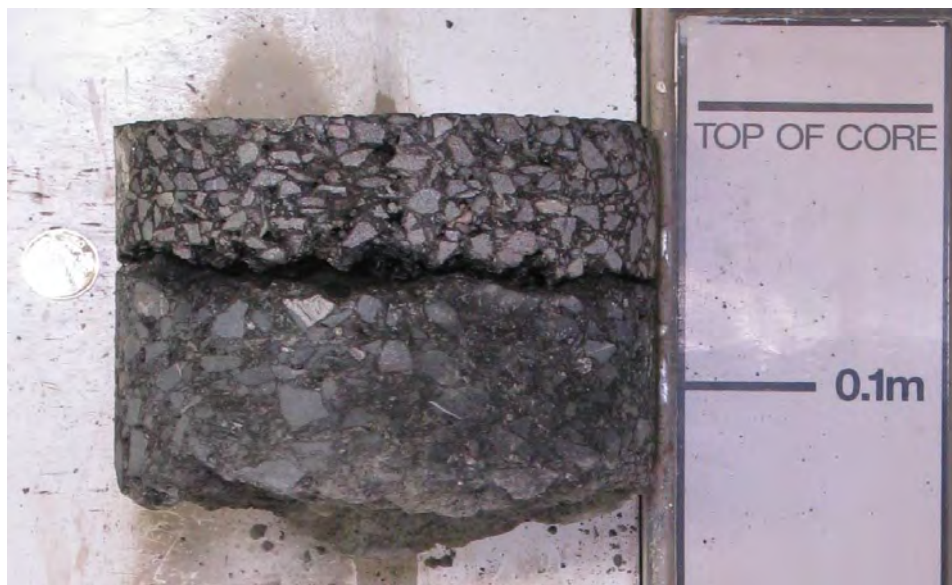
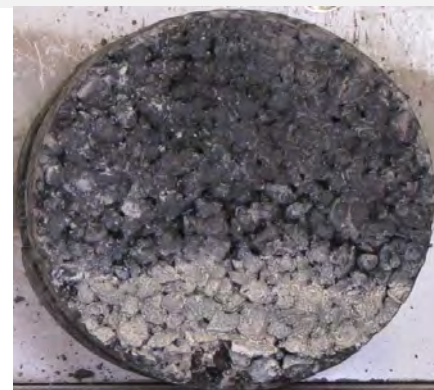
| Job Number : 60485963 Sample Number : T0824 Core Number : 28 Cored / Logged By : RF / BM Date Cored / Logged : 07-12-17 / 20-12-17 Nominal Diameter : 150mm | Scheme : Stafford Depot : Telford Notes: 1. Core taken over joint 2. Coin placed on the heated side of the joint |

| Layer | Depth (mm) | | Thickness (mm) | Material Description ¹ | Suitable for NAT/CS Testing (Yes/No) | PAK-Marker ² | Binder ³ | Aggregate | |
|---|---|---|---|--|---|---|---|---|---|
| 2 | 50 | 115 | 65 | Asphalt Concrete (in half) | No | -ve | Bitumen | 20 | Crushed Rock |
