Area 9 Joint Heater Trials

Technical Report

Kier Services

Project number: 60485963

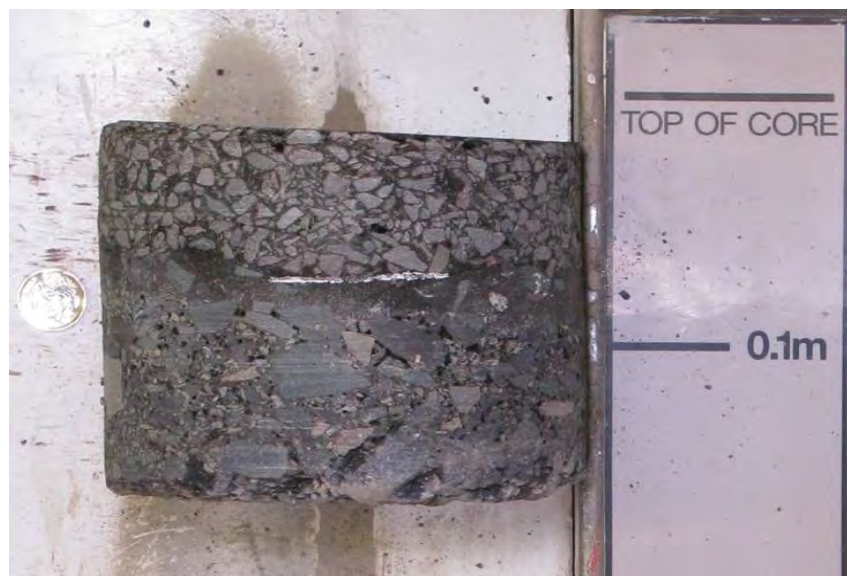
| Job Number : 60485963 Sample Number : T0824 Core Number : 33 Cored / Logged By : RF / BM Date Cored / Logged : 07-12-17 / 20-12-17 Nominal Diameter : 150mm | Scheme : Stafford Depot : Telford Notes: 1. Edge core 2. Coin is placed on the edge closest to the joint Notes: N/A |

| Layer | Depth (mm) | | Thickness (mm) | Material Description ¹ | Suitable for NAT/CS Testing (Yes/No) | PAK-Marker ² | Binder ³ | Aggregate | |
|---|---|---|---|---|---|---|---|---|---|
| 2 | 40 | 110 | 70 | Asphalt Concrete | Yes | -ve | Bitumen | 20 | Crushed Rock |

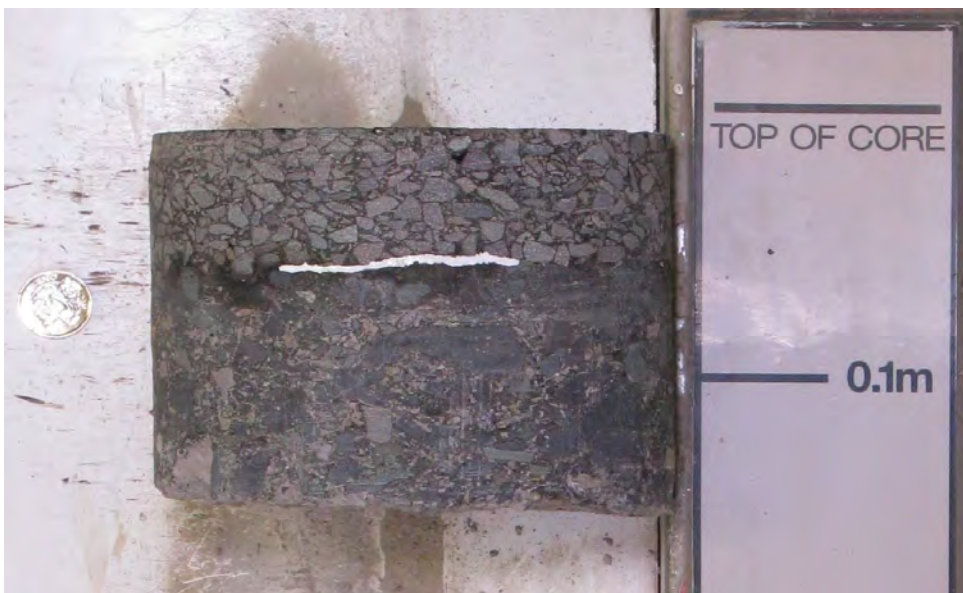
| Job Number : 60485963 Sample Number : T0824 Core Number : 35 Cored / Logged By : RF / BM Date Cored / Logged : 07-12-17 / 20-12-17 Nominal Diameter : 150mm | Scheme : Stafford Depot : Telford Notes: 1. Core taken over the joint 2. Painted joint 3. Coin is placed on the unsupported edge side of the joint |

| Layer | Depth (mm) | | Thickness (mm) | Material Description ¹ | Suitable for NAT/CS Testing (Yes/No) | PAK-Marker ² | Binder ³ | Aggregate | |
|---|---|---|---|---|---|---|---|---|---|
| 2 | 45 | 115 | 70 | Asphalt Concrete | Yes | -ve | Bitumen | 20 | Crushed Rock |

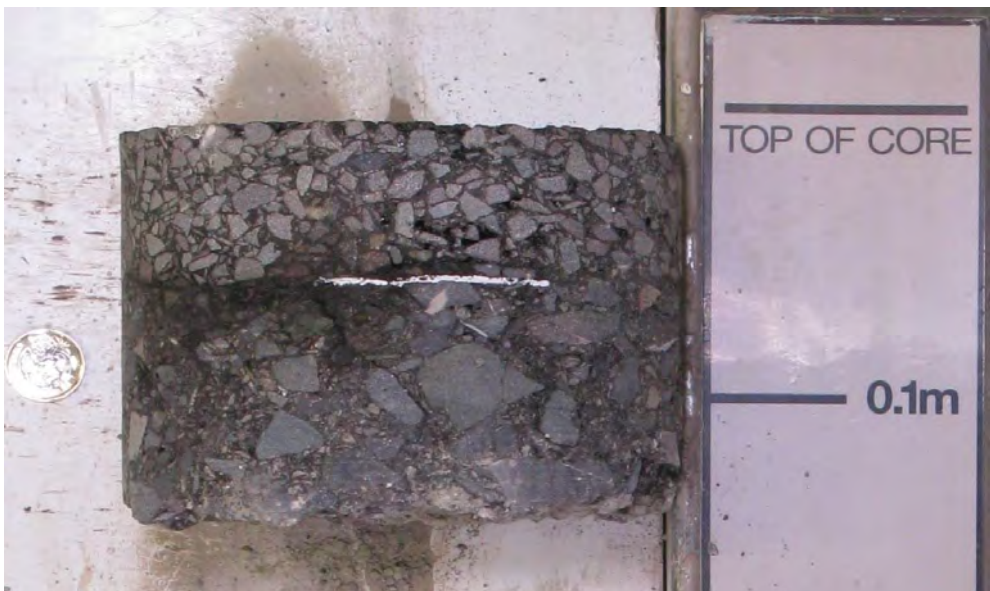
| Job Number : 60485963 | Scheme : Stafford Depot : Telford |
| Sample Number : T0824 | Notes: 1. Core taken over the joint |

| Layer | Depth (mm) | | Thickness (mm) | Material Description ¹ | Suitable for NAT/CS Testing (Yes/No) | PAK-Marker ² | Binder ³ | Aggregate | |
|---|---|---|---|---|---|---|---|---|---|
| 3 | 45 | 110 | 65 | Asphalt Concrete (voided) | Yes | -ve | Bitumen | 20 | Crushed Rock |

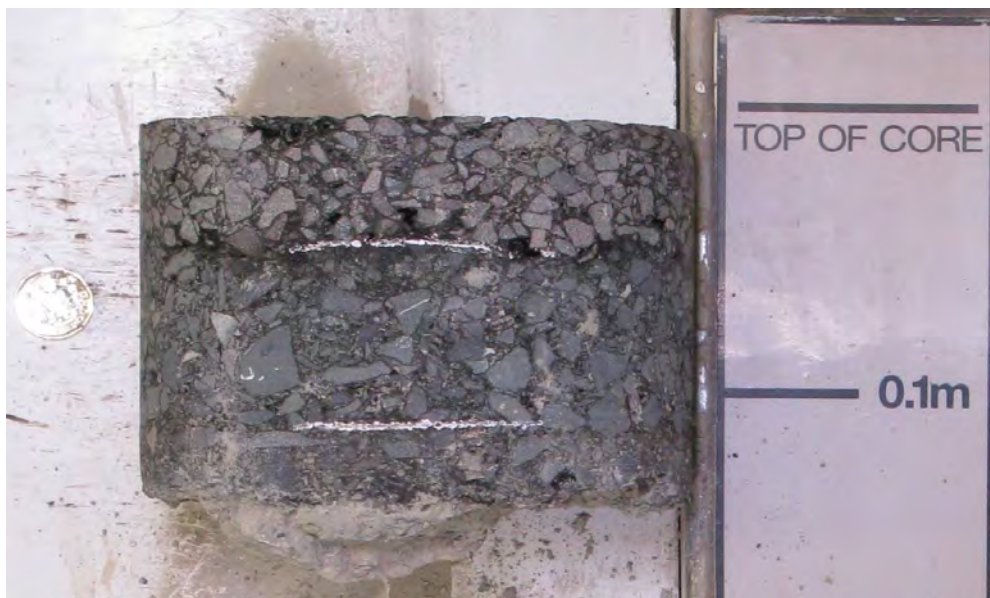
| Job Number : 60485963 | Scheme : Stafford Depot : Telford |
| Sample Number : T0824 | Notes: 1. Core taken over the joint |

| Layer | Depth (mm) | | Thickness (mm) | Material Description ¹ | Suitable for NAT/CS Testing (Yes/No) | PAK-Marker ² | Binder ³ | Aggregate | |
|---|---|---|---|---|---|---|---|---|---|
| 3 | 80 | 105 | 25 | Asphalt Concrete | No | -ve | Bitumen | 14 | Crushed Rock |

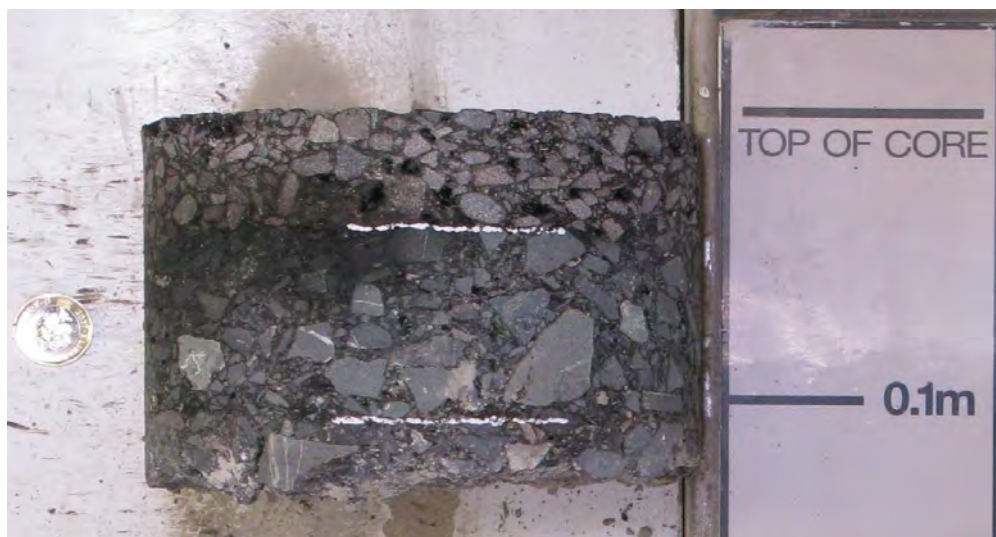
| Job Number : 60485963 Sample Number : T0824 Core Number : 39 Cored / Logged By : RF / BM Date Cored / Logged : 07-12-17 / 20-12-17 Nominal Diameter : 150mm | Scheme : Stafford Depot : Telford Notes: 1. Core taken over the joint 2. Painted joint 3. Coin is placed on the unsupported edge side of the joint |

| Layer | Depth (mm) | | Thickness (mm) | Material Description ¹ | Suitable for NAT/CS Testing (Yes/No) | PAK-Marker ² | Binder ³ | Aggregate | |
|---|---|---|---|---|---|---|---|---|---|
| | | | | Weakly Bound Material | | | | | |

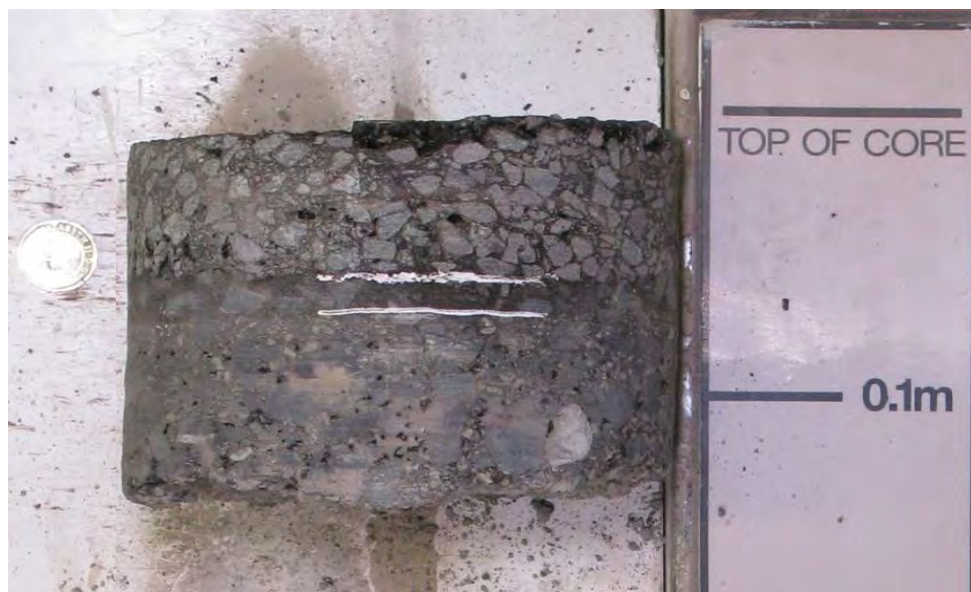
| Job Number : 60485963 Sample Number : T0824 Core Number : 42 Cored / Logged By : RF / BM Date Cored / Logged : 07-12-17 / 20-12-17 Nominal Diameter : 150mm | Scheme : Stafford Depot : Telford Notes: 1. Core taken over joint 2. Coin placed on the heated side of the joint |

| Layer | Depth (mm) | | Thickness (mm) | Material Description ¹ | Suitable for NAT/CS Testing (Yes/No) | PAK-Marker ² | Binder ³ | Aggregate | |
|---|---|---|---|---|---|---|---|---|---|
| 2 | 40 | 105 | 65 | Asphalt Concrete (in half) | No | -ve | Bitumen | 20 | Crushed Rock |

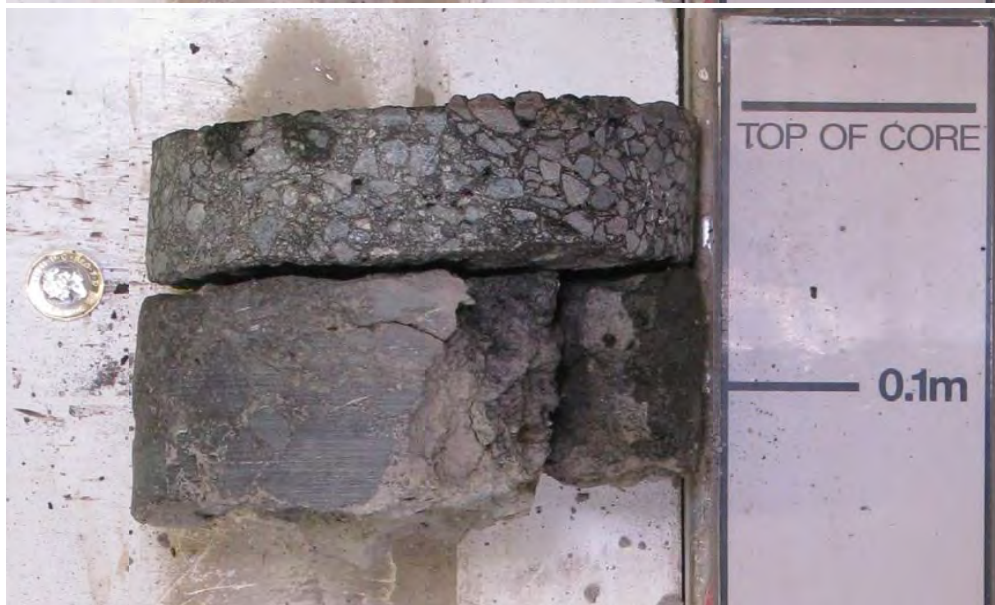
| Job Number : 60485963 | Scheme : Stafford Depot : Telford |
| Sample Number : T0824 | Notes: 1. Core taken over joint |

| Layer | Depth (mm) | | Thickness (mm) | Material Description ¹ | Suitable for NAT/CS Testing (Yes/No) | PAK-Marker ² | Binder ³ | Aggregate | |
|---|---|---|---|---|---|---|---|---|---|
| 2 | 45 | 105 | 60 | Asphalt Concrete (in half) | No | -ve | Bitumen | 20 | Crushed Rock |

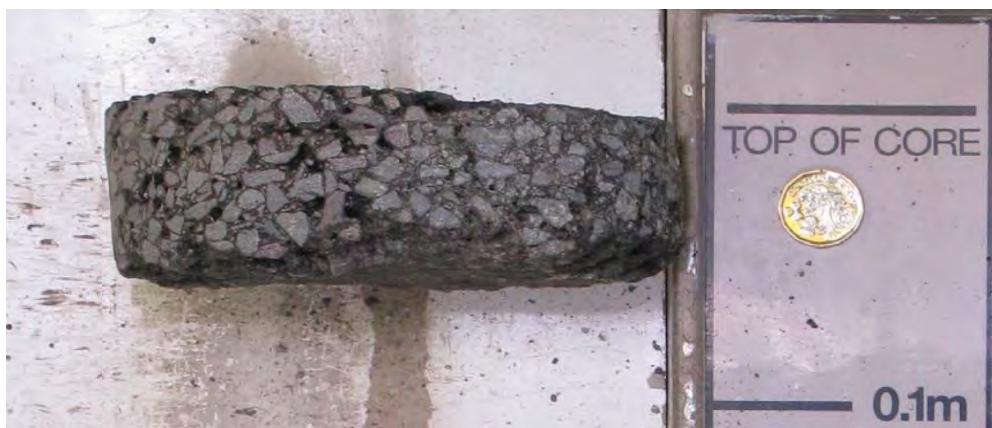
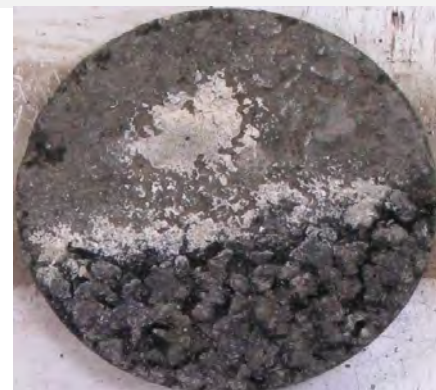
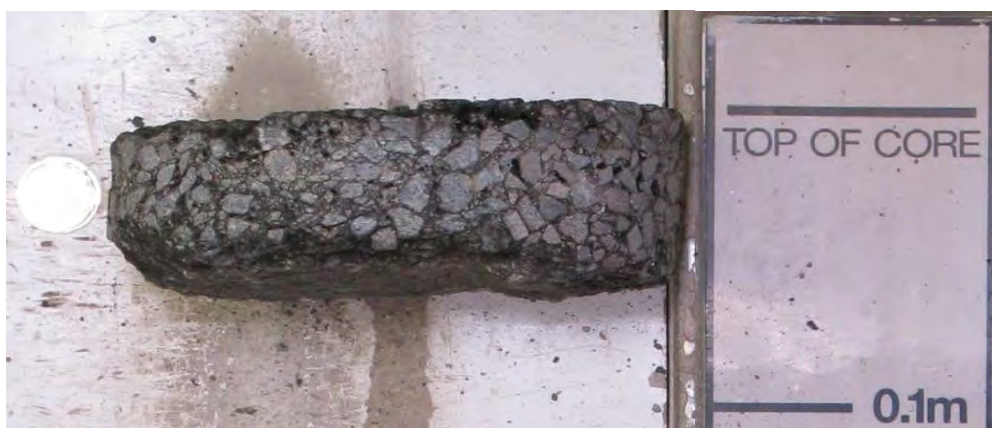
Core Surface

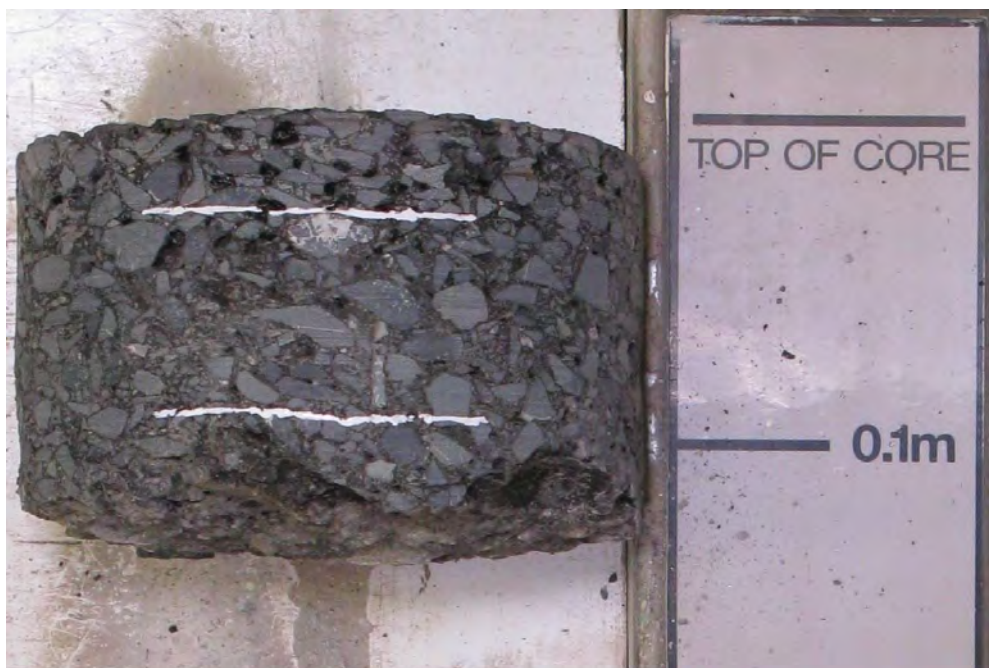
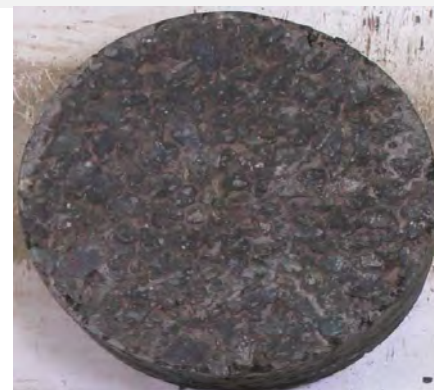
| Layer | Depth (mm) | | Thickness (mm) | Material Description ¹ | Suitable for NAT/CS Testing (Yes/No) | PAK-Marker ² | Binder ³ | Aggregate | |
|---|---|---|---|---|---|---|---|---|---|
| 3 | 80 | 100 | 20 | Asphalt Concrete (broken @ base) | No | -ve | Bitumen | 14 | Crushed Rock |

Core Surface

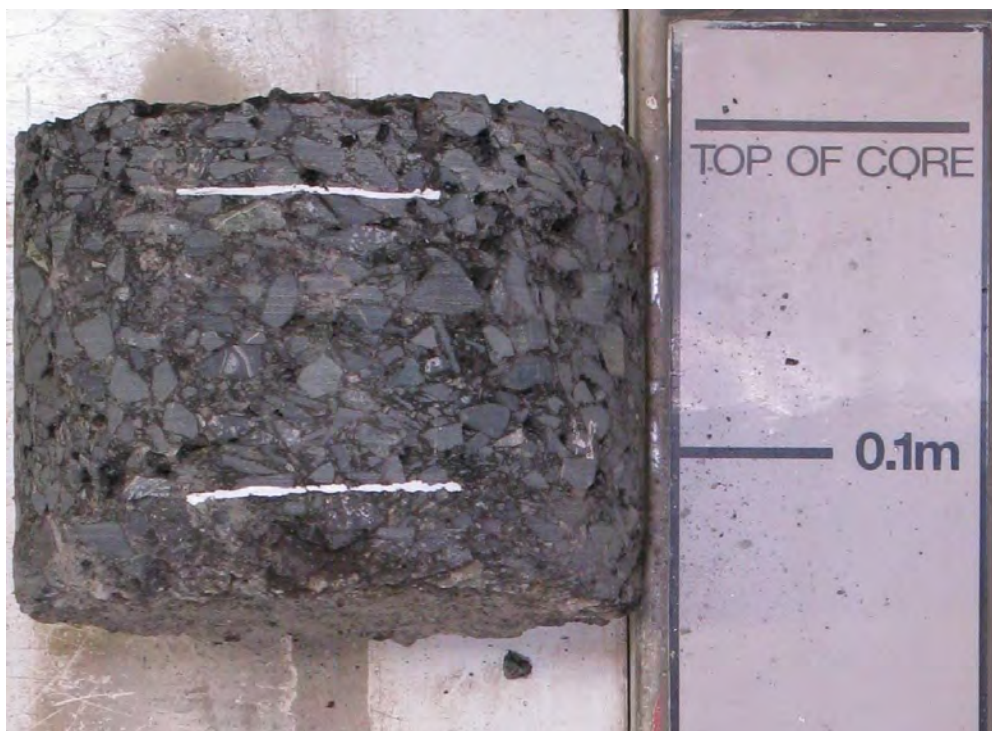
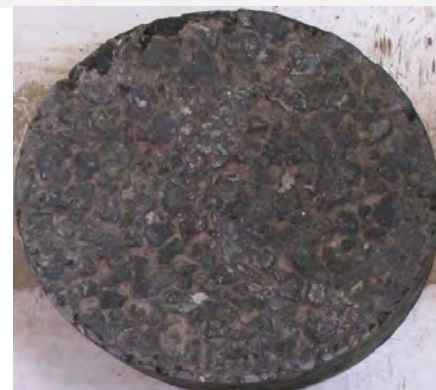
| Layer | Depth (mm) | | Thickness (mm) | Material Description ¹ | Suitable for NAT/CS Testing (Yes/No) | PAK-Marker ² | Binder ³ | Aggregate | |
|---|---|---|---|---|---|---|---|---|---|
| 3 | 100 | 130 | 30 | Asphalt Concrete (voided) | Yes | -ve | Bitumen | 14 | Crushed Rock |

Core Surface

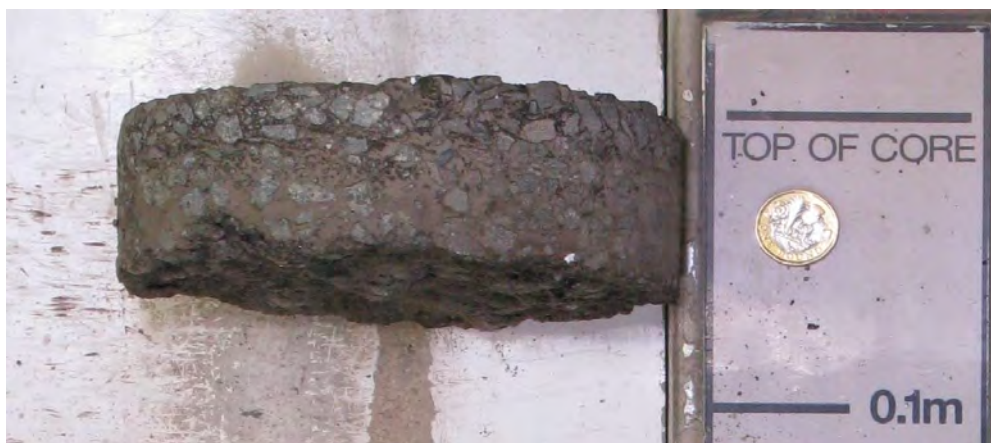
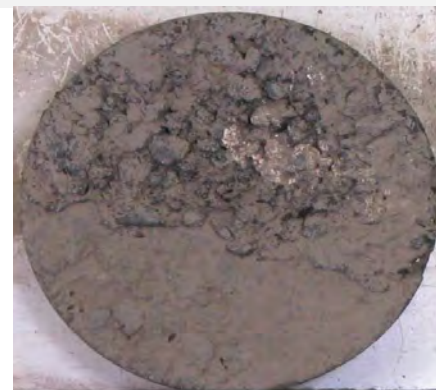
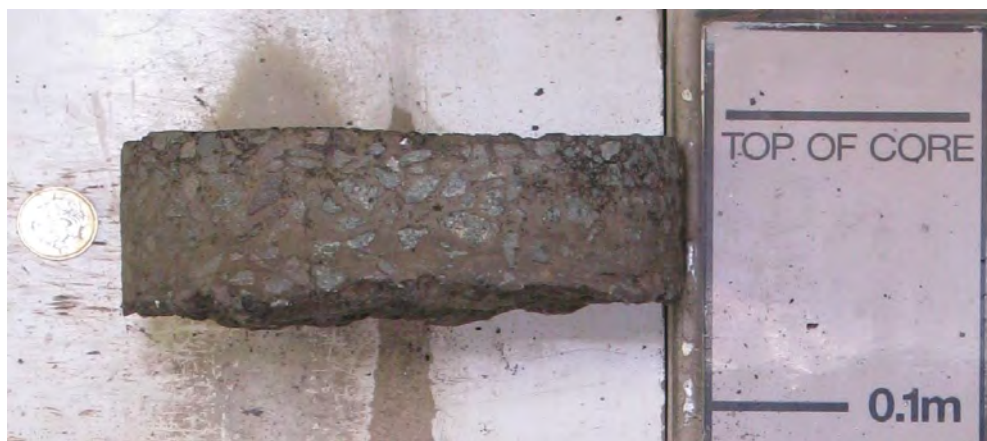
Core Surface

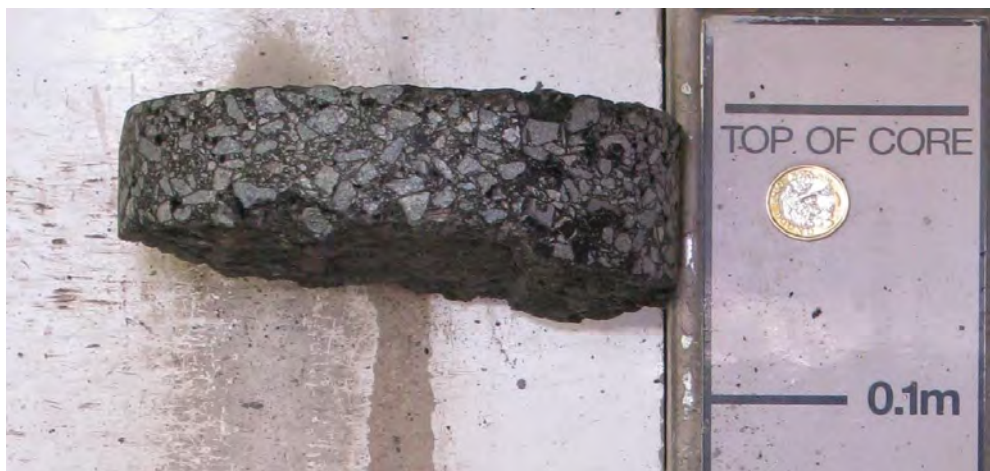
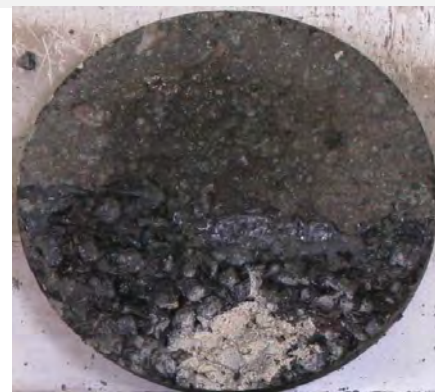
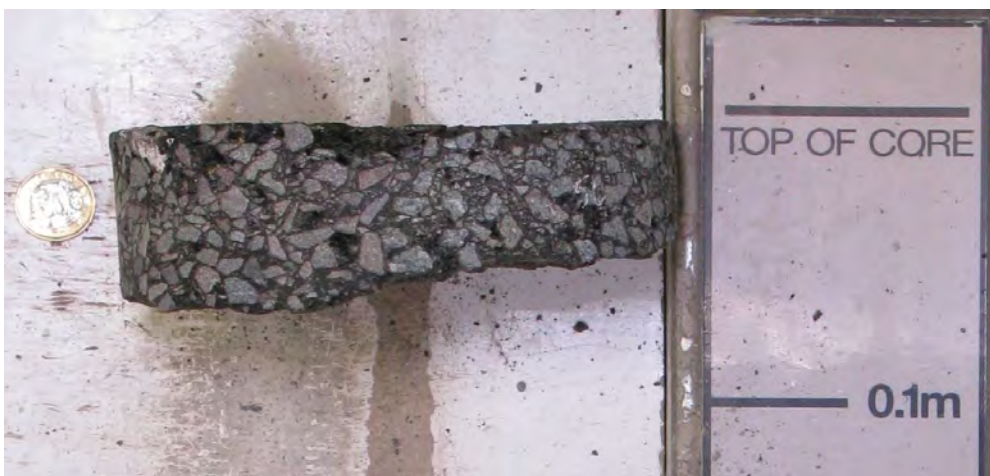
Core Surface

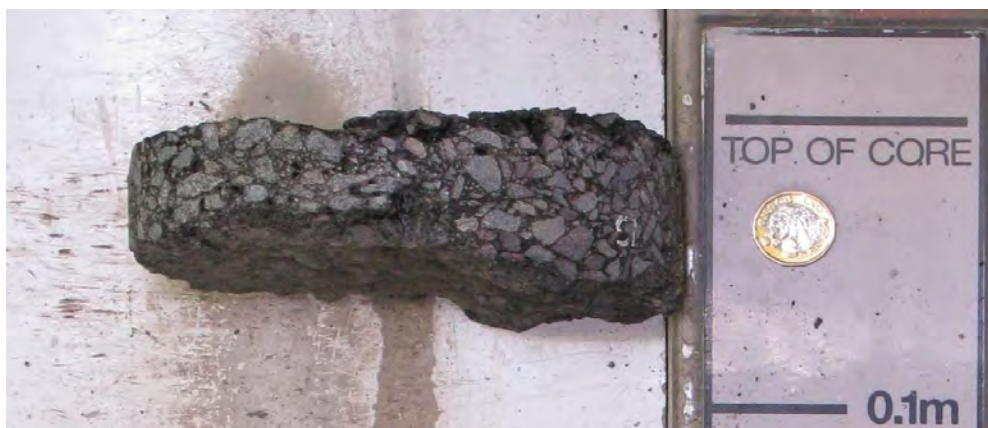
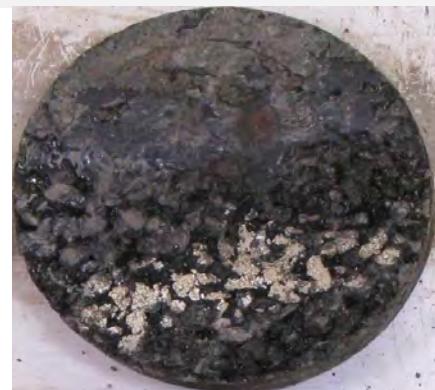
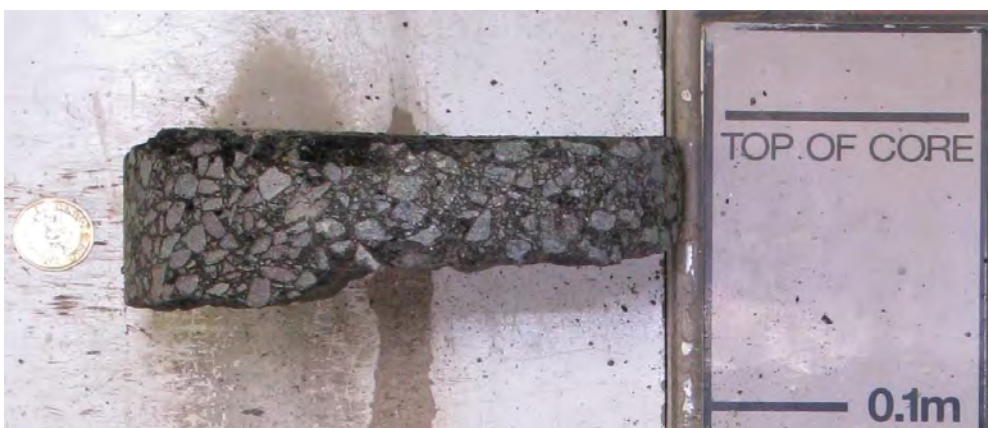
Core Surface

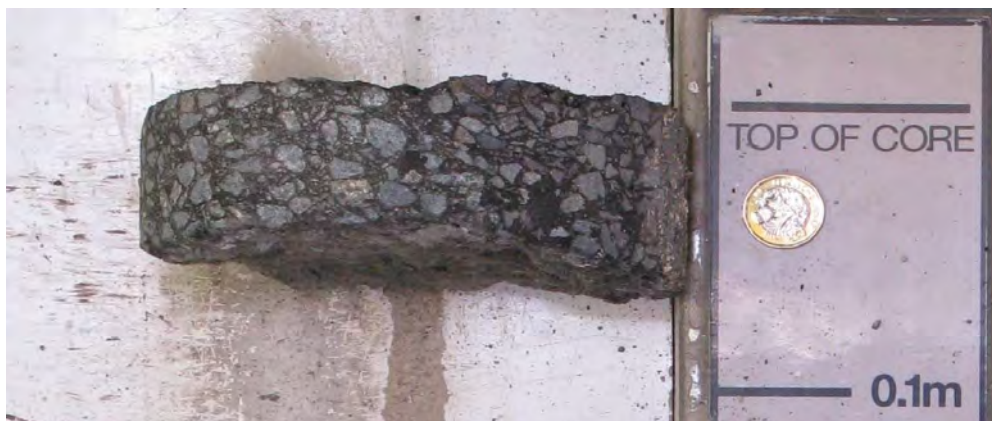
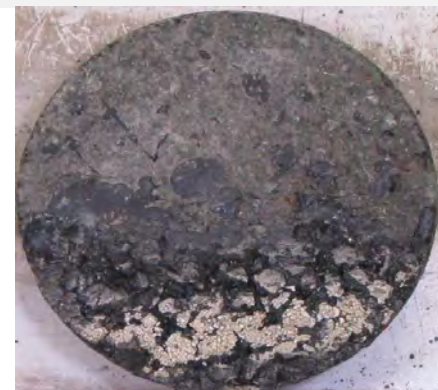
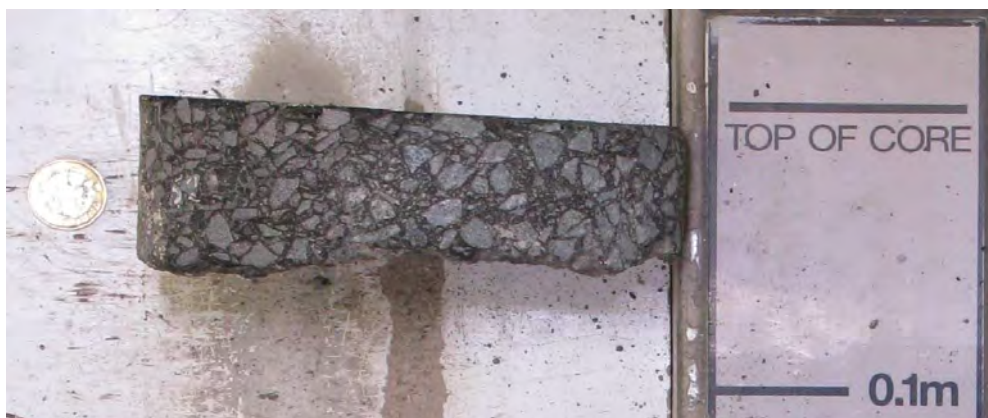
Core Surface

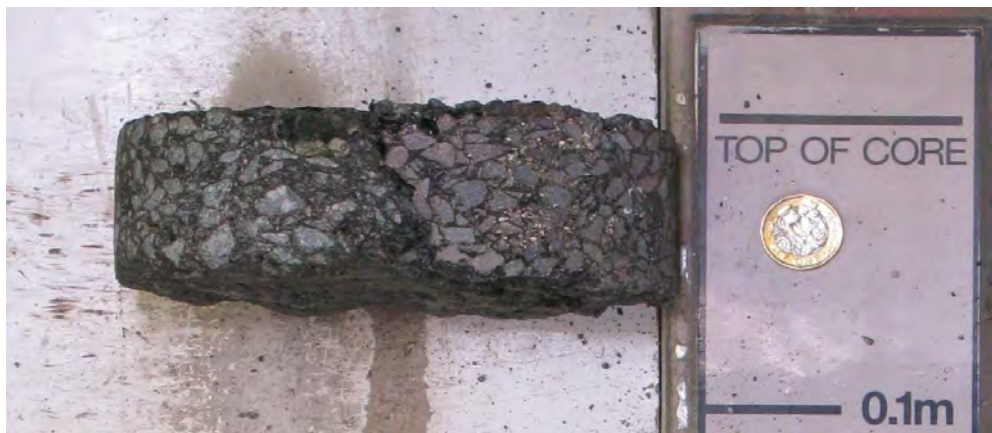
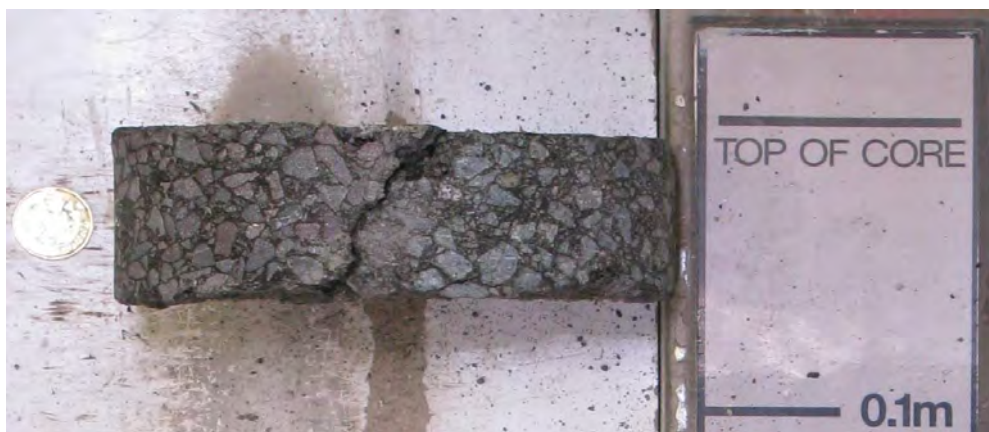
Core Surface

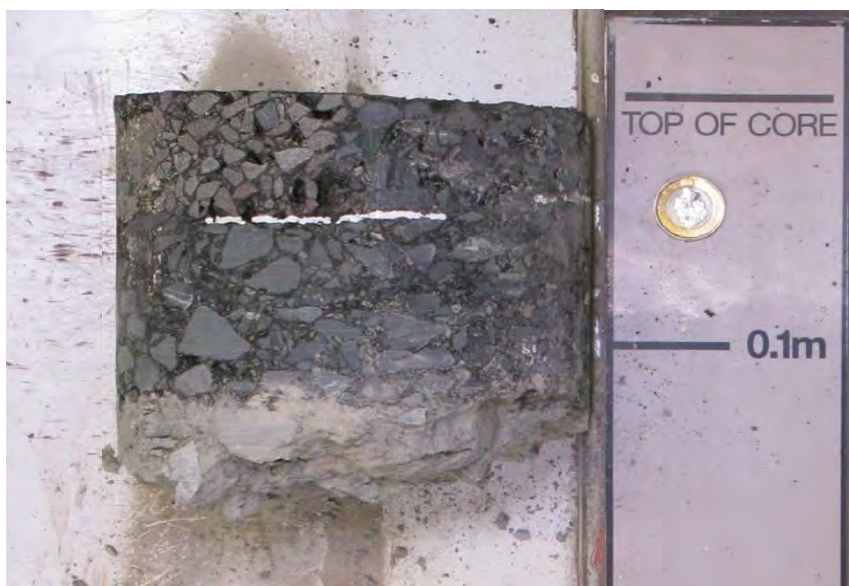
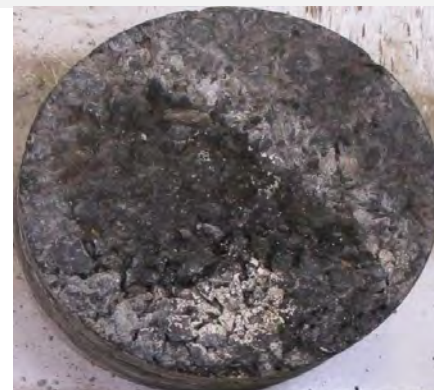
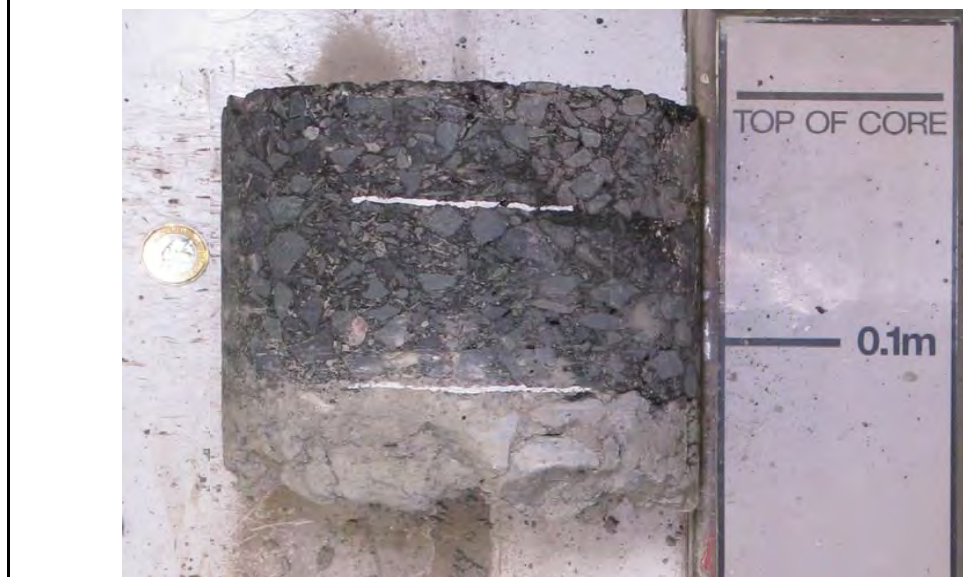
| Layer | Depth (mm) | | Thickness (mm) | Material Description ¹ | Suitable for NAT/CS Testing (Yes/No) | PAK-Marker ² | Binder ³ | Aggregate | |
|---|---|---|---|---|---|---|---|---|---|
| 3 | 100 | 145 | 45 | Weakly Bound Material | | | | | |

Core Surface

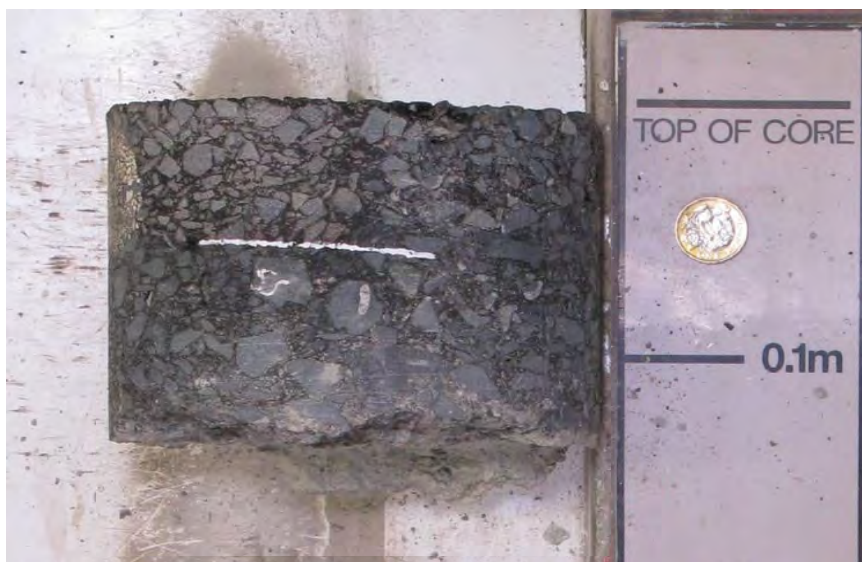
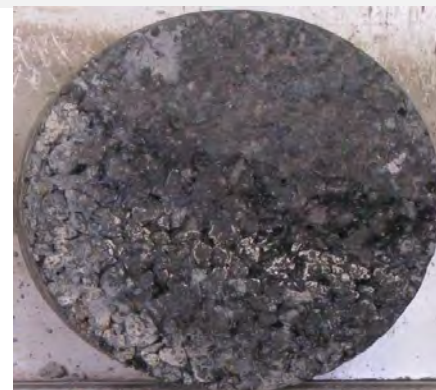
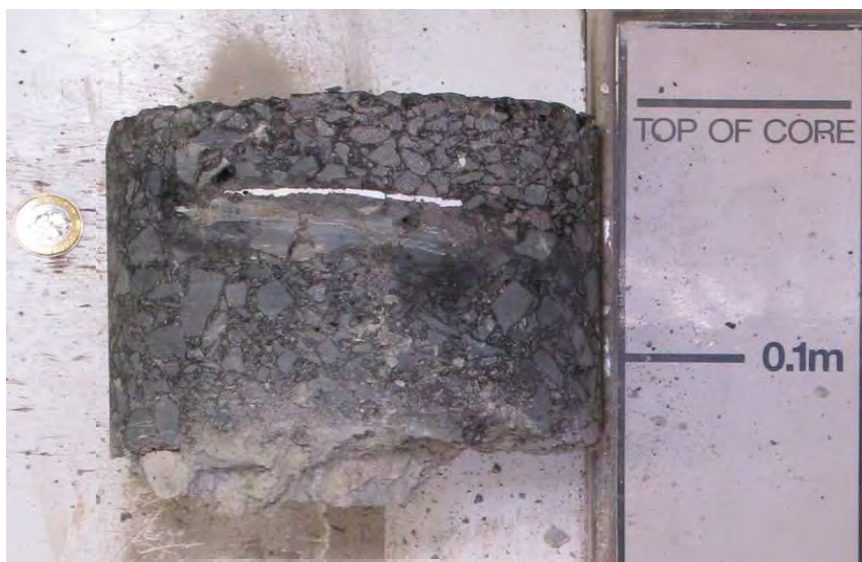
Core Surface

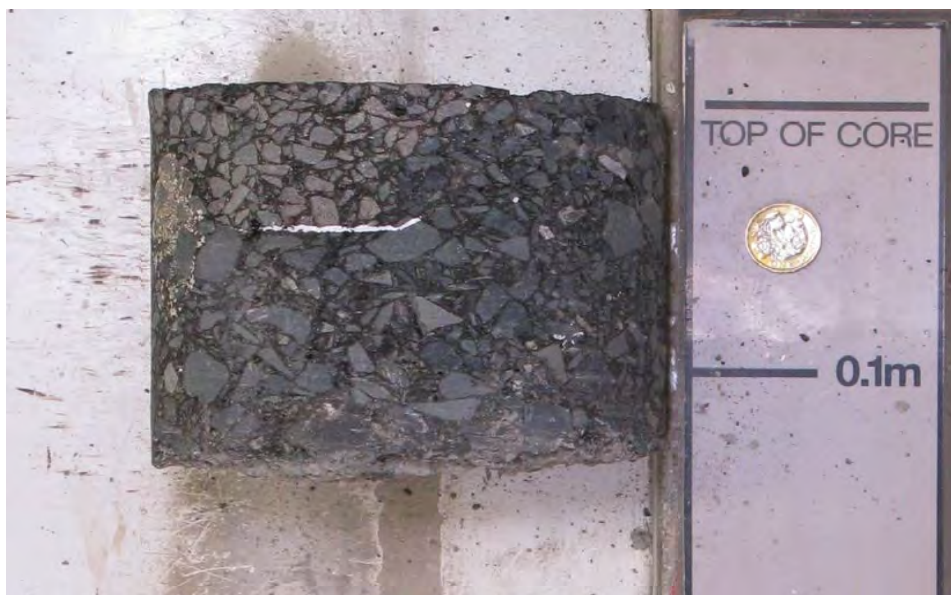
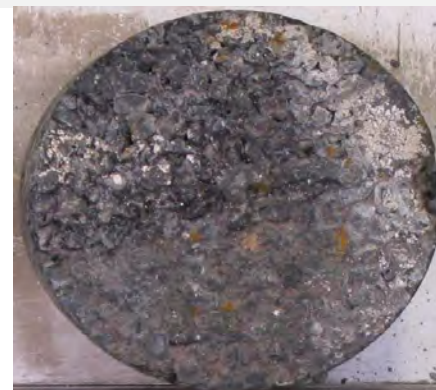
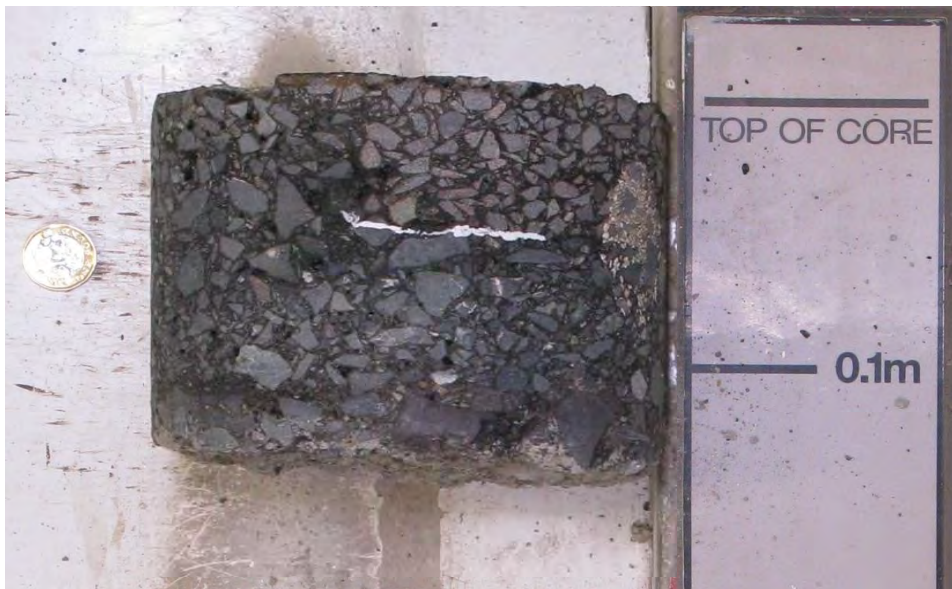
Core Surface

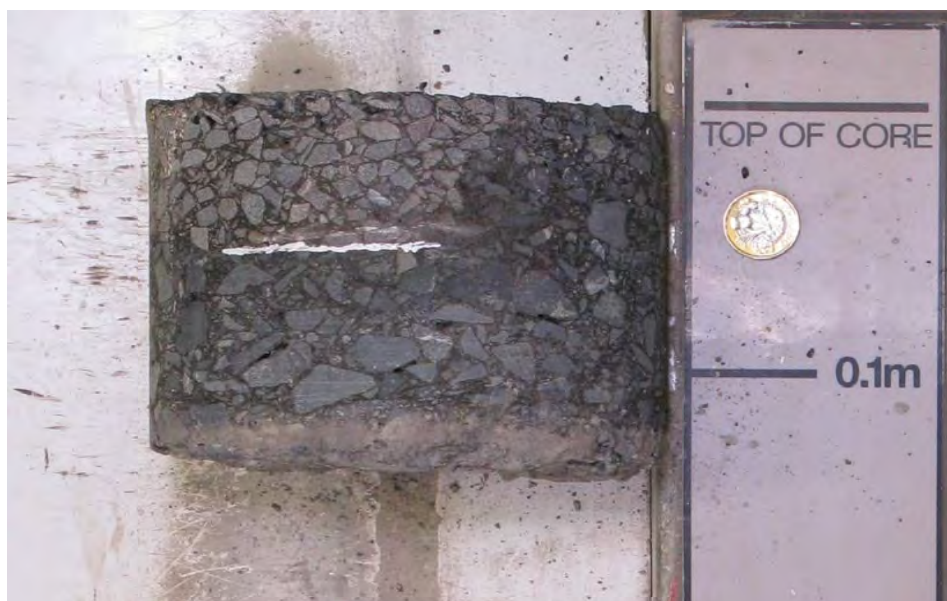
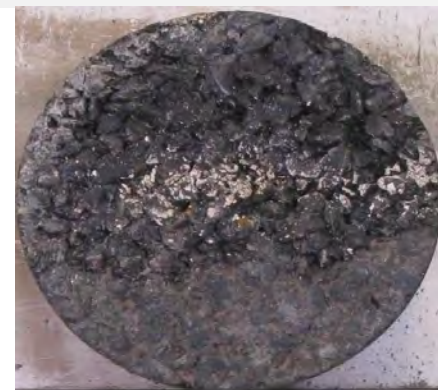
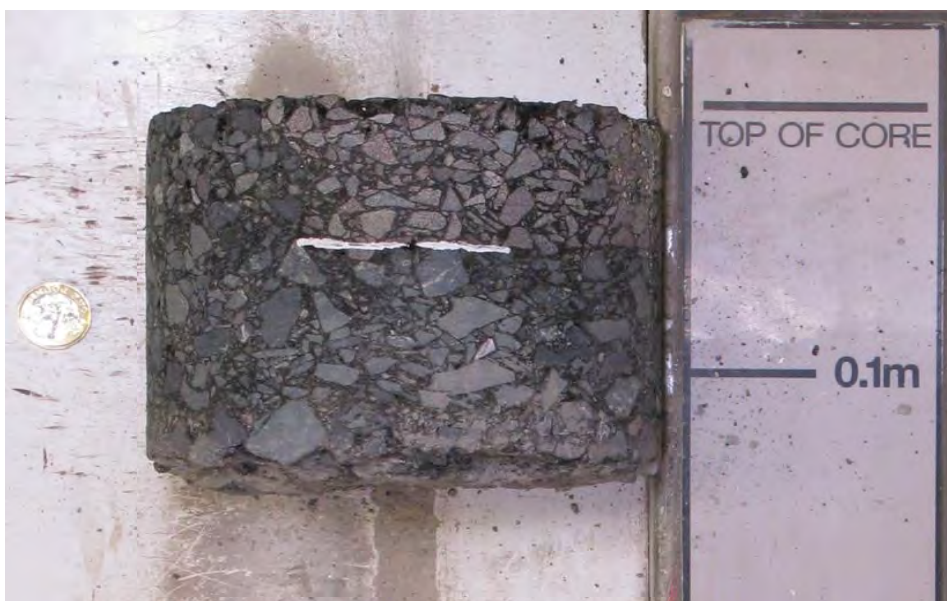
Sample Number : **T0824**

Core Surface

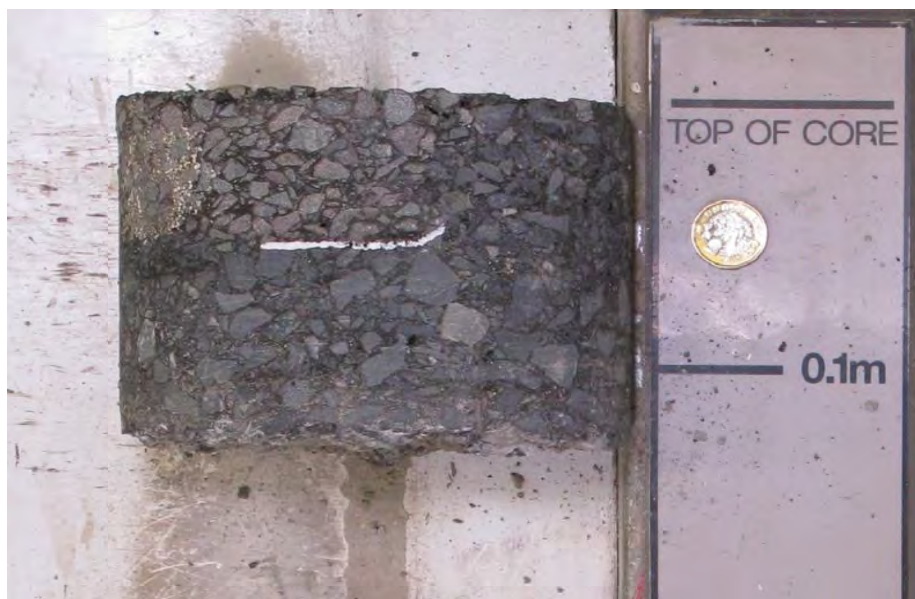
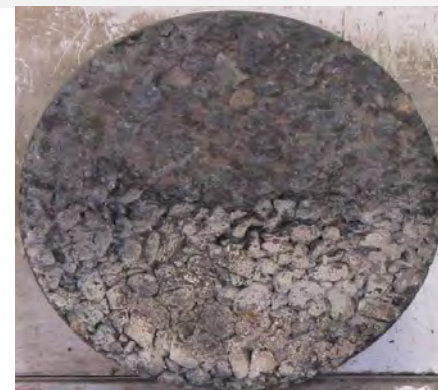
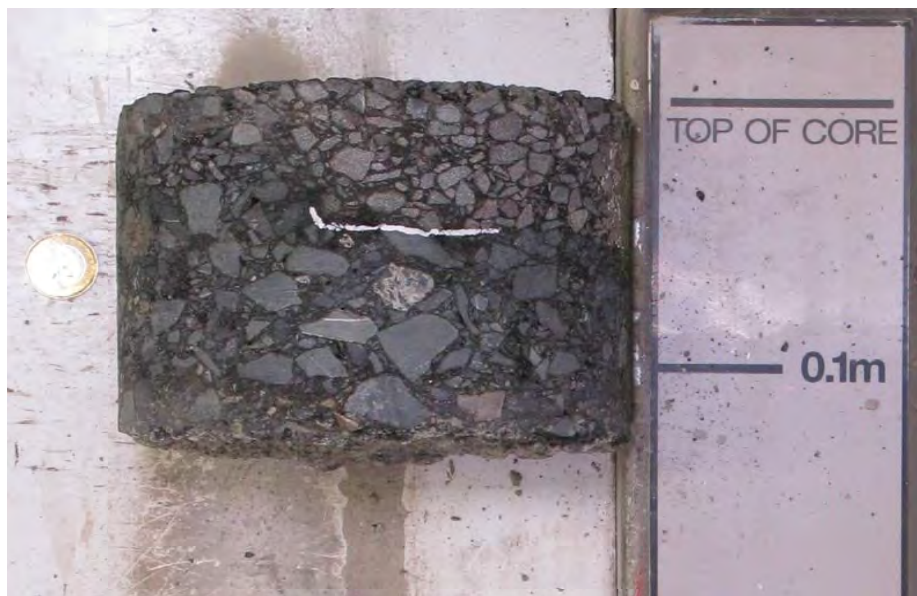
Core Surface

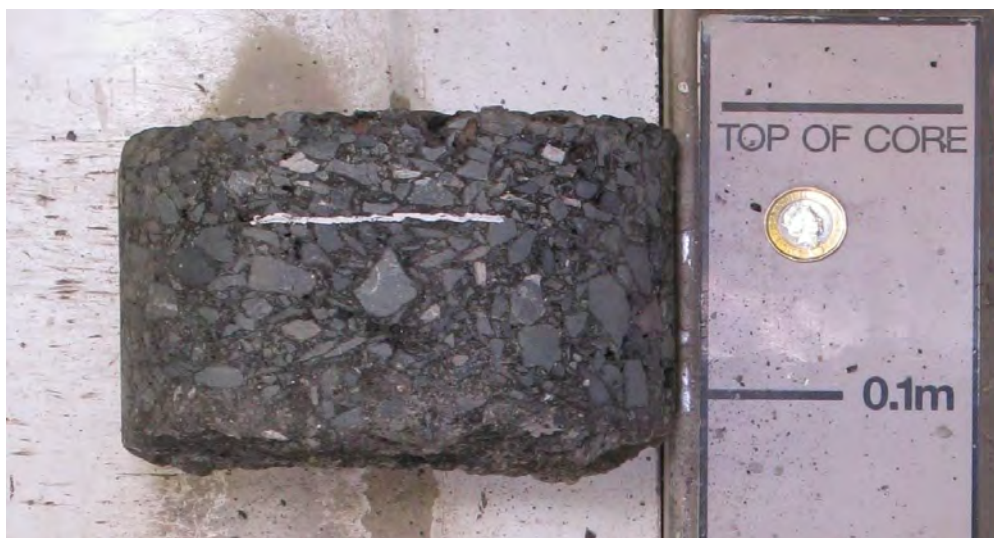
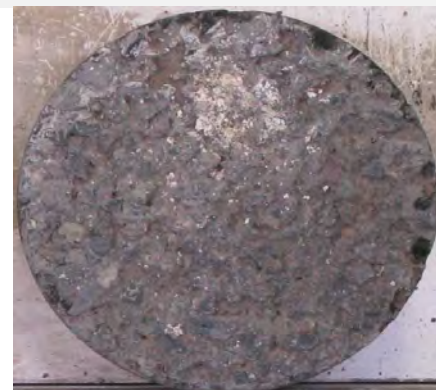
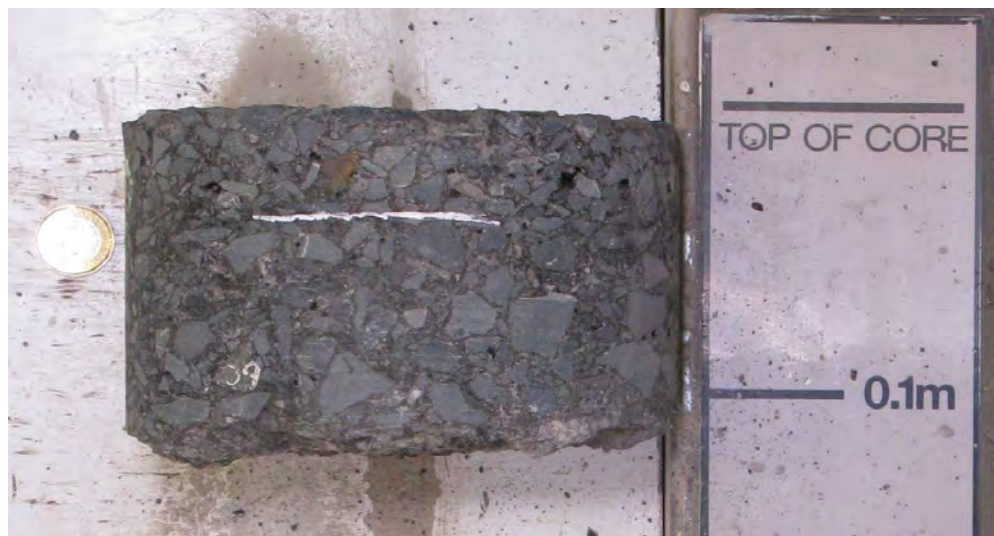
Sample Number : **T0824**

Core Surface

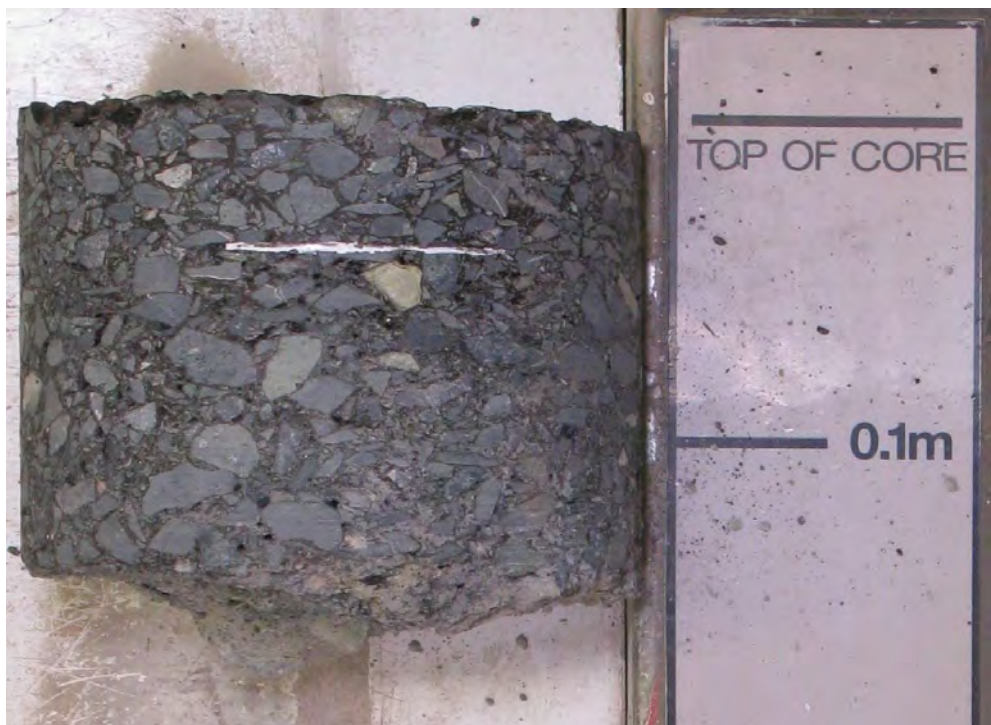
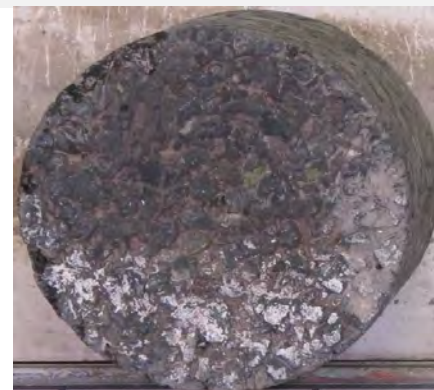
| Job Number : 60485963 Sample Number : T0824 Core Number : 63 Cored / Logged By : RF / BM Date Cored / Logged : 07-12-17 / 20-12-17 Nominal Diameter : 150mm | Scheme : Stafford Depot : Telford Notes: 1. Core taken in central mat 2. Existing material |

| Layer | Depth (mm) | | Thickness (mm) | Material Description ¹ | Suitable for NAT/CS Testing (Yes/No) | PAK-Marker ² | Binder ³ | Aggregate | |
|---|---|---|---|---|---|---|---|---|---|
| 2 | 40 | 135 | 95 | Asphalt Concrete (voided) | Yes | -ve | Bitumen | 14 | Crushed Rock |

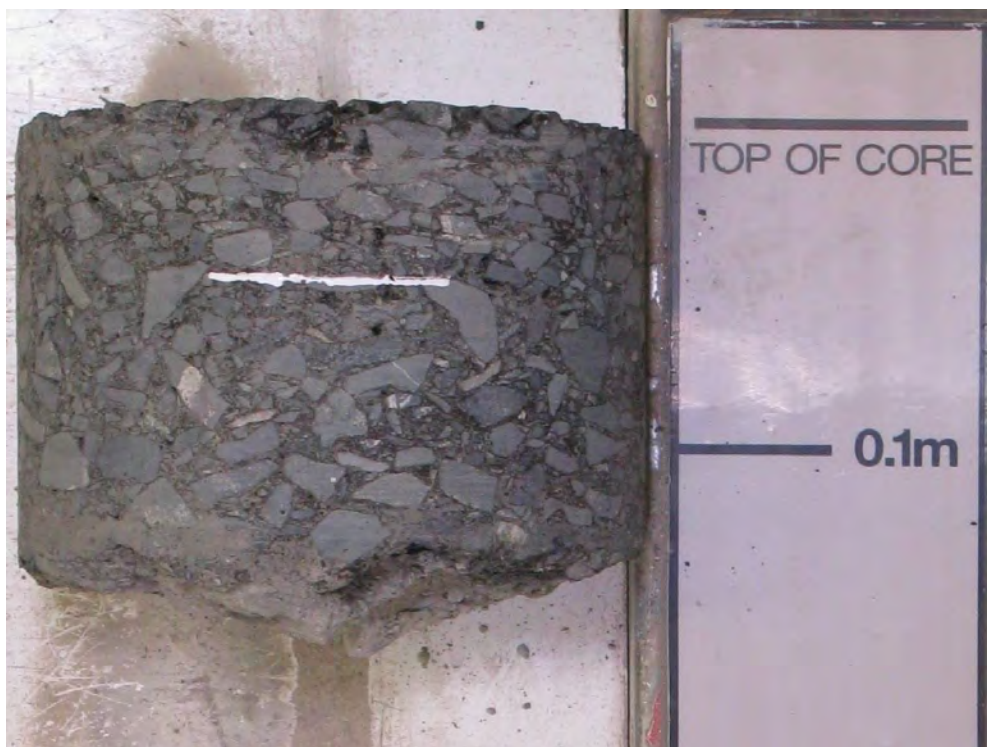
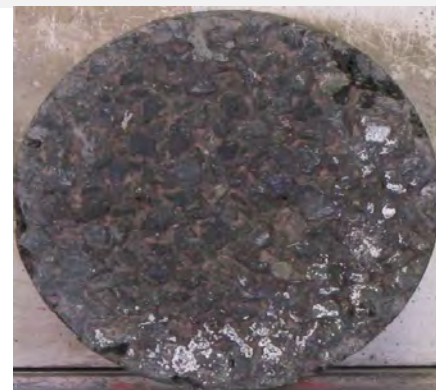
| Layer | Depth (mm) | | Thickness (mm) | Material Description ¹ | Suitable for NAT/CS Testing (Yes/No) | PAK-Marker ² | Binder ³ | Aggregate | |
|---|---|---|---|---|---|---|---|---|---|
| 2 | 45 | 120 | 75 | Asphalt Concrete | Yes | -ve | Bitumen | 14 | Crushed Rock |
