Sub-Task 2.2 – Report on A5 Warm Mix Asphalt

Task 1-111 Collaborative Research Project

Highways England, Mineral Product Association and Eurobitume UK

Project Number: 60523093

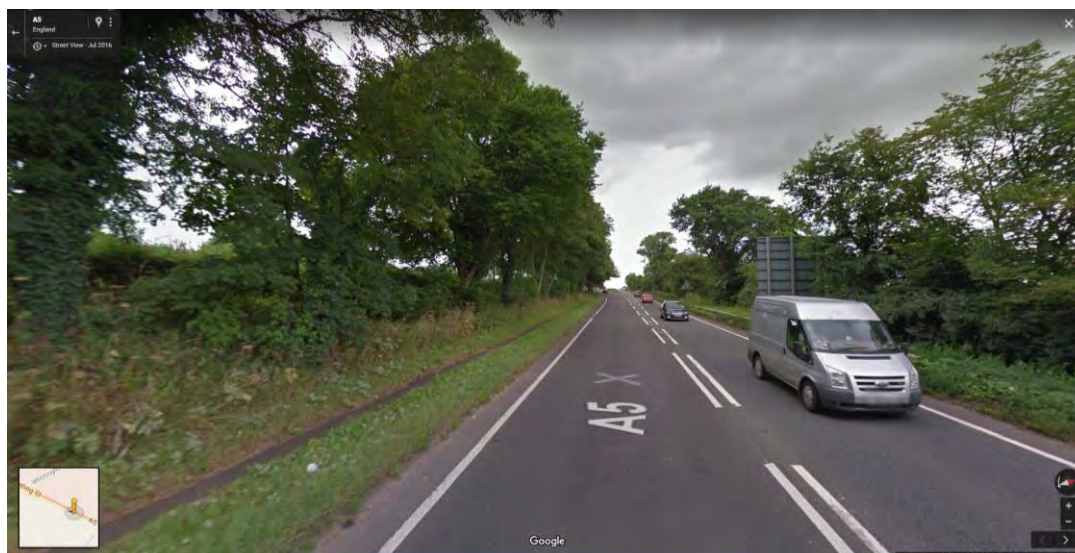
Figure 1: Demonstration Site within the A5 Grendon to Mancetter Maintenance Scheme (Google maps, 2017)

The demonstration site is located within a 1.1 km maintenance scheme on the A5 between Grendon and Mancetter in North Warwickshire, United Kingdom. A section of the westbound carriageway of the A5, approximately 220 m in length (Chainage: 2960-3180 m) was inlaid with 110 m length of WMA binder and surface courses and 110 m length of conventional HMA binder and surface courses acting as a control mixture. The production and application of both binder and surface course layers were closely monitored and the laboratory properties of the asphalt mixtures tested to ascertain mechanical and performance properties (PPR742, 2014).

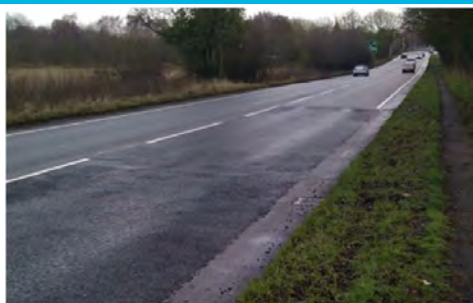
2014 WMA section (looking in EB direction)

Fretting of the surface course materials was also observed in some areas which were noted to a greater extent in the WMA section. It is noted that photographs of the WMA section taken 12 hours after completion of the works in 2014 (shown in Table 4) appear to have a variable surface finish with some areas appearing more open in texture than others.

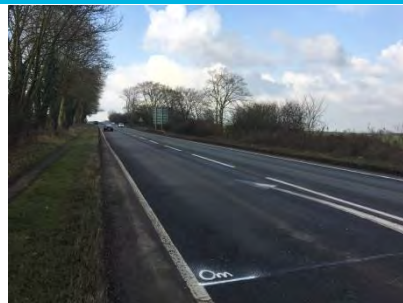
2017 WMA section (looking in WB direction)

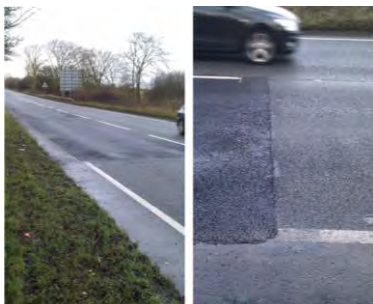
2014 Boundary between WMA and existing surface

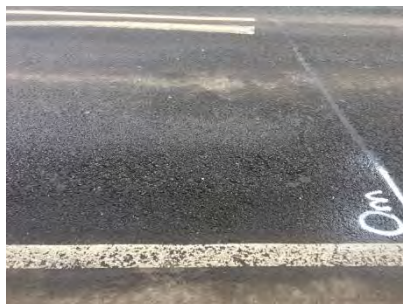
2017 Boundary between WMA and existing surface

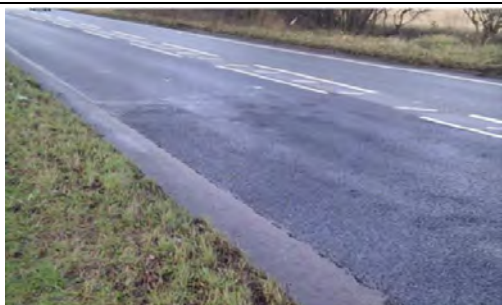
2014 Boundary between WMA (right) and HMA (left)

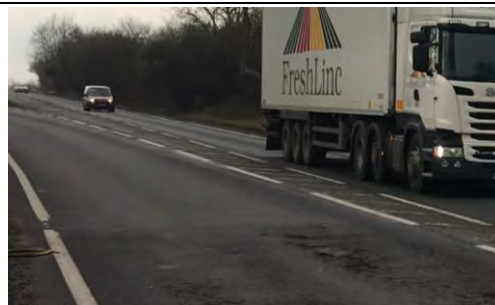
2017 Boundary between WMA (bottom) and HMA (top)

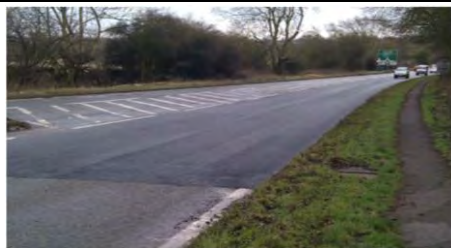
2014 Boundary between HMA & existing surface
(looking in Eastbound direction)

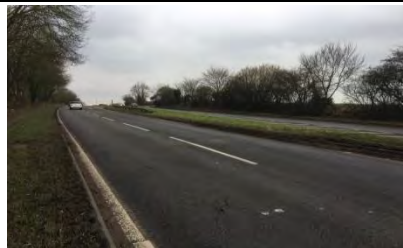
2017 Boundary between HMA & existing surface
(looking in Westbound direction)

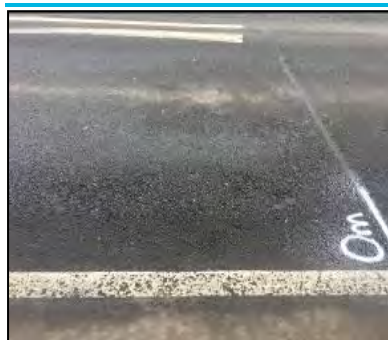
Picture 3: WMA

Section	Chainage	Observation	Photograph
Warm Mix Asphalt	0-92	General observations: Fretting and/or 'open' texture was evident in areas throughout the section. Cracking and crazing were observed with areas of settlement. In some areas there appeared to be some bitumen bleeding in the wheel tracks.	
	0-5m	Possible segregation and/or fretting of the surface course material at the start of the demonstration section.	Picture 3
	5-7m	Extended minor crazing on the pavement surface with wide transverse cracks and block cracking. Similar defects were observed during the VCS conducted by TRL in 2014 pre-works.	Picture 4
	16m	A fatty patch on the surface was observed. There is also evidence of bitumen-rich areas in the wheel tracks.	Picture 5
	21-23m	This section had signs of visible fretting and loss of fine materials on the surface course.	Picture 6
	51m	This section had signs of visible fretting and loss of fine materials on the surface course.	Picture 10

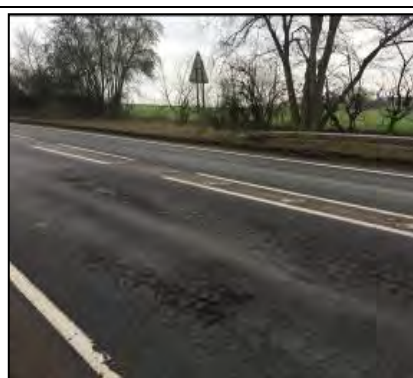
Picture 13: WMA

75-90m	Major rutting and extended crocodile crack defects were observed. In some spots, there was a loss of surface course materials causing potholes. Similar defects were observed in this location in the VCS conducted by TRL in 2014 pre-works.	Picture 13
Hot Mix Asphalt	92-223m	General observations: Some local fretting was observed along with cracking. In some areas there appeared to be some bitumen bleeding in the wheel tracks.	
	135-136m	Minor longitudinal cracks. Visible signs of excessive bitumen on the surface of the road synonymous with fatting/bleeding.	Picture 19
	203m	Visible signs of fretting observed	Picture 25
	204-205m	Medium transverse and longitudinal cracks were observed. Rutting and crazing were recorded in this location as in the TRL 2014 VCS pre-works.	Picture 26

There is evidence of underlying issues (possible subsidence) in certain areas of the demonstration scheme which is observed in the form of rutting, cracking and crazing. It was observed that the recorded defects were located in close proximity to defective areas as identified by TRL in surveys conducted in 2014. This strongly suggests fundamental underlying issues which may be related to the condition of the foundation and/or substrate. Further testing and analysis are required to ascertain pavement condition of the underlying layers. This falls outside the scope of this project.

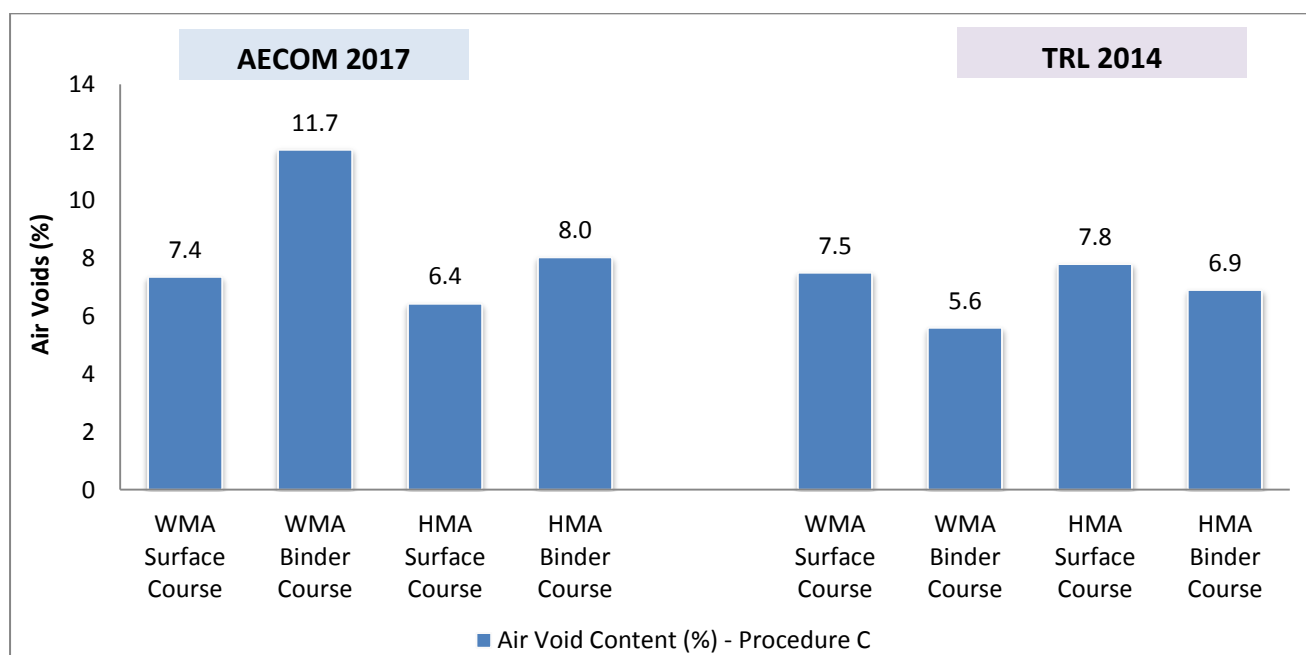
Figure 6: Air Voids Procedure C for AECOM 2017 and TRL 2014

The mixture volumetrics was obtained for both the surface and binder courses using an average of six cylindrical specimens cored from the site. The test results for both Procedures B and C are presented in Appendix C. Comparisons between the mixture volumetrics following testing of samples by AECOM in 2017 and TRL in 2014 (reported in PPR 742, 2014) is shown below in Figure 6.

It should be noted that TRL in 2014 analysed the same number of specimens but made use of laboratory manufactured slabs cored and tested in accordance with BS EN 12697-6 using three procedures: Procedure A (Dry), Procedure C (Sealed) and Procedure D (Dimensions) (Wayman et al., 2015). On this basis, the measured results are not directly comparable and the 2014 testing is not considered to accurately represent the material air voids in service. The air voids for WMA and HMA are higher than would be expected for AC 20 binder course materials. WMA binder course contains 25% recycled asphalt which could contribute to variation in density. This is because the specific gravity of the recycled material may vary to a greater extent than virgin material. PPR742, 2014 reports the average in-situ density measurements as 9.5% and 7.6% for WMA and HMA binder courses respectively. Air voids measured on binder course during this 2017 survey are higher than those recorded in situ.

The air void contents reported varied significantly and were found to be higher than expected. Higher air void contents may indicate that these asphalt materials could be susceptible to increased oxidation and permeability. WMA air voids were found to be higher than HMA. High air voids may result in increased susceptibility to the ingress of water into the pavement structure.

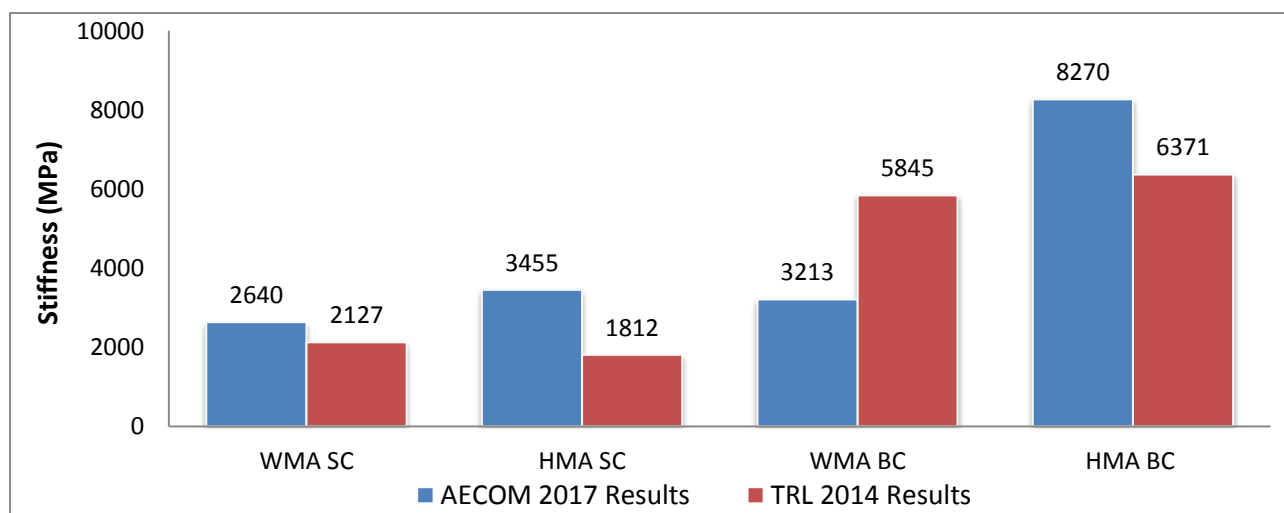
Figure 7: ITSM Test Results

The Indirect Tensile Stiffness Modulus (ITSM) test was conducted in accordance with BS EN 12697-26 at 20°C. The test results are presented in Appendix D. The test results are analysed and summarised below in Figure 7.

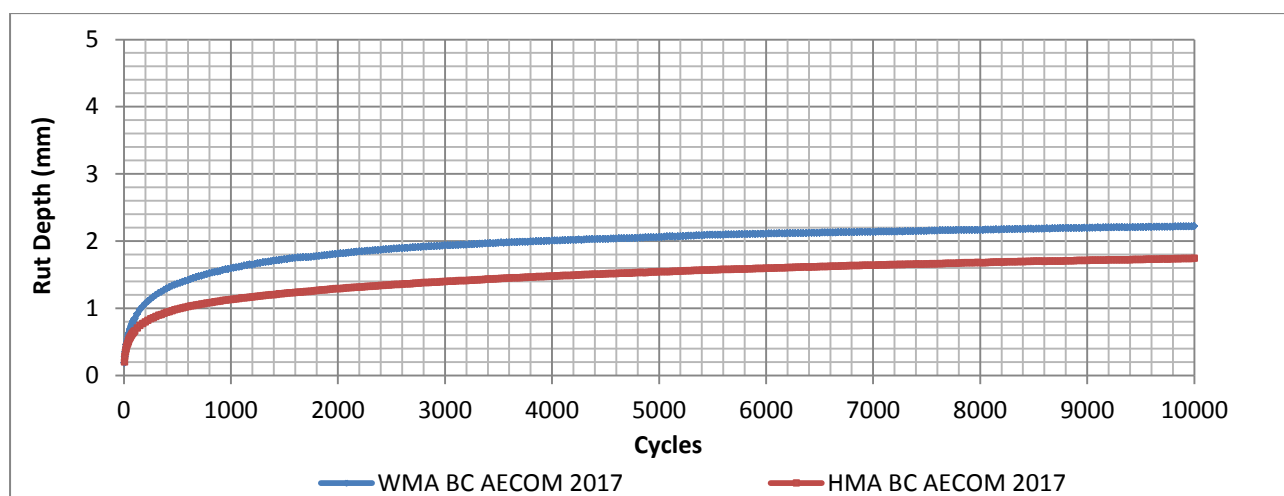
Figure 8: Rut Profile - AECOM 2017

Wheel Tracking Tests were conducted to ascertain the resistance of the asphalt mixtures to permanent deformation. The test was conducted in accordance with BS EN 12697-22, Procedure B in Air at 60°C. Two Binder Course (BC) samples were used in ascertaining resistance to permanent deformation of the WMA and HMA. Appendix E presents the wheel tracking test results. The mean rut profiles are shown below in Figure 8.

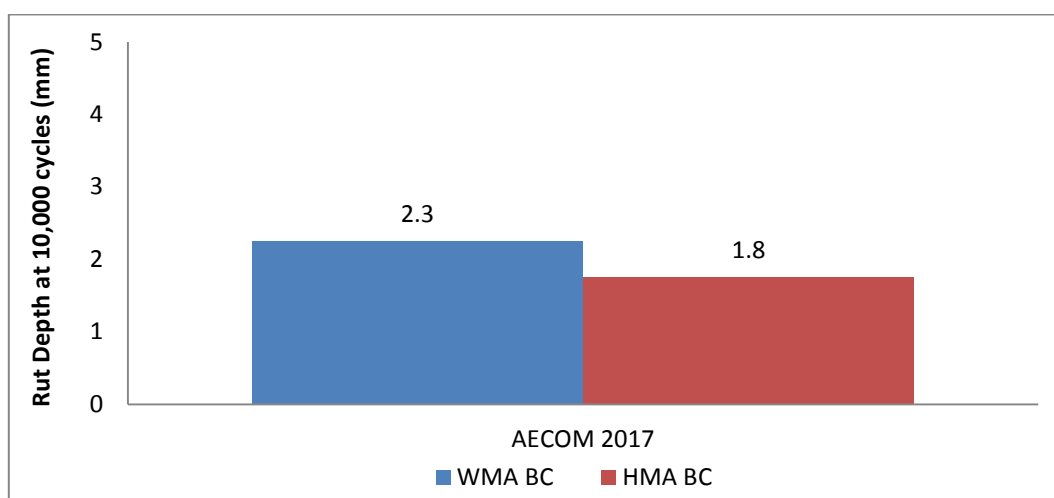
Figure 9: Rut Depth at 10,000 Cycles - AECOM 2017

Figure 9 shows that the rut depth profile of the WMA and HMA materials with rut depths < 3 mm after 10,000 cycles at 60°C (Procedure B).

The mean rut depths for the WMA and HMA binder course were < 3 mm after 10,000 cycles (tested at 60°C in accordance with BS EN 12697-22). WMA rut depth was found to be slightly higher than HMA which could be attributed to higher air voids, the difference in grading which may be associated with the recycled content, or possibly the binder properties. The proportional rut depth and wheel track slope fall within specified limits outlined in PD 9961:2015 Table B4 for asphalt concrete for very heavily stressed sites requiring very high rut resistance.

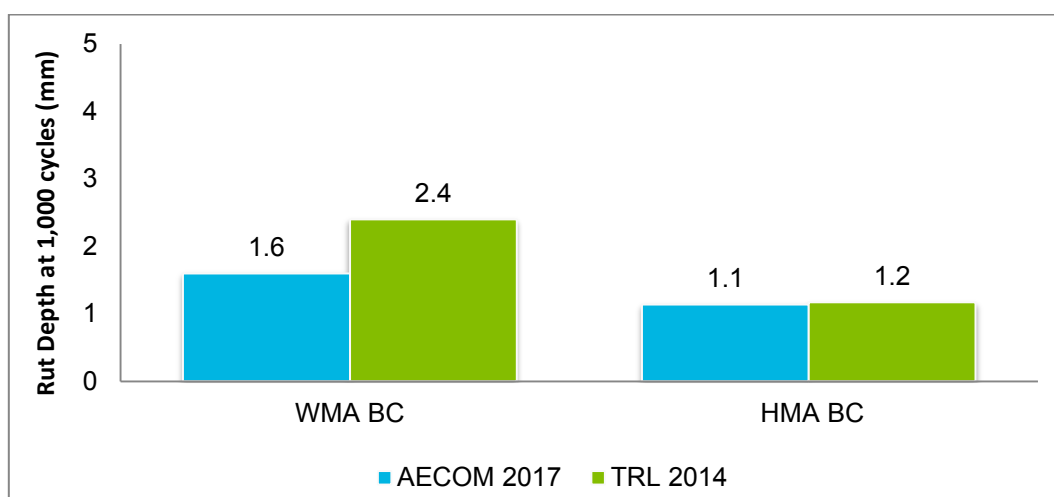
Figure 10: Comparing Rut Depths at 1,000 cycles for AECOM 2017 and TRL 2014

Figure 10 shows the rut depth at 1,000 cycles (Procedure A) used in comparing the resistance to permanent deformation of the AECOM 2017 samples WMA and HMA BC mix. Both rut depths were found to be < 3 mm.

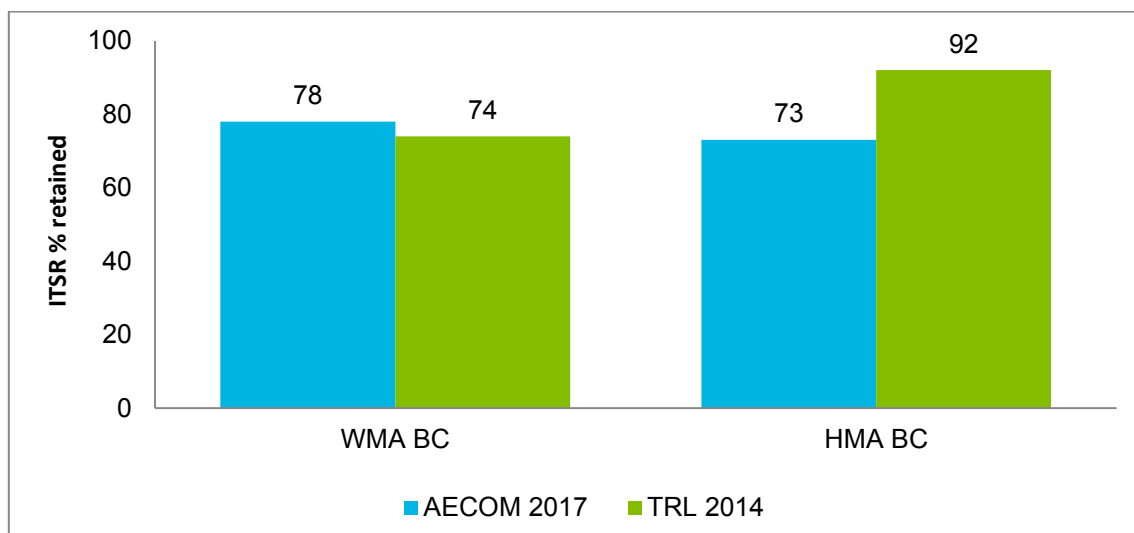
Figure 11: Water Sensitivity Test Results at 20°C

Figure 11 shows that the ITSr values for all the binder course mixtures are above 70% which suggests good resistance to water damage. The WMA BC showed similar test results between the AECOM and TRL samples. The HMA had variable test results with values of 92% for the TRL sample in comparison to 73%. It must be noted that samples used for testing by TRL were laboratory manufactured as opposed to samples obtained from the site. Similar ITSr values are obtained from WMA and HMA mixtures (AECOM and TRL).

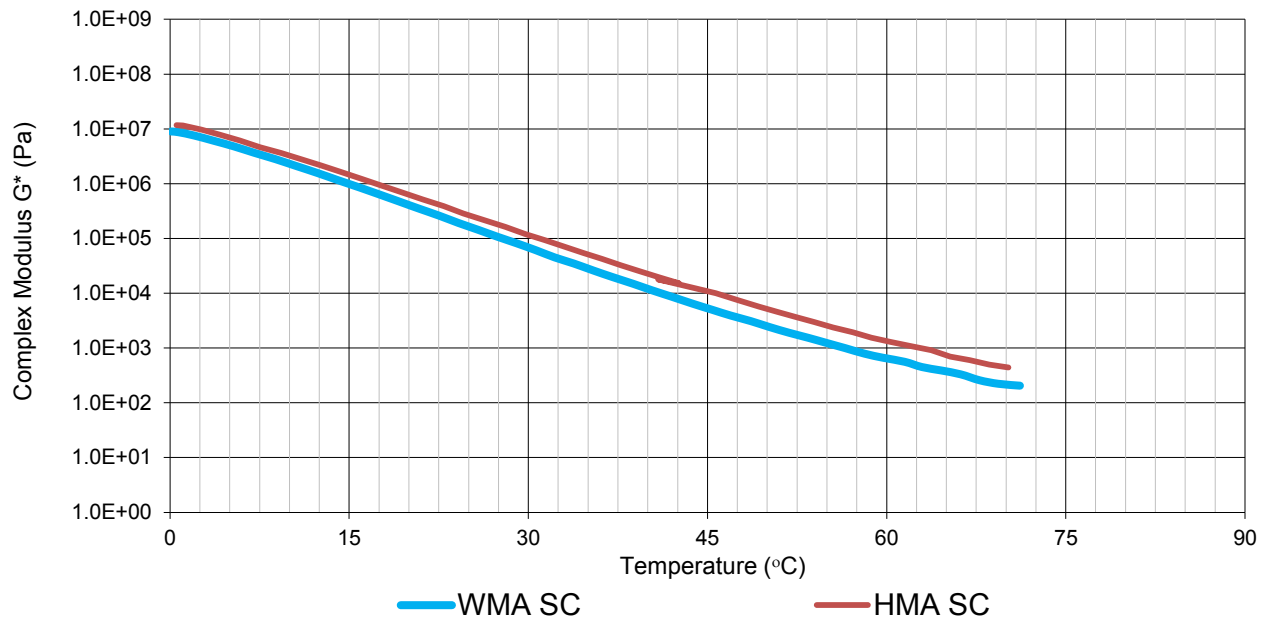
Figure 12: Complex Modulus vs Temperature

The binder rheological properties were tested in accordance with BS EN 14770. The complex modulus as a function of the temperature is presented below in Figure 12. The test was conducted for the surface course WMA and HMA mixtures.

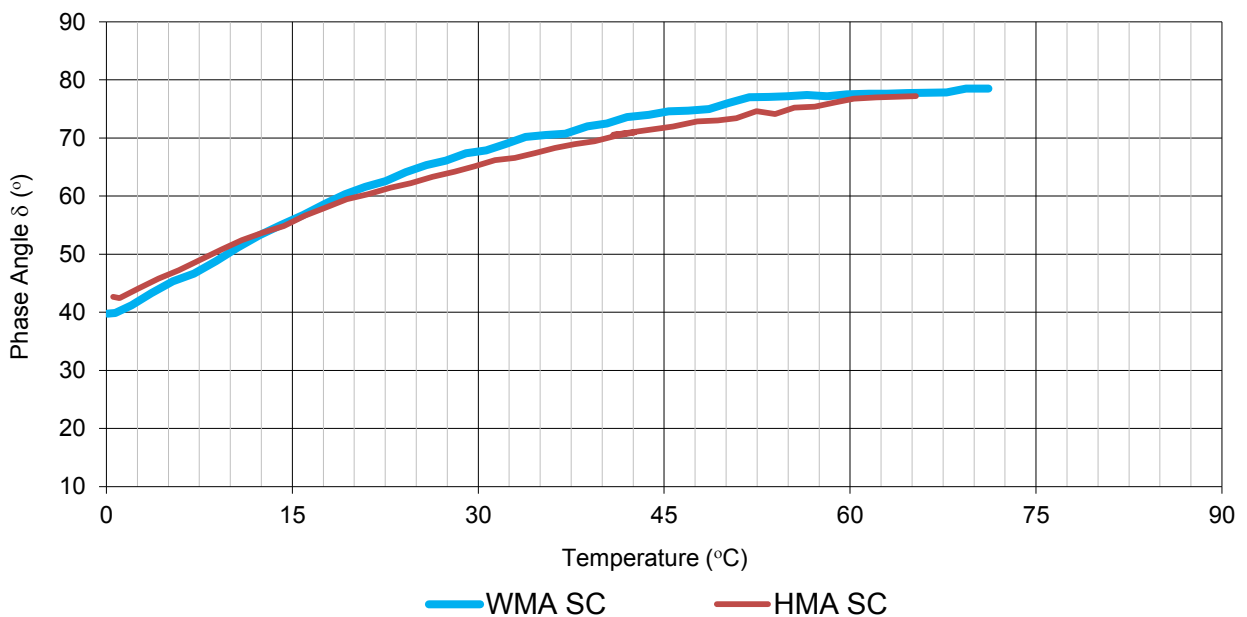
Figure 13: Phase Angle vs Temperature

Figure 13 presents a plot of the phase angle as a function of temperature. The result shows that at increasing temperatures, the phase angles increase to a more viscous state.

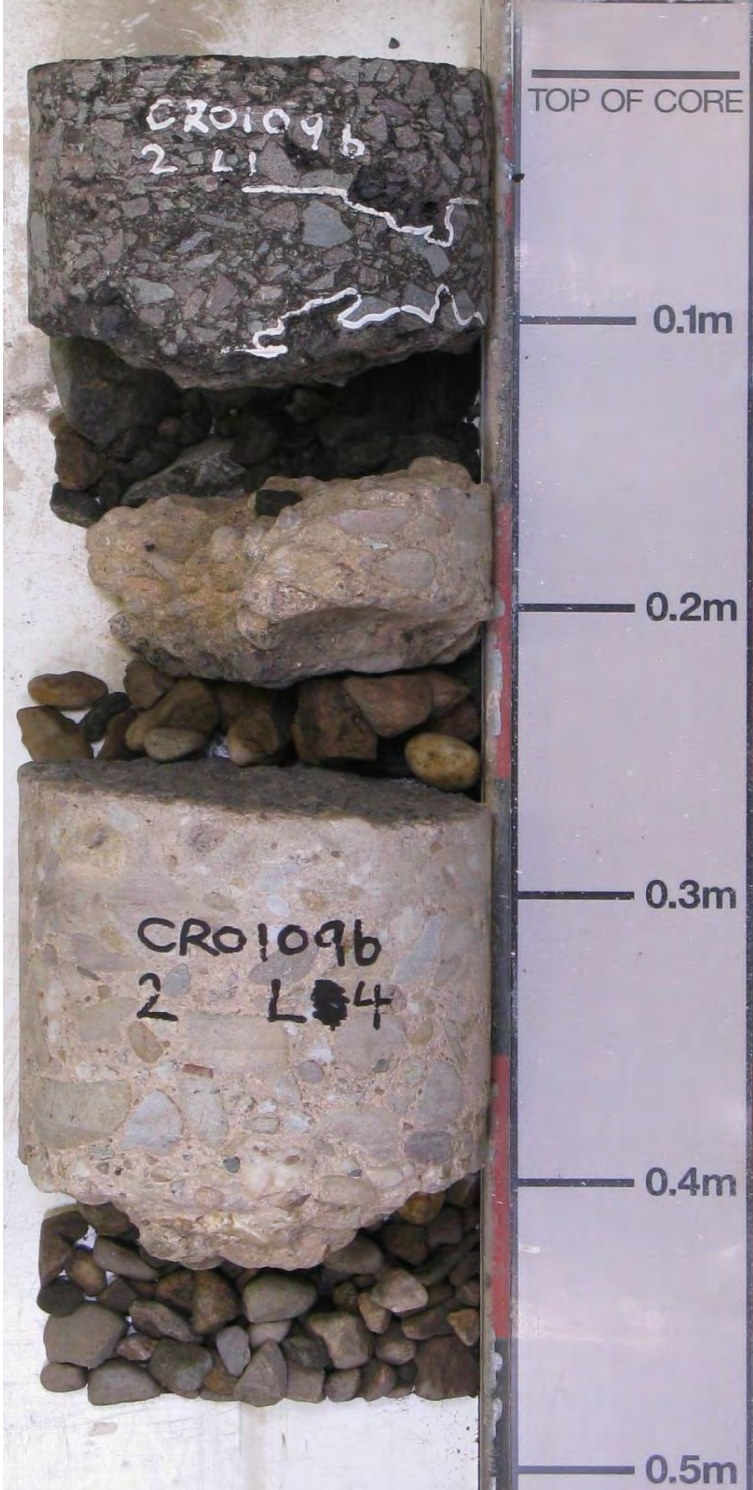
Job Number : 60523093	Scheme : Task 1-111 A5 Warm mix Trials
Sample Number : CR 01096	Location : Northbound, Lane 1, Lane Centre, Offset from nearside white line 1.65m
Core Number : 02	Survey Ch. 15m
Cored / Logged By : TB / RBB	OSGR: SP 29502, 98456
Date Cored / Logged : 13-02-17 / 22-02-17	Notes: N/A
Nominal Diameter : 150mm

Layer	Depth (mm)		Thickness (mm)	Material Description ¹	Suitable for NAT/CS Testing (Yes/No)	PAK-Marker ²	Binder ³	Aggregate	
	From	To						Size ⁴	Type
1	0	47	47	Asphalt Surfacing	Yes	-ve	Bitumen	14	Crushed Rock
2	47	140	93	Asphalt Concrete (broken @ base and top)	No	-ve	Bitumen	20	Crushed Rock
				Layers 2 & 3 Not Bonded					
3	140	255	115	Concrete - Type D Voids (broken up)	No	n/a	Cement	32	Crushed Rock
				Layers 3 & 4 Not Bonded					
4	255	350	95	Concrete - Type B Voids (broken @ base)	No	n/a	Cement	32	Crushed Rock/Gravel
				Loose Granular Material

It was observed that the surface and binder courses were bonded together. However, the lower layers were not well bonded, especially at the interface between the asphalt and concrete layers. In addition, there were visible signs of loss of material mostly between the asphalt and cement bound layers.

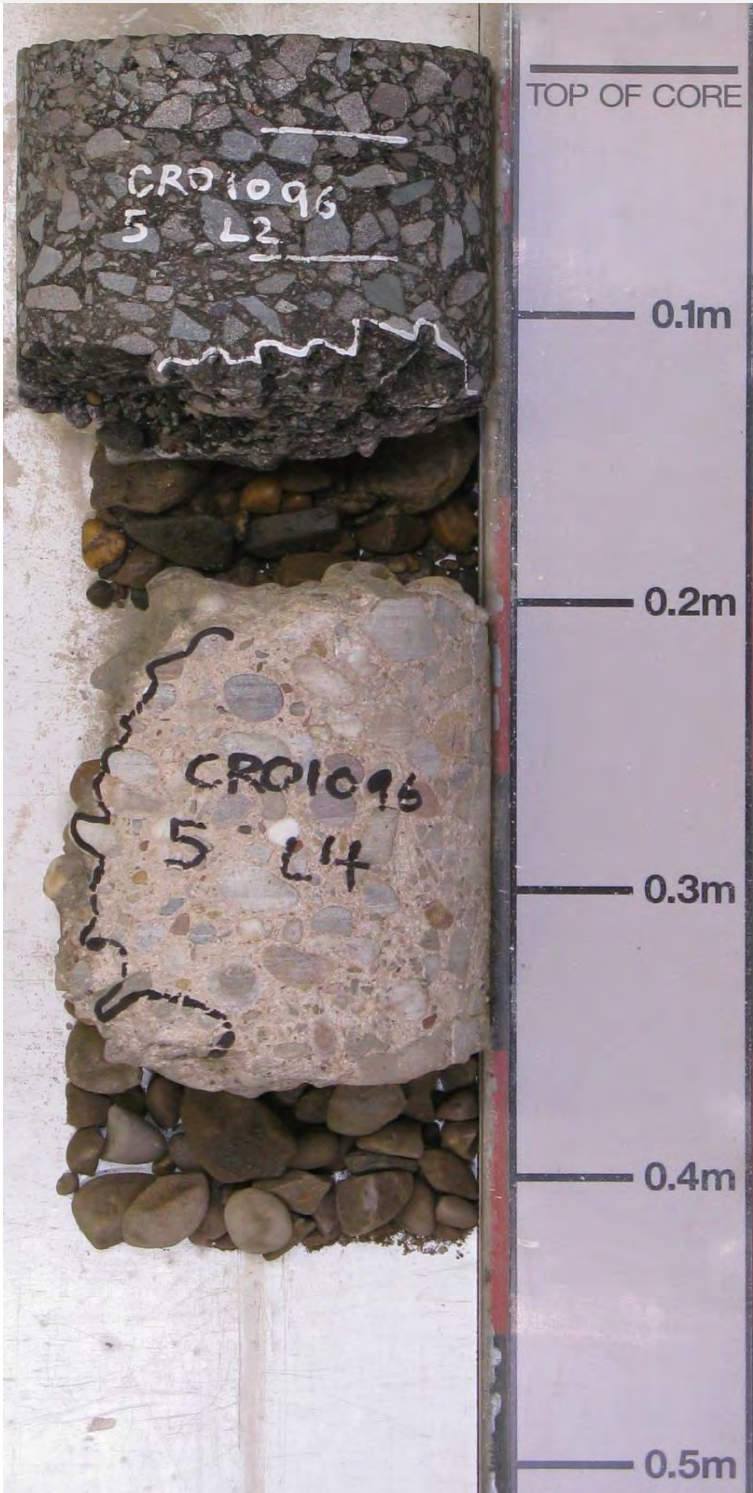
Job Number : 60523093	Scheme : Task 1-111 A5 Warm mix Trials
Sample Number : CR 01096	Location : Northbound, Lane 1, Lane Centre, Offset from nearside white line 1.56m
Core Number : 05	Survey Ch. 45m
Cored / Logged By : TB / RBB	OSGR: SP 29477, 98468
Date Cored / Logged : 13-02-17 / 22-02-17	Notes: N/A
Nominal Diameter : 150mm

Layer	Depth (mm)		Thickness (mm)	Material Description ¹	Suitable for NAT/CS Testing (Yes/No)	PAK-Marker ²	Binder ³	Aggregate	
	From	To						Size ⁴	Type
1	0	35	35	Asphalt Surfacing	Yes	-ve	Bitumen	14	Crushed Rock
2	35	75	40	Asphalt Concrete	Yes	-ve	Bitumen	20	Crushed Rock
3	75	135	60	Asphalt Concrete (broken @ base)	No	-ve	Bitumen	20	Crushed Rock
				Layers 3 & 4 Not Bonded					
4	135	310	175	Concrete - Type B Voids (broken up)	No	n/a	Cement	20	Crushed Rock/Gravel
				Loose Granular Material

150	5	135	3 asphalt layers identified. No bond between asphalt and concrete layers (Layers 3 and 4). 3 rd layer broken with the loss of material. Concrete layer is broken up.
200	6	170	3 asphalt layers identified. No bond between asphalt and concrete layers. 3 rd layer broken with the loss of material.
150	7	120	3 asphalt layers identified. No bond between both Layers 2 and 3, and Layers 3 and 4. 3 rd layer broken with the loss of material.
150	8	154	3 asphalt layers identified. No bond between both Layers 2 and 3, and Layers 3 and 4. 3 rd layer broken up with the loss of material.
150	9*	205	3 asphalt layers identified. No bond between asphalt and concrete layers (Layers 3 and 4). 3 rd layer broken up with the loss of material.
150	10*	175	3 asphalt layers identified. No bond between both Layers 2 and 3, and Layers 3 and 4. 3 rd layer broken and 4 th layer disintegrated with the loss of material.

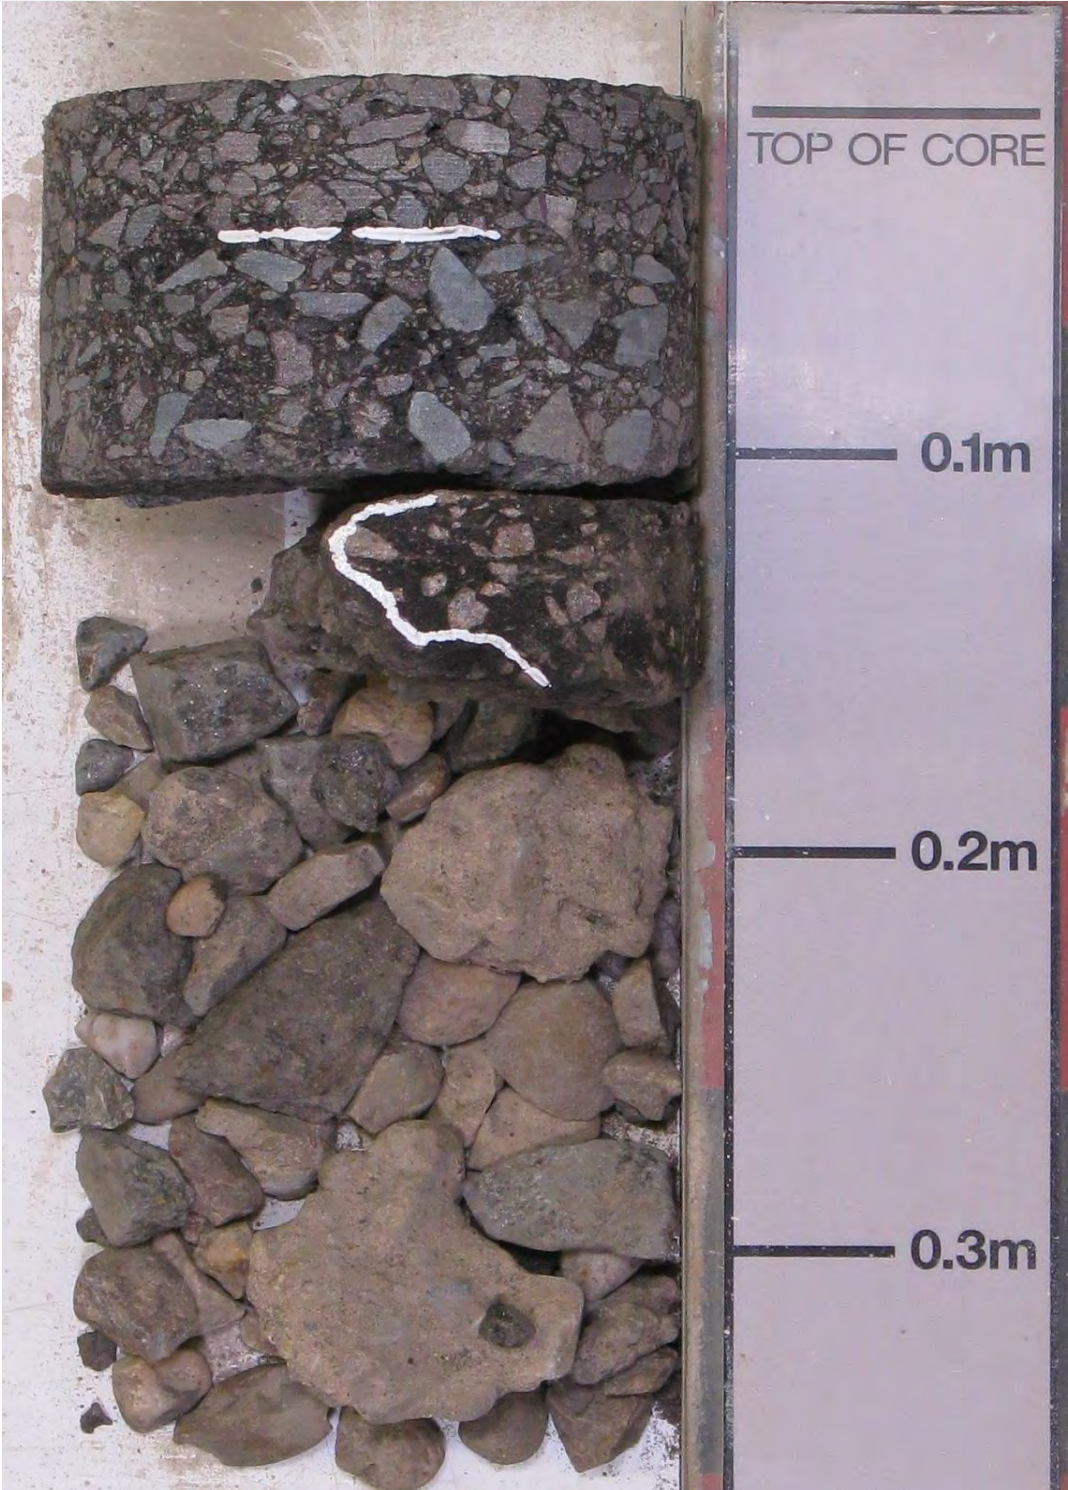
Job Number : 60523093	Scheme : Task 1-111 A5 Warm mix Trials
Sample Number : CR 01096	Location : Northbound, Lane 1, Lane Centre, Offset from nearside white line 1.65m
Core Number : 08	Survey Ch. 75m
Cored / Logged By : TB / RBB	OSGR: SP 29451, 98483
Date Cored / Logged : 14-02-17 / 22-02-17	Notes: N/A
Nominal Diameter : 150mm

Layer	Depth (mm)		Thickness (mm)	Material Description ¹	Suitable for NAT/CS Testing (Yes/No)	PAK-Marker ²	Binder ³	Aggregate	
	From	To						Size ⁴	Type
1	0	40	40	Asphalt Surfacing	Yes	-ve	Bitumen	14	Crushed Rock
2	40	100	60	Asphalt Concrete (voided)	Yes	-ve	Bitumen	20	Crushed Rock
				Layers 2 & 3 Not Bonded					
3	100	154	54	Hot Rolled Asphalt (broken up)	No	-ve	Bitumen	14	Crushed Rock
				Layers 3 & 4 Not Bonded					
4	154	350	196	Concrete (disintegrated)	No	n/a	Cement	32	Crushed Rock/Gravel
				Concrete Layer Not Recovered

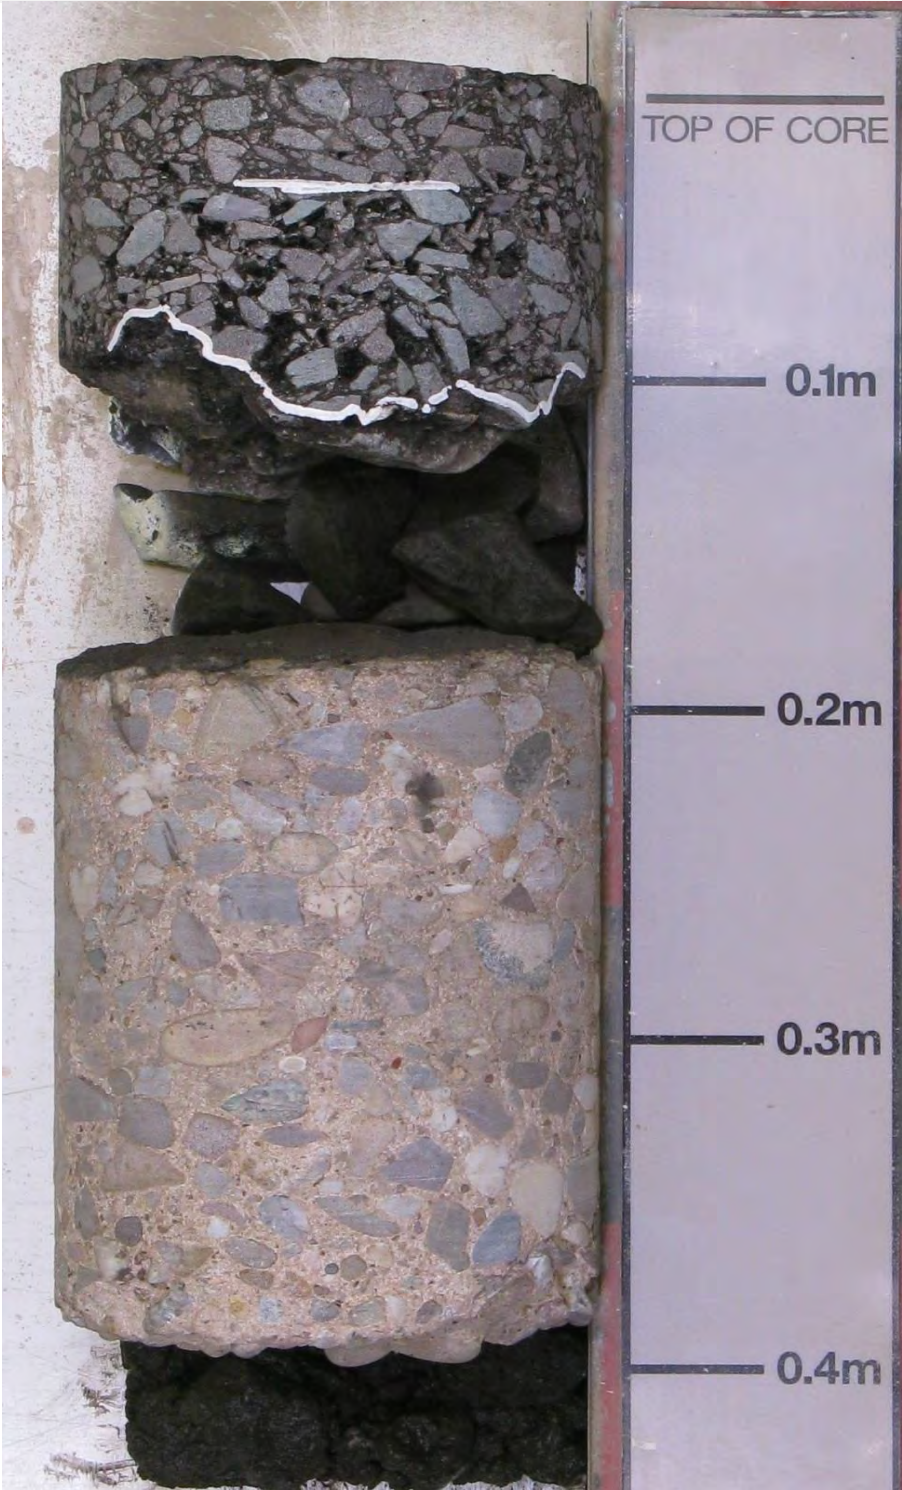
Job Number : 60523093	Scheme : Task 1-111 A5 Warm mix Trials
Sample Number : CR 01096	Location : Northbound, Lane 1, Lane Centre, Offset from nearside white line 1.65m
Core Number : 10	Survey Ch. 130m
Cored / Logged By : TB / RBB	OSGR: SP 29402, 98503
Date Cored / Logged : 14-02-17 / 22-02-17	Notes: N/A
Nominal Diameter : 150mm

Layer	Depth (mm)		Thickness (mm)	Material Description ¹	Suitable for NAT/CS Testing (Yes/No)	PAK-Marker ²	Binder ³	Aggregate	
	From	To						Size ⁴	Type
1	0	40	40	Asphalt Surfacing	Yes	-ve	Bitumen	14	Crushed Rock
2	40	105	65	Asphalt Concrete (broken @ base and voided)	Yes	-ve	Bitumen	20	Crushed Rock
				Layers 2 & 3 Not Bonded					
3	105	175	70	Asphalt Concrete (disintegrated)	No	+ve	Tar	32	Crushed Rock
				Layers 3 & 4 Not Bonded					
4	175	385	210	Concrete - Type B Voids	Yes	n/a	Cement	32	Crushed Rock/Gravel
				Loose Granular Material

Table 7 summarises the core log information. The Tar Spray Test for Poly Aromatic Compounds (PAC) was conducted to check for the possible presence of tar on the cores. It was observed that cores 9, 10, 11 and 13 showed the possible presence of tar on Layer 3 of the cores.

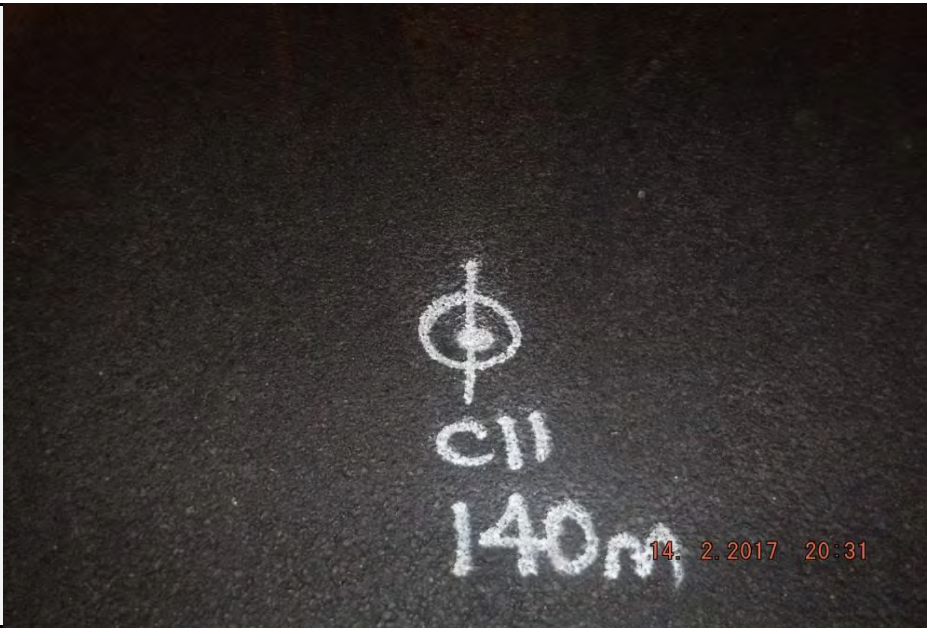
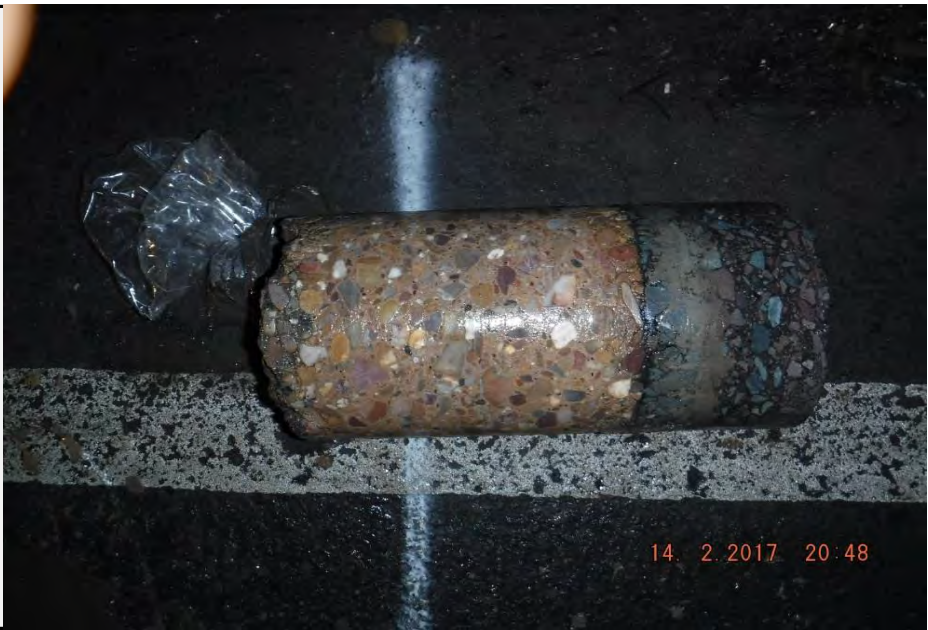
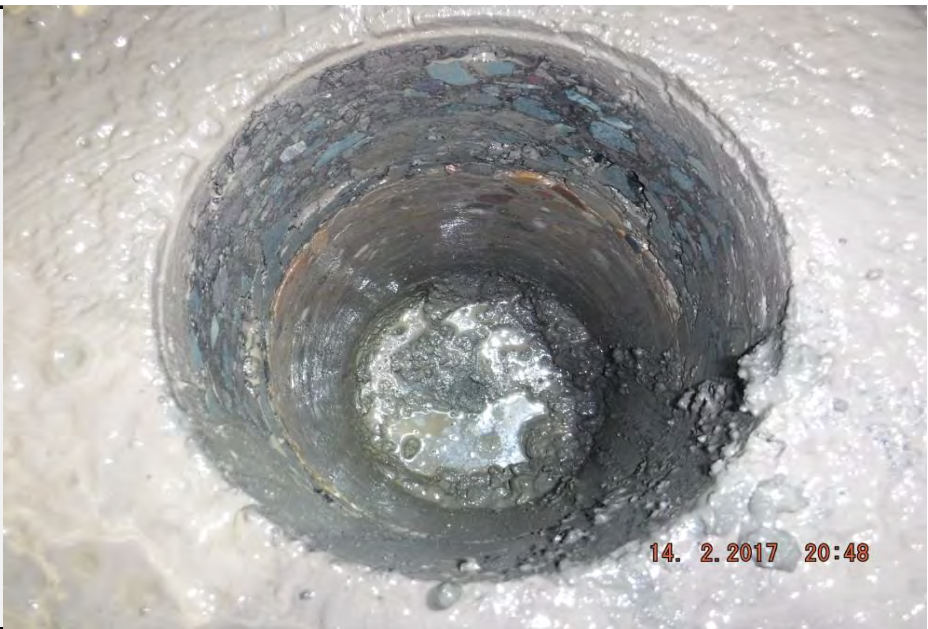
Job Number : 60523093	Scheme : Task 1-111 A5 Warm mix Trials
Sample Number : CR 01096	Location : Northbound, Lane 1, Lane Centre, Offset from nearside white line 1.78m
Core Number : 11	Survey Ch. 140m
Cored / Logged By : TB / RBB	OSGR: SP 29392, 98508
Date Cored / Logged : 14-02-17 / 22-02-17	Notes: N/A
Nominal Diameter : 200mm

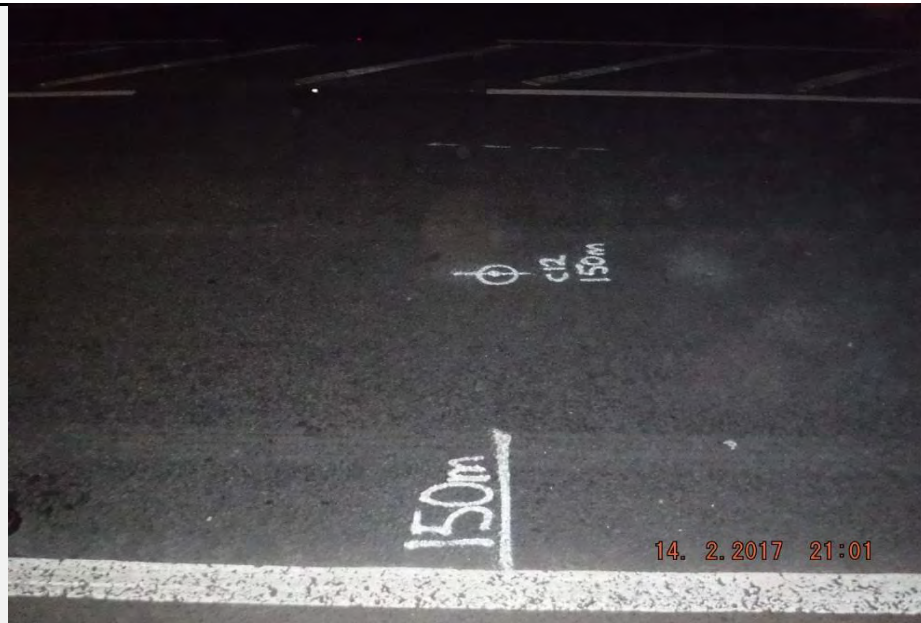
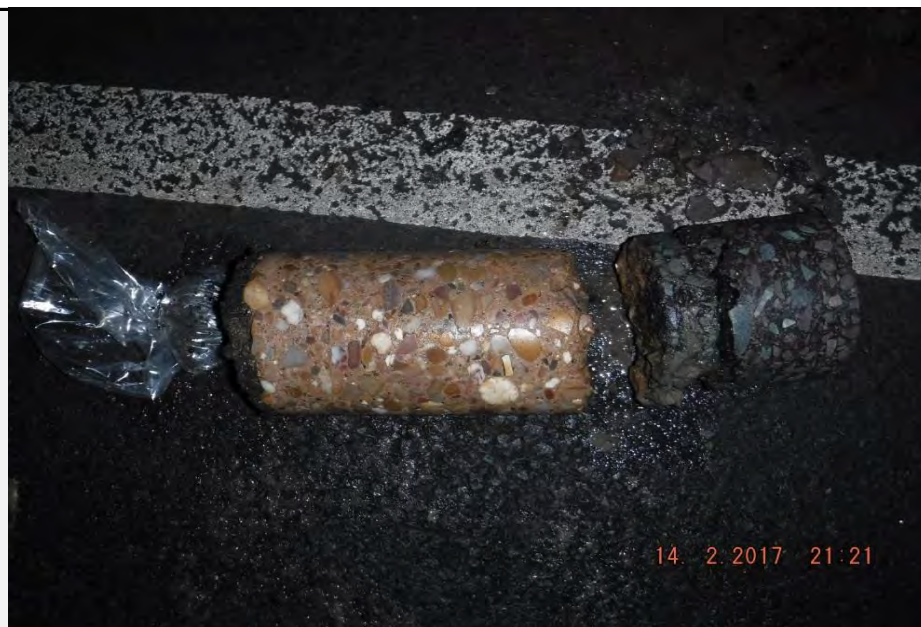
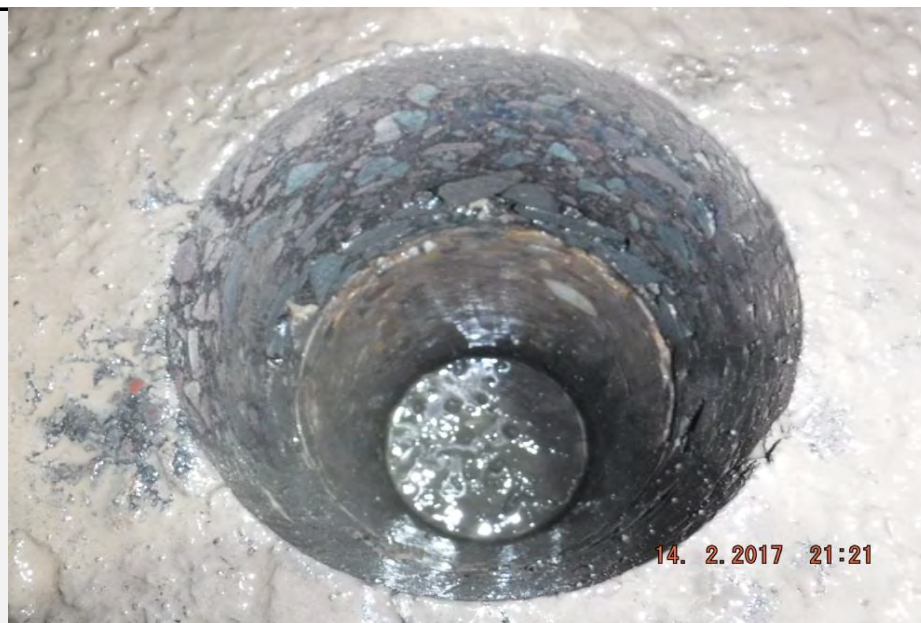
Job Number : 60523093	Scheme : Task 1-111 A5 Warm mix Trials
Sample Number : CR 01096	Location : Northbound, Lane 1, Lane Centre, Offset from nearside white line 1.68m
Core Number : 12	Survey Ch. 150m
Cored / Logged By : TB / RBB	OSGR: SP 29382, 98513
Date Cored / Logged : 14-02-17 / 23-02-17	Notes: N/A
Nominal Diameter : 150mm

Layer	Depth (mm)		Thickness (mm)	Material Description ¹	Suitable for NAT/CS Testing (Yes/No)	PAK-Marker ²	Binder ³	Aggregate	
	From	To						Size ⁴	Type
1	0	30	30	Asphalt Surfacing	Yes	-ve	Bitumen	14	Crushed Rock
2	30	82	52	Asphalt Concrete	Yes	-ve	Bitumen	20	Crushed Rock
3	82	150	68	Asphalt Concrete (damage to face - delaminated @ 12mm)	No	-ve	Bitumen	32	Crushed Rock
				Layers 3 & 4 Not Bonded					
4	150	410	260	Concrete - Type B Voids	Yes	n/a	Cement	32	Crushed Rock/Gravel
				Loose Granular Material

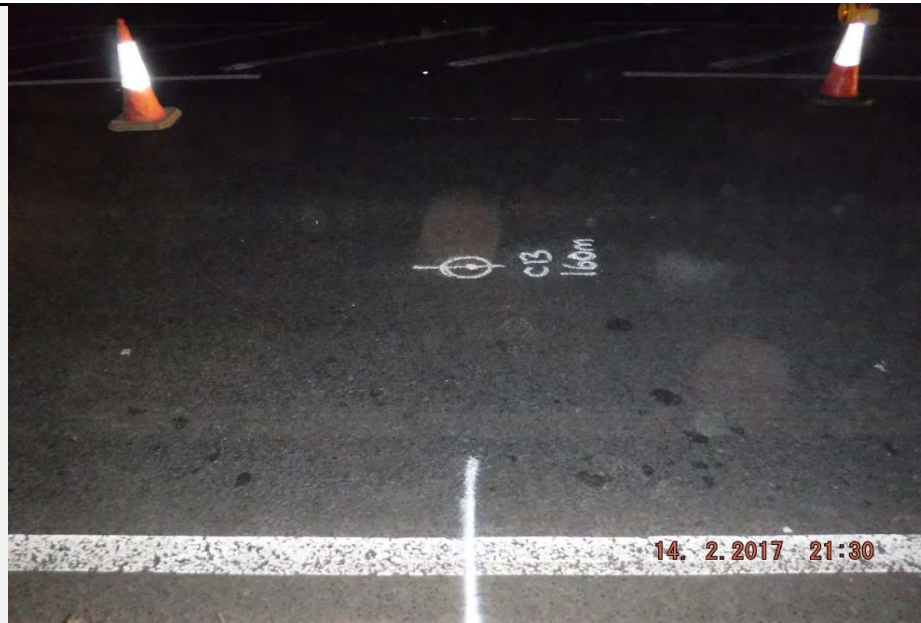
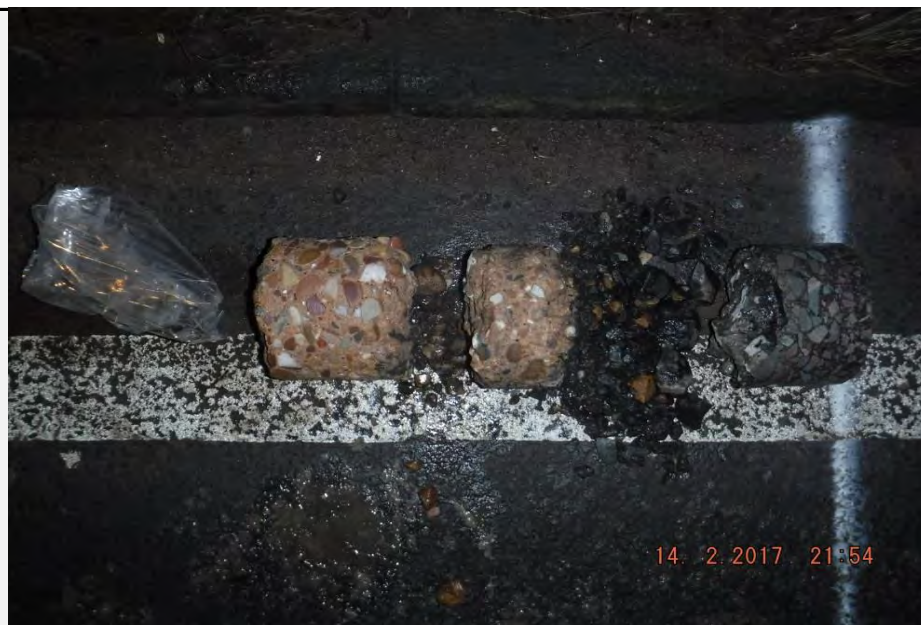
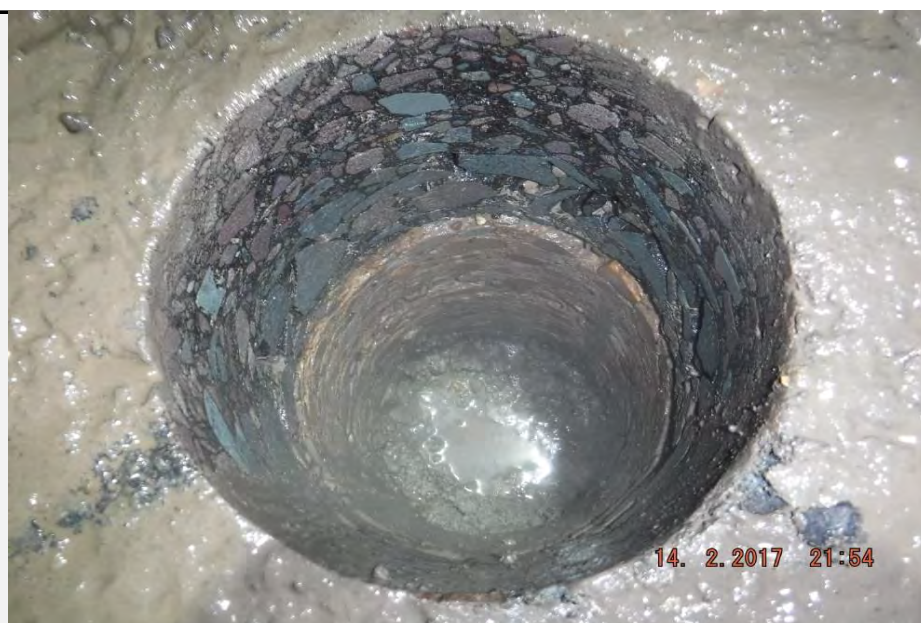
Job Number : 60523093	Scheme : Task 1-111 A5 Warm mix Trials
Sample Number : CR 01096	Location : Northbound, Lane 1, Lane Centre, Offset from nearside white line 1.6m
Core Number : 13	Survey Ch. 160m
Cored / Logged By : TB / RBB	OSGR: SP 29374, 98517
Date Cored / Logged : 14-02-17 / 23-02-17	Notes: N/A
Nominal Diameter : 150mm

Layer	Depth (mm)		Thickness (mm)	Material Description ¹	Suitable for NAT/CS Testing (Yes/No)	PAK-Marker ²	Binder ³	Aggregate	
	From	To						Size ⁴	Type
1	0	30	30	Asphalt Surfacing	Yes	-ve	Bitumen	14	Crushed Rock
2	30	80	50	Asphalt Concrete	Yes	-ve	Bitumen	20	Crushed Rock
3	80	150	70	Asphalt Concrete (broken up)	No	+ve	Tar	32	Crushed Rock
				Layers 3 & 4 Not Bonded					
4	150	435	285	Concrete - Type C Voids (broken up from 260mm - 300mm)	Yes	n/a	Cement	32	Crushed Rock/Gravel
				Loose Granular Material
