Sub-Task 2.2 – Report on A5 Warm Mix Asphalt

Task 1-111 Collaborative Research Project

Highways England, Mineral Product Association and Eurobitume UK

Project Number: 60523093

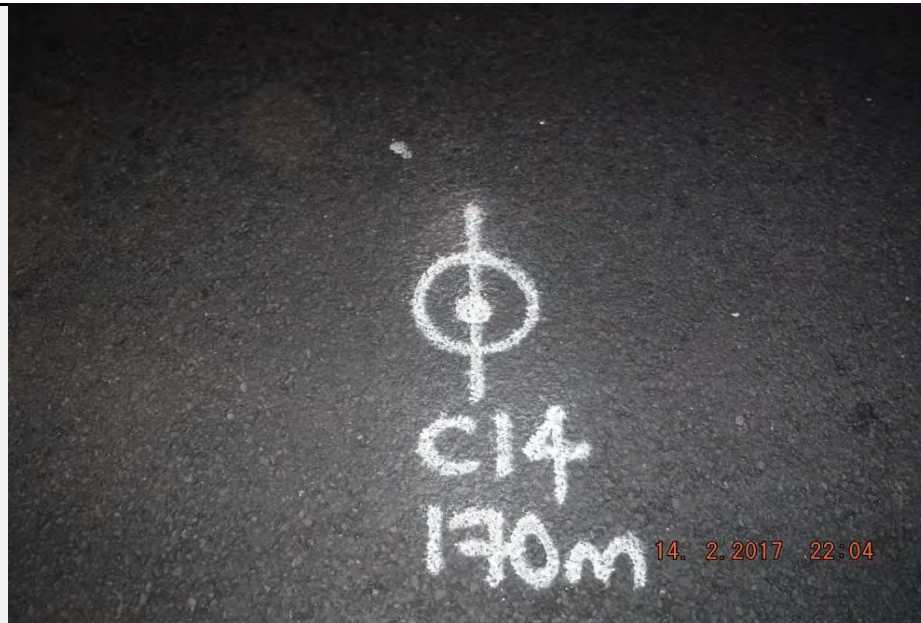
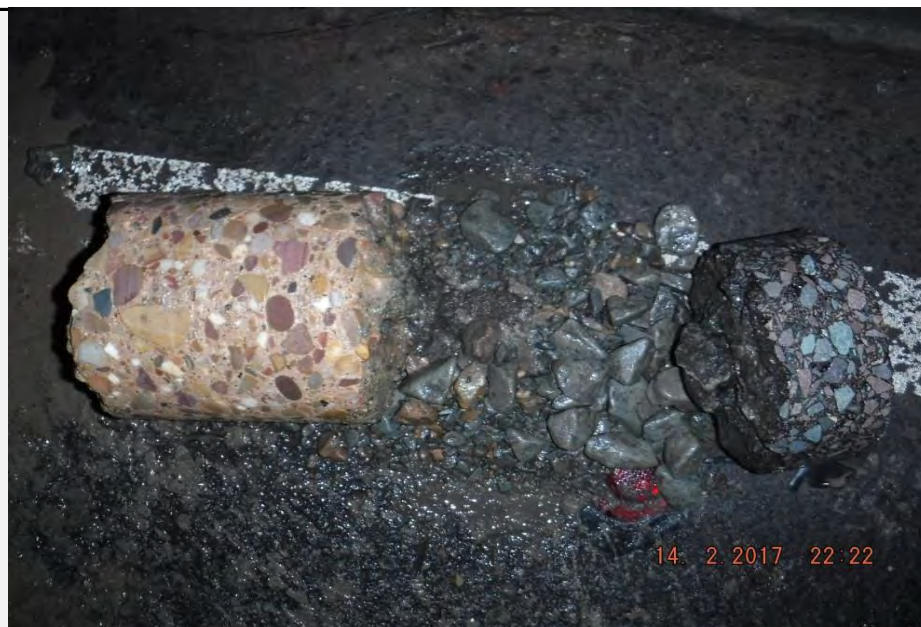
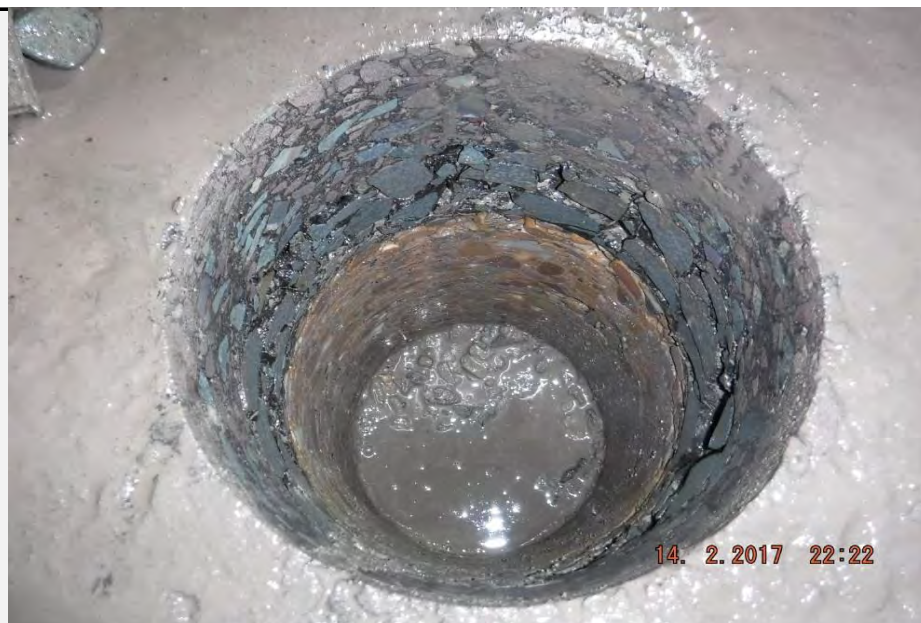
Job Number : 60523093	Scheme : Task 1-111 A5 Warm mix Trials
Sample Number : CR 01096	Location : Northbound, Lane 1, Lane Centre, Offset from nearside white line 1.4m
Core Number : 14	Survey Ch. 170m
Cored / Logged By : TB / RBB	OSGR: SP 29365, 98520
Date Cored / Logged : 14-02-17 / 23-02-17	Notes: N/A
Nominal Diameter : 200mm

Layer	Depth (mm)		Thickness (mm)	Material Description ¹	Suitable for NAT/CS Testing (Yes/No)	PAK-Marker ²	Binder ³	Aggregate	
	From	To						Size ⁴	Type
1	0	36	36	Asphalt Surfacing	Yes	-ve	Bitumen	14	Crushed Rock
2	36	80	44	Asphalt Concrete	Yes	-ve	Bitumen	20	Crushed Rock
				Layers 2 & 3 Not Bonded					
3	80	170	90	Asphalt Concrete (disintegrated)	No	-ve	Bitumen	32	Crushed Rock
				Layers 3 & 4 Not Bonded					
4	170	390	220	Concrete - Type B Voids (broken @ top)	Yes	n/a	Cement	32	Crushed Rock
				Loose Granular Material

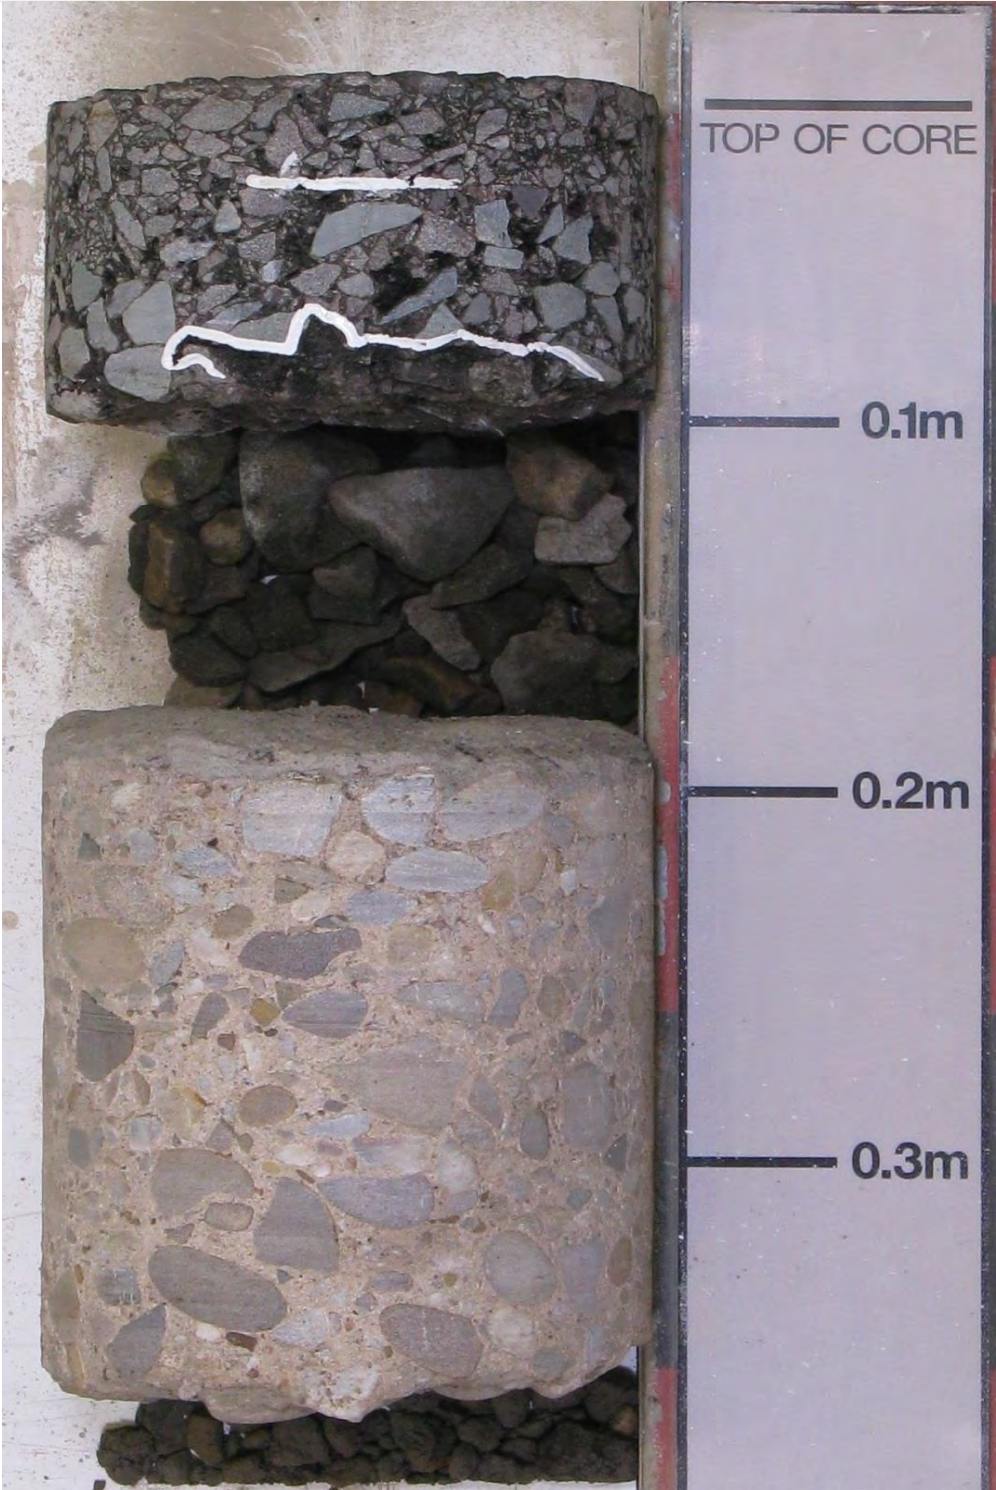
Job Number : 60523093	Scheme : Task 1-111 A5 Warm mix Trials
Sample Number : CR 01096	Location : Northbound, Lane 1, Lane Centre, Offset from nearside white line 1m
Core Number : 15	Survey Ch. 180m
Cored / Logged By : TB / RBB	OSGR: SP 29356, 98523
Date Cored / Logged : 14-02-17 / 23-02-17	Notes: N/A
Nominal Diameter : 150mm

Layer	Depth (mm)		Thickness (mm)	Material Description ¹	Suitable for NAT/CS Testing (Yes/No)	PAK-Marker ²	Binder ³	Aggregate	
	From	To						Size ⁴	Type
1	0	31	31	Asphalt Surfacing	Yes	-ve	Bitumen	14	Crushed Rock
2	31	90	59	Asphalt Concrete (broken @ base and voided)	Yes	-ve	Bitumen	20	Crushed Rock
				Layers 2 & 3 Not Bonded					
3	90	175	85	Asphalt Concrete (disintegrated)	No	-ve	Bitumen	32	Crushed Rock
				Layers 3 & 4 Not Bonded					
4	175	355	180	Concrete - Type B Voids	Yes	n/a	Cement	32	Crushed Rock/Gravel
				Loose Granular Material

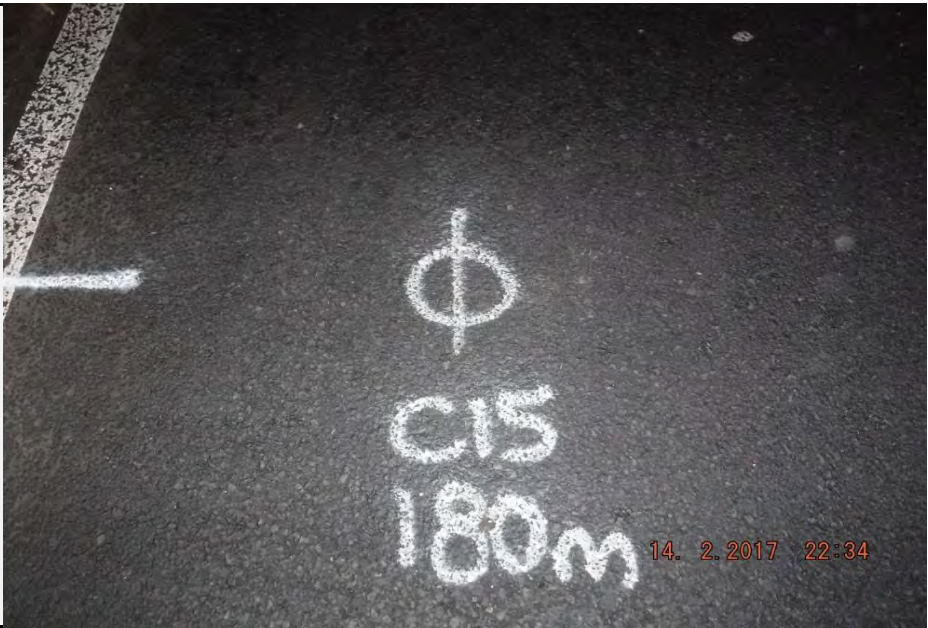
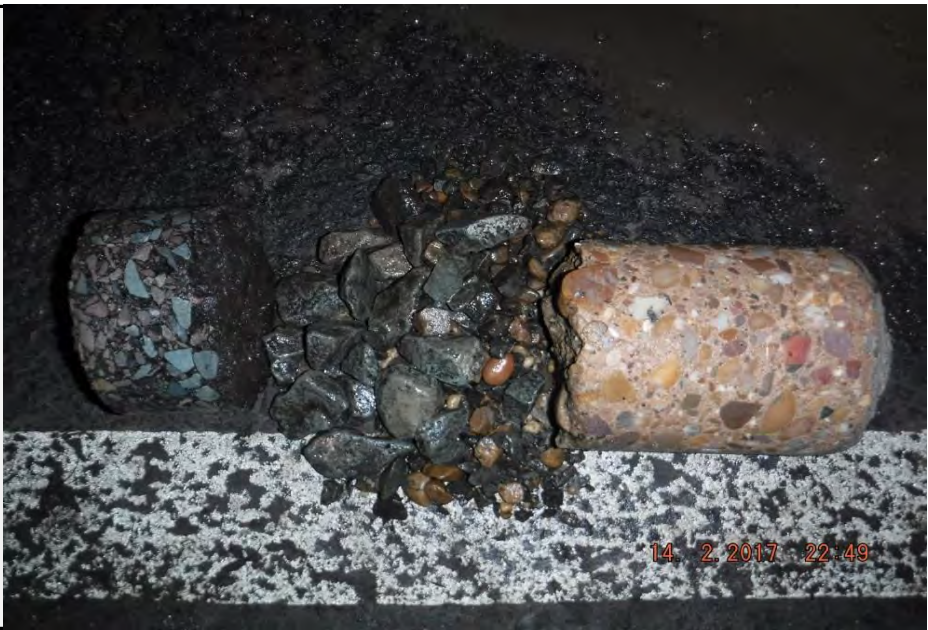
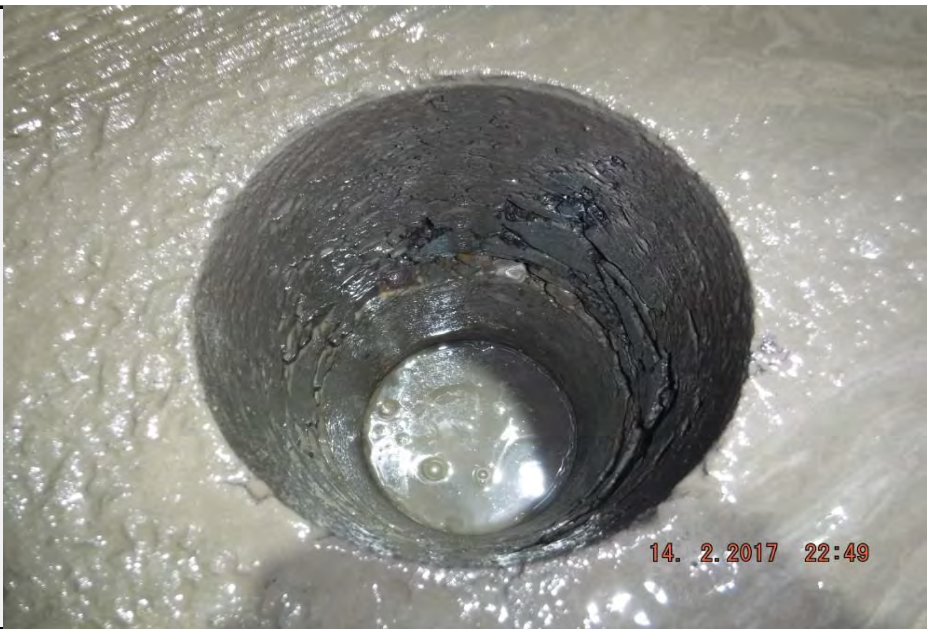
Job Number : 60523093	Scheme : Task 1-111 A5 Warm mix Trials
Sample Number : CR 01096	Location : Northbound, Lane 1, Lane Centre, Offset from nearside white line 1m
Core Number : 15	Survey Ch. 180m
Cored / Logged By : TB / RBB	OSGR: SP 29356, 98523
Date Cored / Logged : 14-02-17 / 23-02-17	Notes: N/A
Nominal Diameter : 150mm

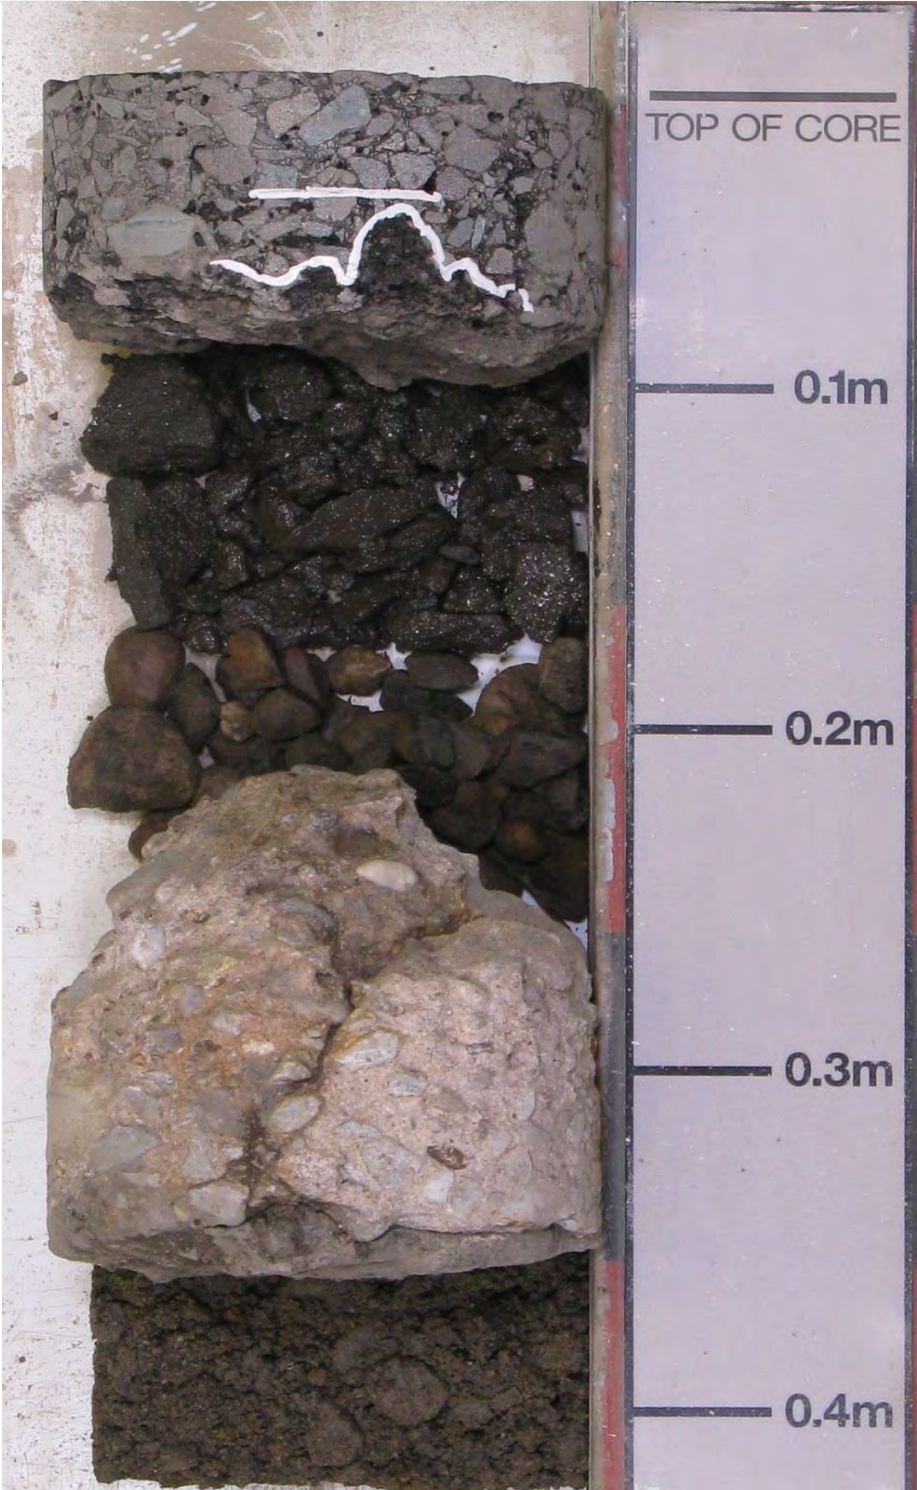
Job Number : 60523093	Scheme : Task 1-111 A5 Warm mix Trials
Sample Number : CR 01096	Location : Northbound, Lane 1, Lane Centre, Offset from nearside white line 0.91m
Core Number : 16	Survey Ch. 190m
Cored / Logged By : TB / RBB	OSGR: SP 29345, 98527
Date Cored / Logged : 14-02-17 / 23-02-17	Notes: N/A
Nominal Diameter : 150mm

Layer	Depth (mm)		Thickness (mm)	Material Description ¹	Suitable for NAT/CS Testing (Yes/No)	PAK-Marker ²	Binder ³	Aggregate	
	From	To						Size ⁴	Type
1	0	35	35	Asphalt Surfacing (voided)	Yes	-ve	Bitumen	14	Crushed Rock
2	35	75	40	Asphalt Concrete (broken @ base)	No	-ve	Bitumen	20	Crushed Rock
				Layers 2 & 3 Not Bonded					
3	75	170	95	Asphalt Concrete (disintegrated)	No	-ve	Bitumen	32	Crushed Rock
				Layers 3 & 4 Not Bonded					
4	170	340	170	Concrete - Type E Voids (broken up)	No	n/a	Cement	32	Crushed Rock
				Loose Granular Material
