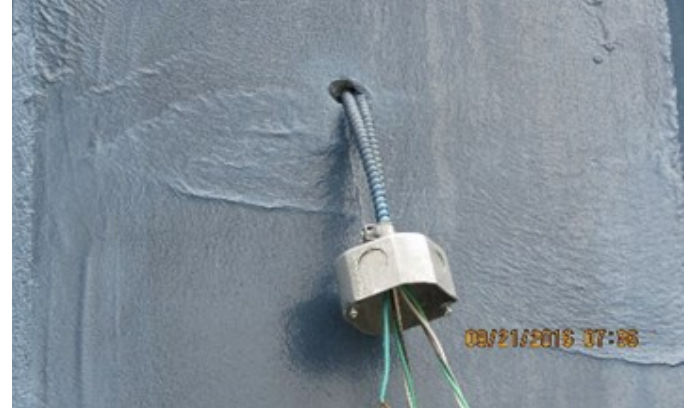
When the project has lightning protection or an exterior grounding wire, the braided wire will likely go through the AVB (or waterproofing).

Braided wires cannot be sealed...unless the wire is made solid. Discuss with the lightning protection and electrical contractor to coordinate a solid section via soldering, installing a solid section of material, or something similar.

Also – make sure that the braided wire is rigidly supported on the interior side.
