Task 318(4/45/12)

Durability of High Friction Surfacing

Report 47070859

Prepared for: Highways England

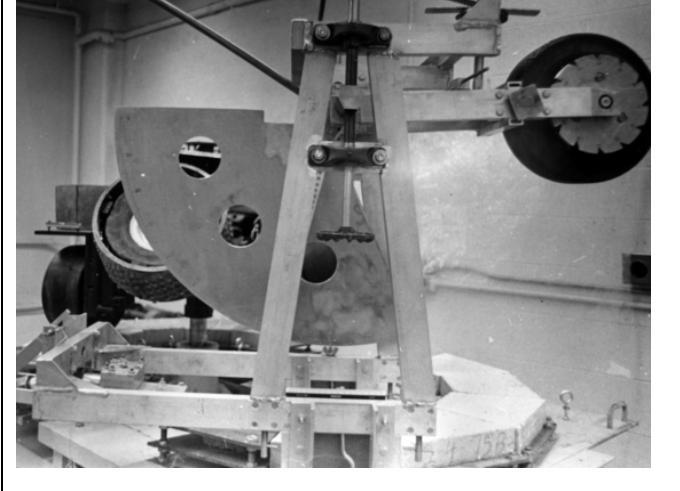
ASTM E660 test method describes a laboratory procedure for estimating the extent to which aggregates or pavement surfaces are likely to polish when subjected to traffic. Specimens to be evaluated for polishing resistance are placed in a circular track and subjected to the wearing action of four small-diameter wheels with or without use of abrasive. Terminal polish is achieved after approximately 8 h of exposure. Pneumatic tyres are used for assessing wear of asphaltic materials whilst steel wheel with studs mounted in the periphery is normally applied for assessing concrete surface. However similar to the limitation of scuffing test, there could be issue with testing thermoplastic HFS as aggregates may become embedded into the material and this may make interpretation become problematic if tests were carried out at elevated temperatures. Furthermore the equipment is not available in the UK.

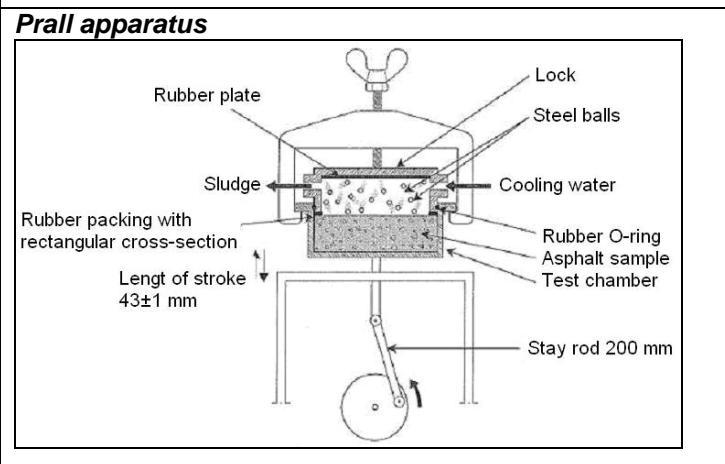
The Prall method is described by EN 12697-16:2004. It was developed to determine wear resistance of asphalt mixtures. The pavement sample with height 30 mm and diameter 100 mm is conditioned in water at 4-5°C, before it is put in a test chamber with 40 steel balls. The steel balls, which are 12 mm in diameter, hammer the sample driven by a stay rod which rotates with 950 RPM, and cooling water is flushed through the chamber with efficiency 2 litre per minute. Particles torn loose from the sample are washed out by the cooling water into a collector and finally the Prall value is calculated. Requirements for resistance to studded tire wear after Prall method, wearing course (Norwegian public road administration, Handbook N200). Nevertheless, Prall test is not a simulative test and the test adaptation in the UK may not be realistic since the use of studded tyres is limited.

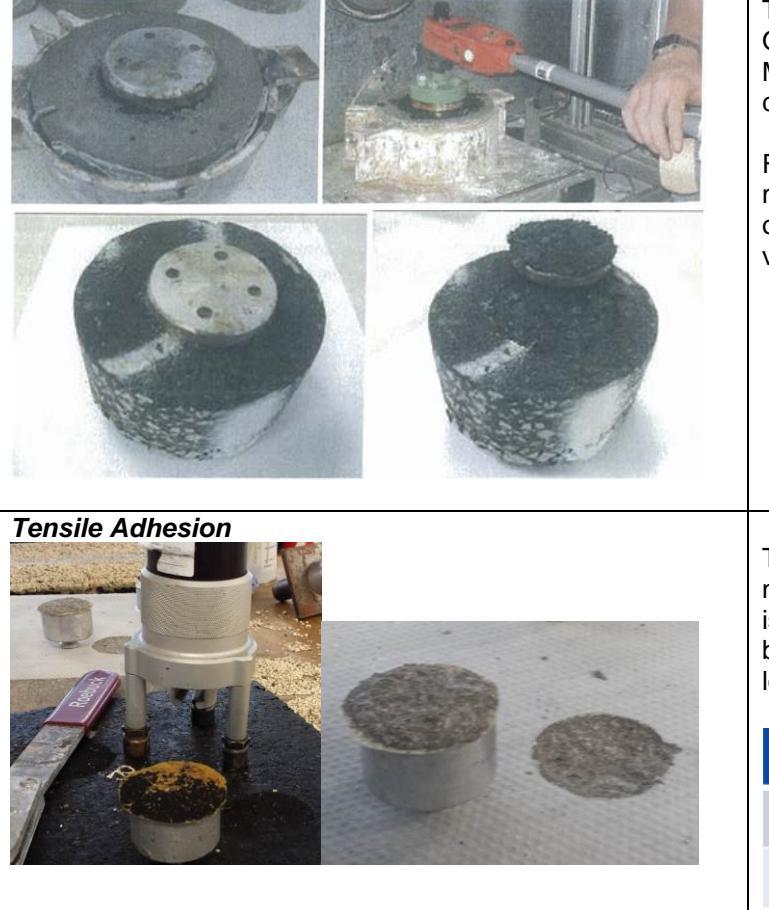
Shear Bond Strength

This test method is currently specified for slurry surfacing produced to Defence Infrastructure Organisation (DIO) Specification 045, to assess early life and long-term performance of the material. Materials meeting Table 4.2 of the specification criteria will be deemed as acceptable under the contract.

Furthermore, DIO has commissioned another study to extend application of this test method to measure surface shear strength of asphalt surfacing. Considering the simplicity and practical aspects of this method, and the track record on its use on slurry surfacing, this method is considered as a viable option for assessing stability of HFS materials.

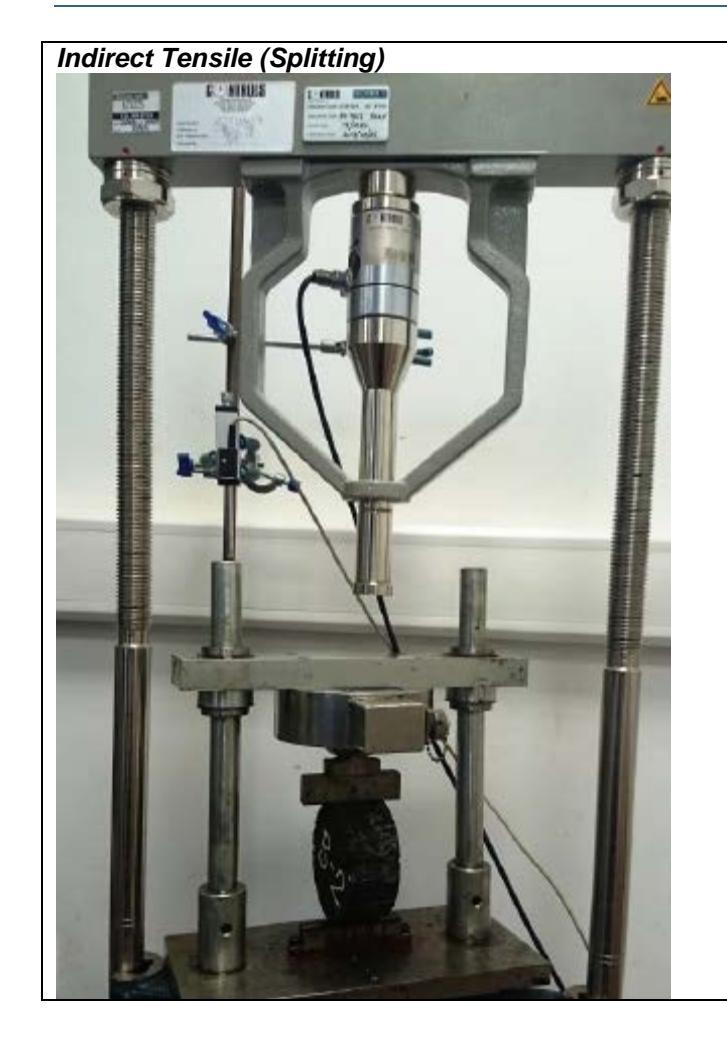
This is a very simple but standardised test which has been widely adopted for concrete and asphalt materials testing. The test involves applying monotonic vertical loading to a cylindrical specimen until the specimen fails into halves (i.e. split) and the maximum force and the associated deformation are recorded. The test does not directly represent resistance of material against lateral force, however it has been known to provide good indication of the binder cohesion in bituminous mixtures which often affected by excessive heating during production. Considering the current practices during laying and production of thermoplastic HFS, where block of cold HFS materials are often re-heated under gas burner prior to laying on site, this test could help in managing the QA/QC (quality assurance/quality control) process during construction.
